Natural migration barriers for fish by hydropower plants

Methods to assess historic passability. Case studies of
migration barriers

Course title: Independent Project/Degree Project in Biology - Master's thesis

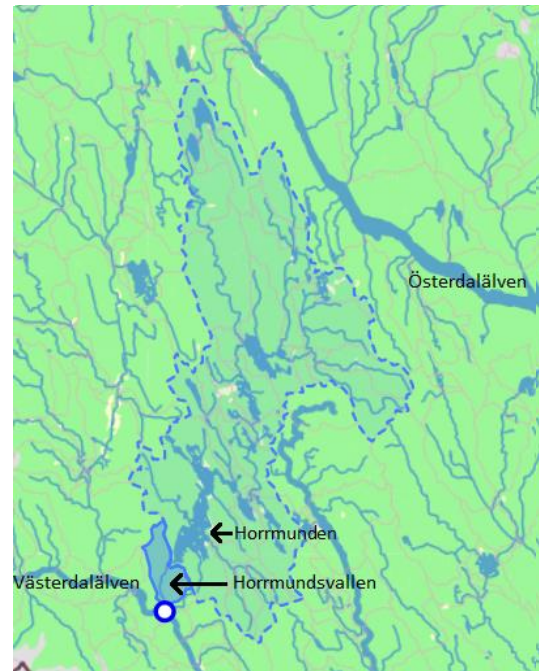
Figure 1: Lake Horrmunden catchment area, dotted line. Horrmundsvallen local catchment area, solid line (SMHI vattenwebb, 2015).

Horrmundsvallen watercourse is located in Malung-Sälén municipality in Dalarna (Figure 1). The river flows into Västerdalälven River and has its original water flow from the Lake Horrmunden. Today there is a hydropower dam that stops the water flowing into Horrmundsvallen. The water goes instead through Horrmundsvalla power station (built in 1960) and passes through a tailrace tunnel directly into Västerdalälven River. The power station has an annual production of 25 GWh and an water capacity of 11 m³/s. Horrmunden has a catchment area of 354 km² and a MQ of 4 m³/s (SMHI vattenwebb, 2015). The land use in the catchment area consists mostly of forest and mire, a total of 90 % (SMHI vattenwebb, 2015) (Figure 2). Horrmundsvallen watercourse has a local catchment area of 10 km². The river is 3.7 kilometers long, with a total vertical drop of 90 m and an average water flow at the mouth to the Västerdalälven River of 0.43 m³/s (local runoff) (SMHI water Webb, 2015). Furthermore, Lake Horrmunden is a storage reservoir with a regulated amplitude of about 2 m. Horrmundsvallen have poor ecological status, mainly because it is a “dry” streambed. An assessment of the ecological status for the watercourse, done in 2009, found it to be in unsatisfying status (VISS, 2015). The biological parameter that was investigated was fish fauna. However, at the same time the fish community parameter was assessed to have good ecological status. The fish community showed a relatively high density of trout (30 ind./100 m²) and a few bullheads were found during the electrofishing in 2006-08-29 (Sers, 2016). In 2015

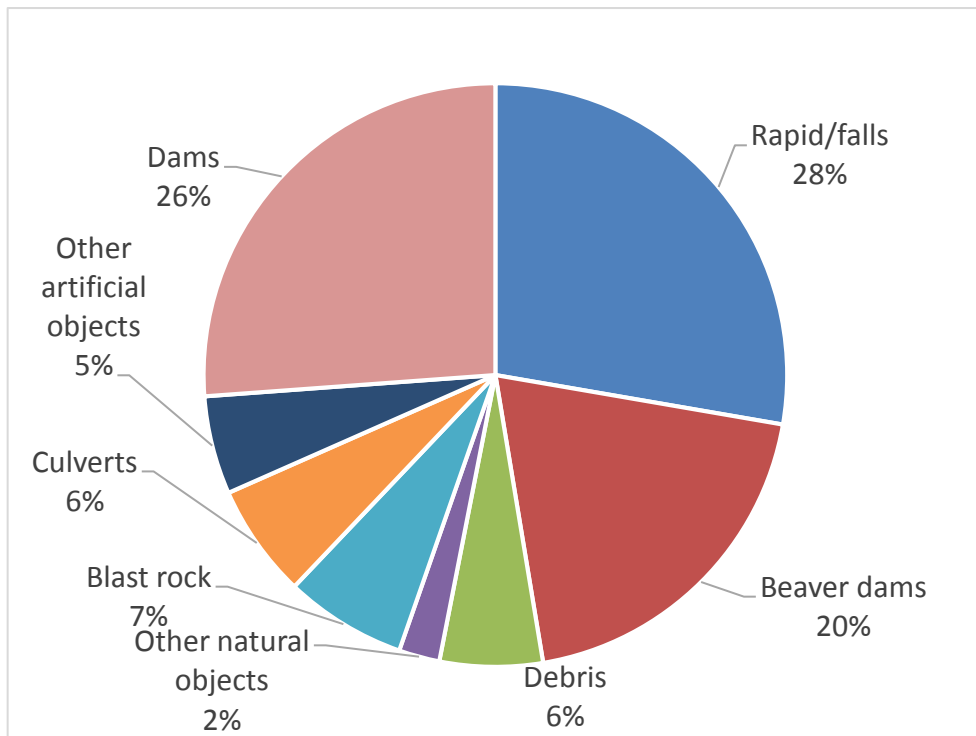
Figure 4: Different types of migration barriers in Värmland. Total 2385 pieces inventoried.

Of the 2385 migration barriers that were surveyed in Värmland, there were most rapids / falls (661 pcs) followed by dams (624 pcs) and finally beaver dams (469 pcs) (Figure 4). Blast rock (161 pcs), culverts (150 pcs), "other artificial objects" (130 pcs) and debris (136 pcs), constituted a smaller part of the migration barriers in the landscape. The fewest migration barriers were made out of "other natural objects", in total 54 pieces. The total distance surveyed was 2903 km long, divided into 478 water bodies. Of the 478 water bodies there were 57 water bodies that completely lacked migration barriers for trout. Migration barriers that are considered natural are rapids / falls, beaver dams, debris and "other natural objects." The artificial migration barriers are dams, culverts, "other artificial objects" and blasted rock. Of the total 2385 migration barriers surveyed, 1319 of these were natural migration barriers and 1066 as artificial migration barriers in a rough estimate.

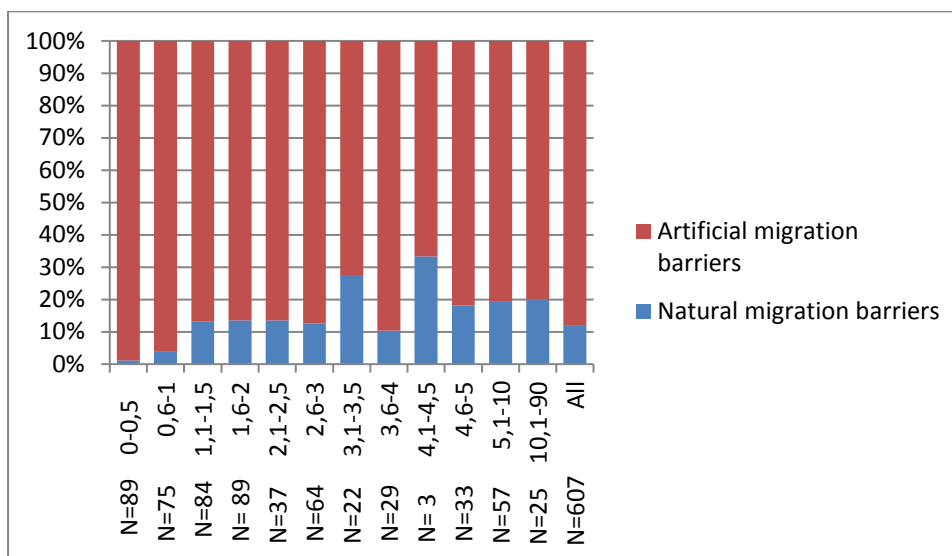
Figure 7: Artificial and natural migration barriers for 607 dams. Dams have been sorted by total height of barriers (not always dam height) in steps of 0.5 m up to 5 m height. Dams that have a total drop height between 5.1 and 10 m represent one interval. All dams over 10.1 m have been sorted to an own interval. N represents the numbers of dams in each interval, note that there is a difference in number of dams in different intervals. Dams that have been classified as uncertain (N=2) have been removed from the figure. Dams that did not have a total height, have also been removed.

Dams that had a total height drop between 0 and 1 m had the lowest proportion of dams classified as natural migration barriers (Figure 7). Of the dams that had a total height drop between 1.1 and 3 m had roughly 12-13 % classified as natural migration barriers. In dams that had a total height drop between 3.1 and 4.5 m there was a varied amount of natural migration barriers. The dams had a higher total height drop of over 4.5 m, 18-20 % were classified as natural migration barriers. For the four height classes, see figure 8 for their 95 % confidence intervals.

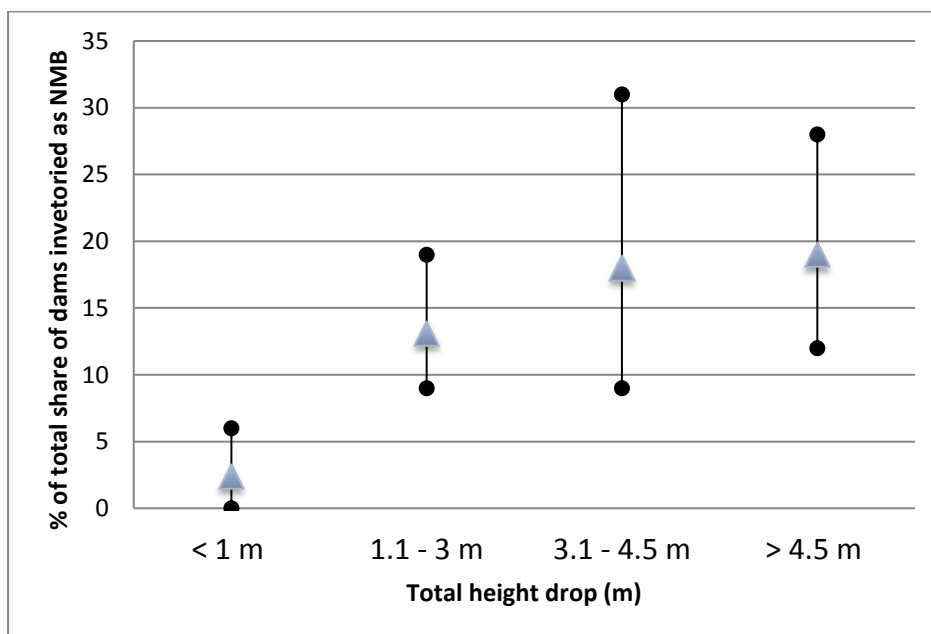
Figure 8: Expected share of natural migration barriers by dams based on the data from habitat mapping in Värmland. Confident intervals (95 %) is based on number of dams that have been classified as natural migration barrier in different height classes. Number of dams in the analysis were 164, 274, 54 and 115 from the lowest to highest interval.

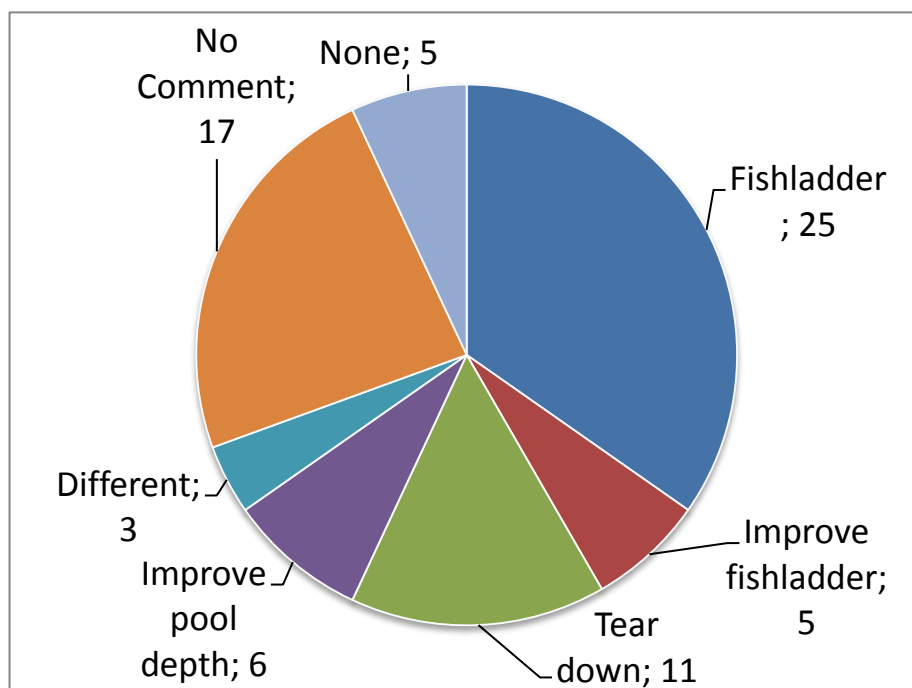
Figure 9: Proposed action to 72 dams that have been classified as natural migration barriers. If there have been several actions suggestions to one dam, only one have been taken into account.

Of the action proposals that are linked to the 72 dams classified as natural migration barriers, 50 dams had proposed actions that were linked to increase fish migration (Figure 9). Only 5 of them stated that nothing should be done, and 17 of them had no comment. For the 661 rapids and falls, there were 258 (39 %) action proposals that can be related to increased fish migration. For the 275 definitive migration barriers for trout in the class rapids and falls, there was 86 (31 %) suggested actions linked to increased migration or dispersal of fish. Furthermore, there was a variation among the survey personnel and how many natural migration barriers were being classed among the dams (which you would expect when different people make different assessment on various dams).

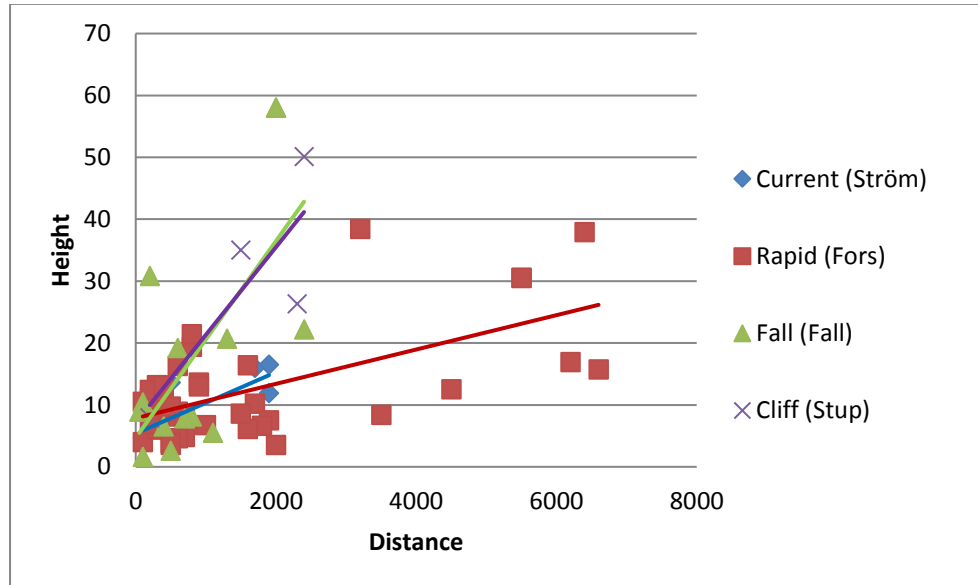
Figure 10: Fall heights and distances for different name endings for some water stretches in bigger rivers in Sweden. The coloured lines represent the best linear model for different endings.

Four names almost always occur in the naming of water stretches that have a higher water velocity than the rest of the watercourse. As stated earlier these are: *current* (-ström), *rapid* (-fors), *fall* (-fall) and *cliff* (-stup). The greatest fall height in the shortest length can be found in water stretches whose names end in *-cliff* and *-fall* (Figure 10). Water stretches whose names ends in *-current* and *-rapid* have comparable slopes with each other and are both lower than *-cliff* and *-fall*. The sub-name

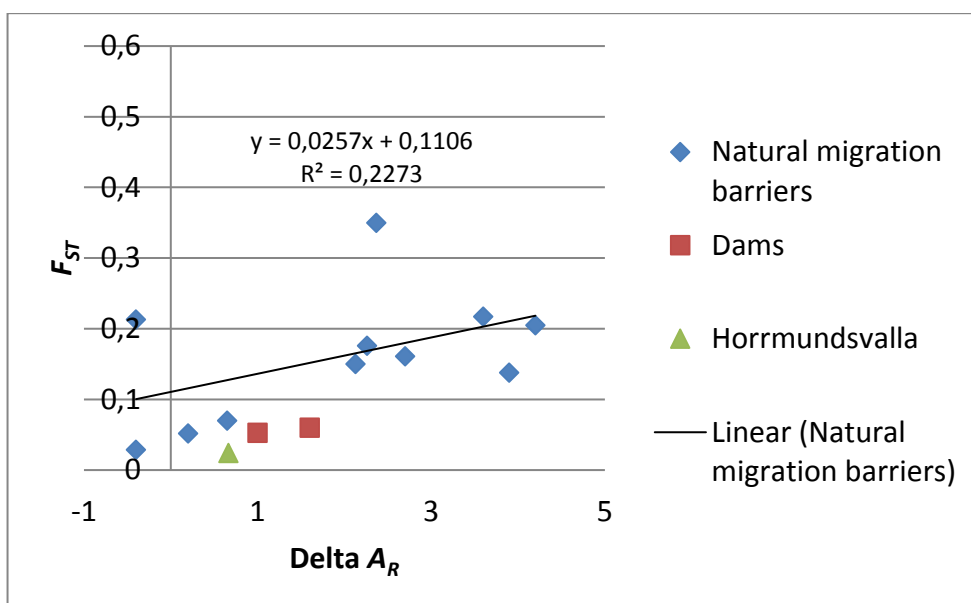
Figure 16: Data from different studies on difference in DNA upstream and downstream waterfalls and dams on Salmonides. ΔA_R (allelic richness) is the difference between downstream and upstream populations. F_{ST} is measure for genetic differentiations between populations.

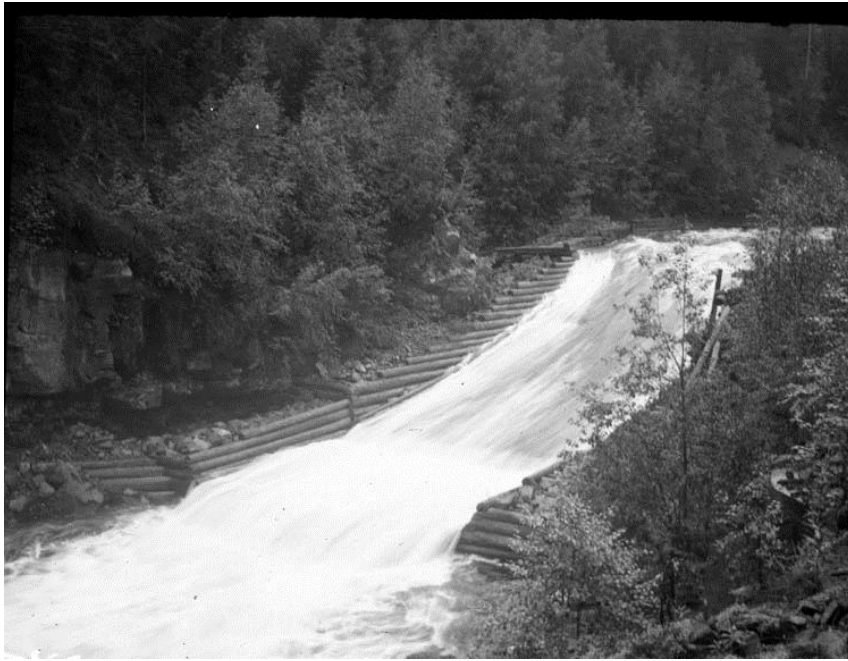
Figure 19: Horrmundsvallafallet, the fall is affected by the log driving activities. A weir has been constructed to make the log driving easier. Stones have been placed in the timber constructions. The picture is taken 1915-07-29 (SMHI, historiskt bildgalleri, 2015).

Four historical pictures of the falls have been found (Figure 18, 19, 20, 21). Two of the photos are taken 1915-07-29 (SMHI, historical gallery, 2015). Figure 18 is from a postcard probably older than 1915, there are no small trees at the side of the fall compared to figure 19. The saw building, belonging to Resjövallens village could also be seen on the picture. The picture was taken in the spring when log driving activities occurred. Figure 19 shows a weir over the fall. Weirs were built to enhance the log drive. It is noted that upstream passage of trout and weak swimming fish species have not likely occurred over the weir. The smaller fall (Figure 20) shows

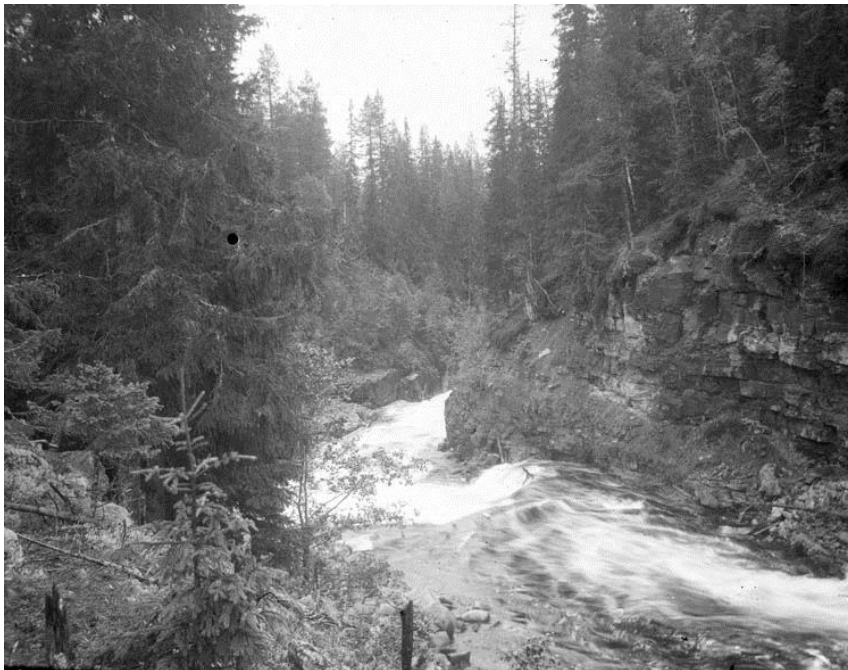
Figure 20: Downstream Horrmundsvallafallet, one cannot clearly see that morphology of the water course has been altered drastically. Picture is taken 1915-07-29 (SMHI, historiskt bildgalleri, 2015).

no signs of human impact. The most recent historic picture (Figure 21) is taken in the summer, the saw building is no longer on the site. One picture was also found of the dam and the railway track over Horrmundsvallen (Figure 22).

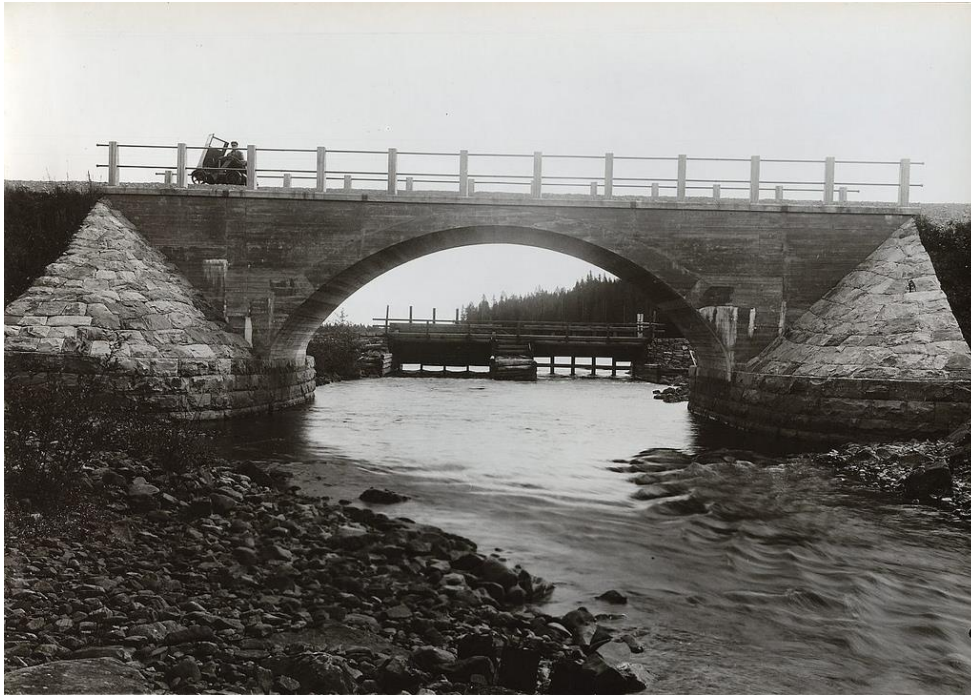
Figure 22: Railway bridge over Horrmundsvallen and the regulating dam by Lake Horrmunden. A person with dresin, picture taken around 1915 (Flickr, Tekniska Museet, 2015)

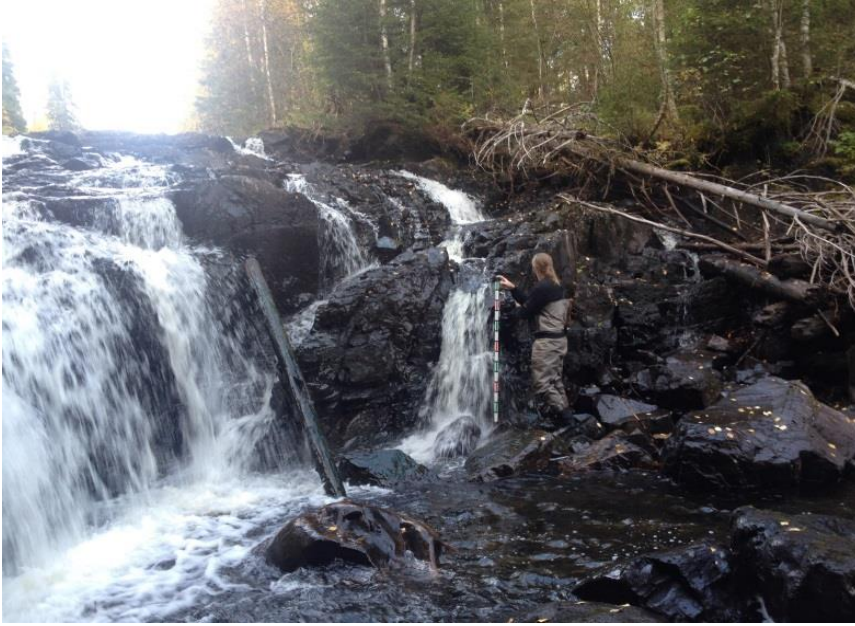
Figure 3: Horrmundsvallafallet today. The rod is 1.5 m high and is held somewhat above the water level to represent more natural water conditions.

During the fieldwork six pieces of falls or rapids were found at stretch no. 3 (Figure 3). The first was about 1.5 m high and had been blasted, like the historical documentation from 1883 was indicating. The second step was slightly smaller than the first one; this one was also blasted. The third, however, was less affected than the first two. The fourth seems to be blasted, but significantly less affected than the first and second rapids. The fifth consisted of a small drop of about 1-1.5 m (Figure 20, 24). The sixth and last was the largest one on the route and is called Horrmundsvallafallet (Figures 18, 19, 21, 23). Rapids and falls 1-5 on the route are historically definite migration barriers to weak swimming fish species and partially passable for trout. Horrmundsvallafallet is and has most likely been a historically (before the weir, in 1870) definitive migration barrier to trout (Annex 1). A good entering approach (pool) does not exist at Horrmundsvallafallet and the trout have no chance to pass the waterfall. None of the previous migration barriers in the stream had the same high magnitude and often there were pools to rest in between the passages for trout. Horrmundsvallafallet is about 8 m high (measured by GPS).

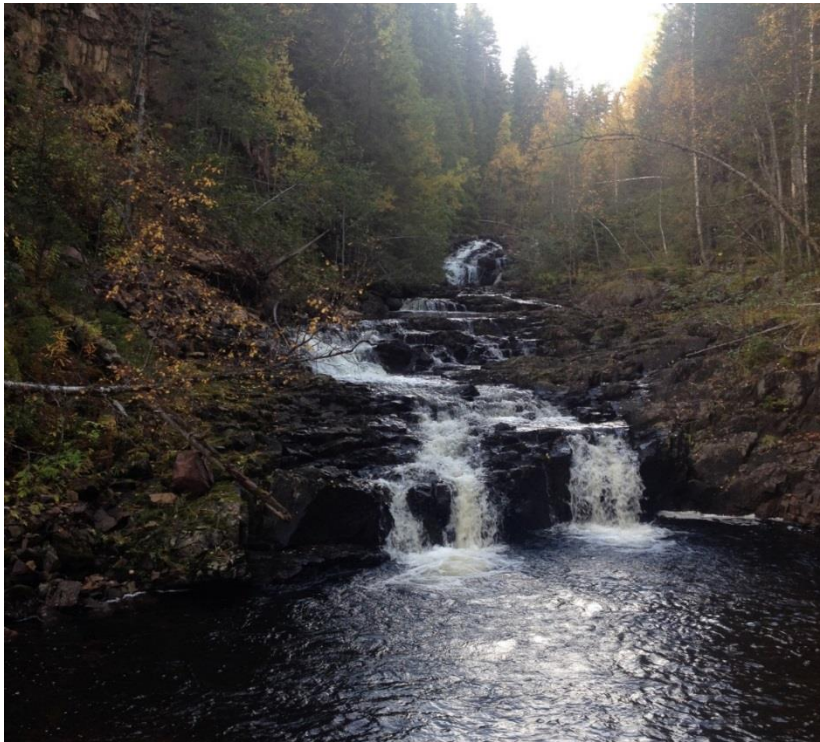
Figure 24: Horrmundsvallafall at longer distance. Compare figure 21, note that the pictures are taken from different places.

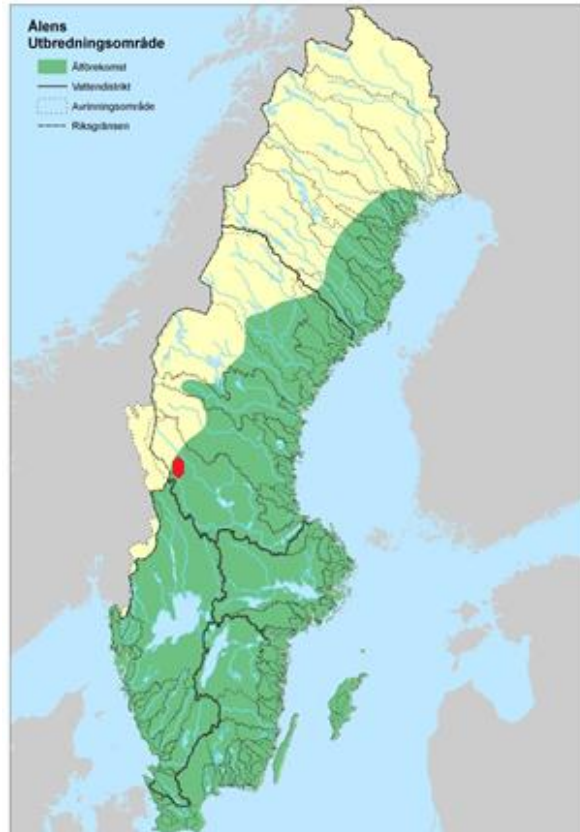
Figure 26: Distribution map for European eel in Sweden (green). Red area denotes Horrmundsvalla catchment area where there is high chance that the eels could not colonize the area because of natural migration barriers. Distribution map (green area) from Clevestam & Wickström, (2008).

smaller falls in stretch three will probably be greater than the critical limit of what eel can swim. My conclusion then is that Horrmundsvallafallet / falls is a definitive natural migration barrier for eel (Figure 26). One cannot be absolutely sure that eels that were caught between 1910 and 1940 in Lake Horrmunden have not been able to get up to the lake by their own. Because no stocking history of eel has been found for the river catchment (stocking history have been found for 1952 and 1953). If eels could pass Horrmundsvallafallet they must have passed the weir, something Håkan Wickström sees unlikely. If stocking of eels can be confirmed between 1910 and 1940, then one can with higher confidence confirm that eels have not been able to pass the falls in Horrmundsvallen. Domnarvet was the first dam that dammed up Dalälven River (1870), and thereby blocking all eel migration upstream. It is prior to Domnarvsforsen being exploited which is considered as a reference condition for eels in this study.
