# **The effect of urban runoff on the water quality of the Sweetbriar Brook, Ampthill, UK**

Examensarbete (Master Thesis)

**Swedish University of Agricultural Sciences  
Department of Soil Sciences  
Division of Hydrotechnics**

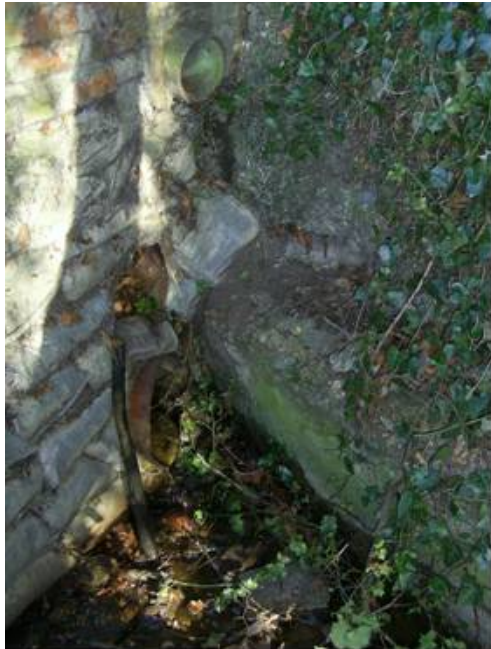
Sampling point 1: the headwall pipes with a continuous, although small, flow in the lower pipe

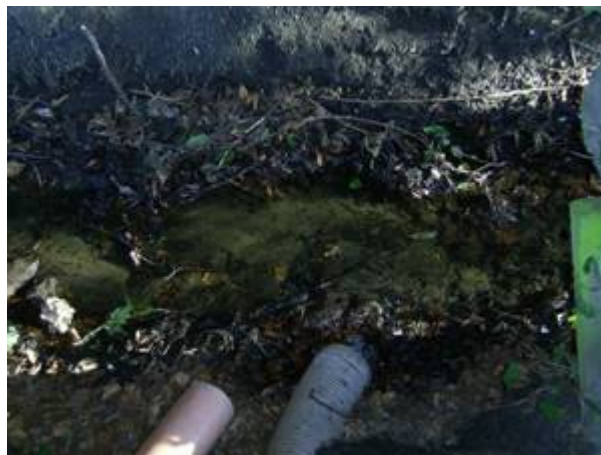
Sampling point 2: 1st tributary pipe with a continuous flow (right pipe on the picture)
