The legacy of the mill – a metal polluted forest soil in Gusum

Master's Thesis in Soil Science
Environmental Pollution and Risk Assessment – Master's programme

SLU, Swedish University of Agricultural Sciences
Faculty of Natural Resources and Agricultural Sciences
Department of Soil and Environment

Keywords: Gusum, copper, zinc, MicroResp, brass, contaminated soil

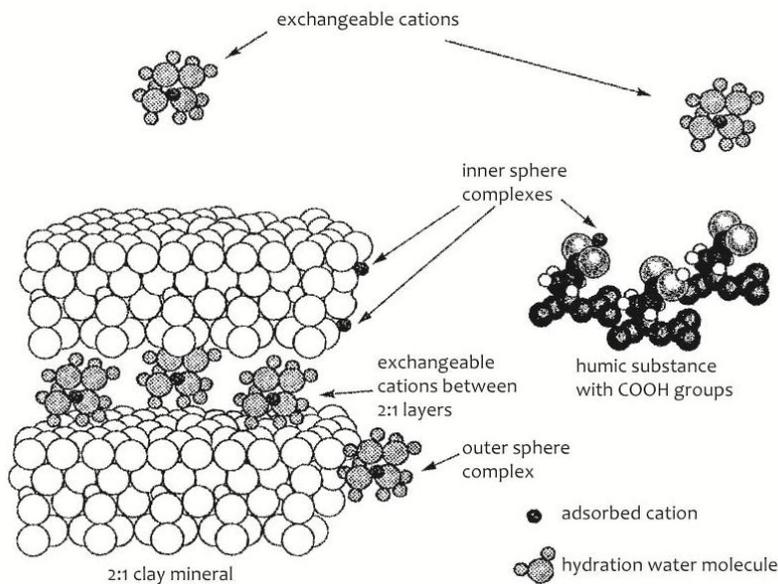
Figure 2. The binding of inner sphere complexes, outer sphere complexes and exchangeable cations to a clay mineral and a humic substance (from Eriksson et al, 2005).

Inner sphere complexes are chemically bound to a specific site on the particle. There is no hydration sphere between the ions. In *outer sphere complexes* the hydration sphere that the ion had before it was adsorbed is retained and the ion is electrostatically bound (Figure 2) (Eriksson et al., 2005).

Ion exchange is another form of electrostatic binding, where the ion is not bound to a specific site on the particle (Figure 2). Ions in ion exchange still have their hydration sphere (Eriksson et al., 2005). Because of the distance caused by the hydration sphere the ions are easily exchanged by other ions. Soil particles in little weathered soils almost exclusively have a negative net charge, which means that adsorption of cations in exchangeable form is much more common than that of anions (Gustafsson et al., 2007).

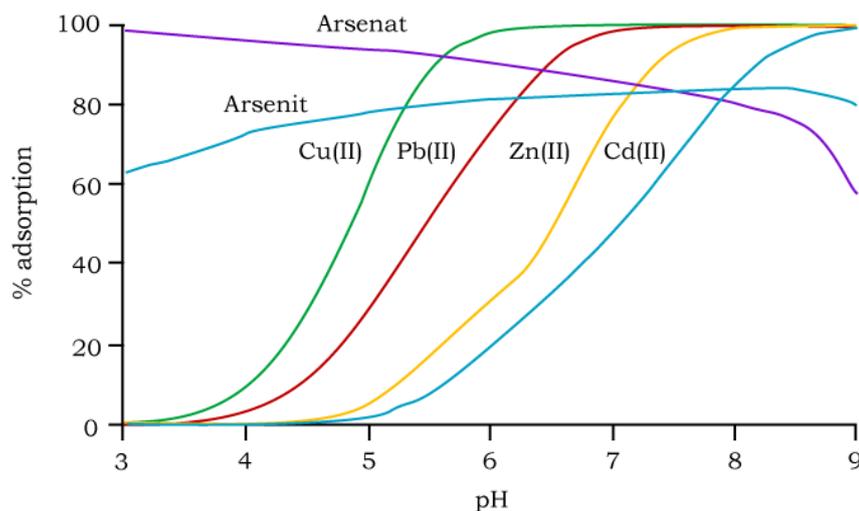
Figure 3. Adsorption of copper, lead, zinc and cadmium to an iron oxyhydroxide (goethite), and its dependence on pH (MiMi, 2003).

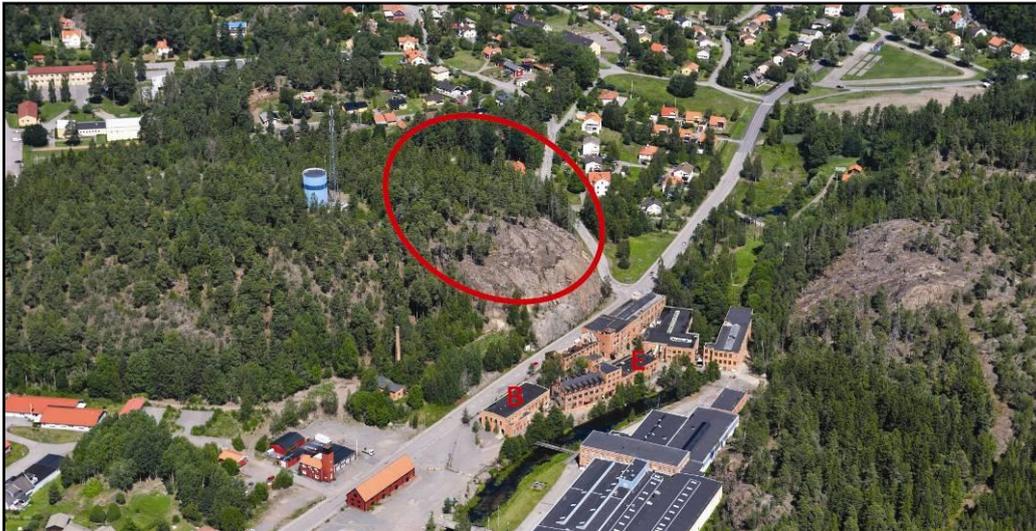
Figure 4. Aerial photo of Gusum, July 2008. The brick buildings in the centre of the photo are the old mill. The smelter was situated in building E 1944-1954 and in building B 1954-1968 (Lindqvist, 2008). Stångberget is the hill to its left and the investigated area marked with red circle on the photo. To the right of the mill another ecologically disturbed area can be seen. (Photo lent by the municipality of Valdemarsvik).

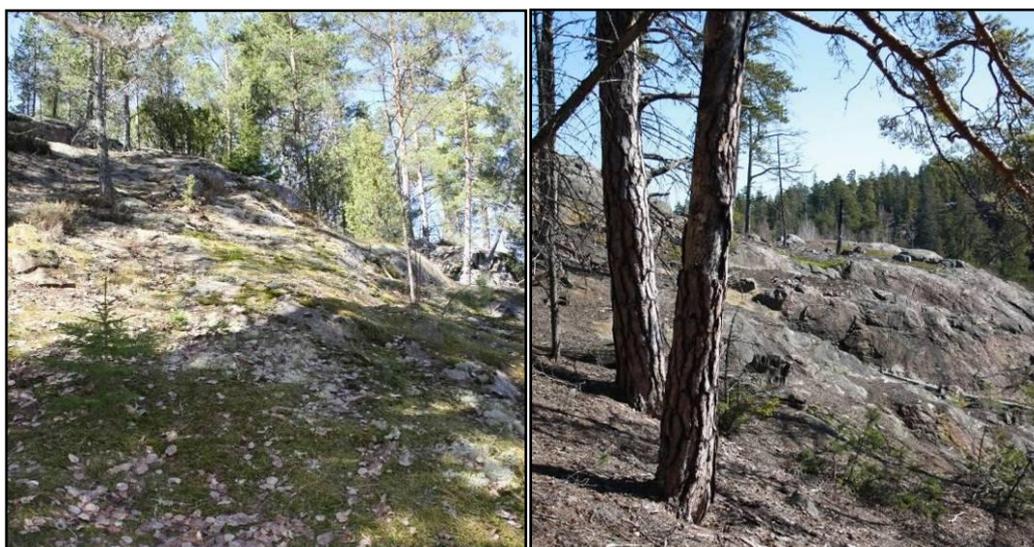
Figure 6. A steep hill on the reference area (left) compared to the steep hill on Stångberget (right). The hill in the reference area is covered with vegetation whereas the hill on Stångberget lies bare except for a few trees and some undecomposed litter. Photos: H. Almqvist 100414.

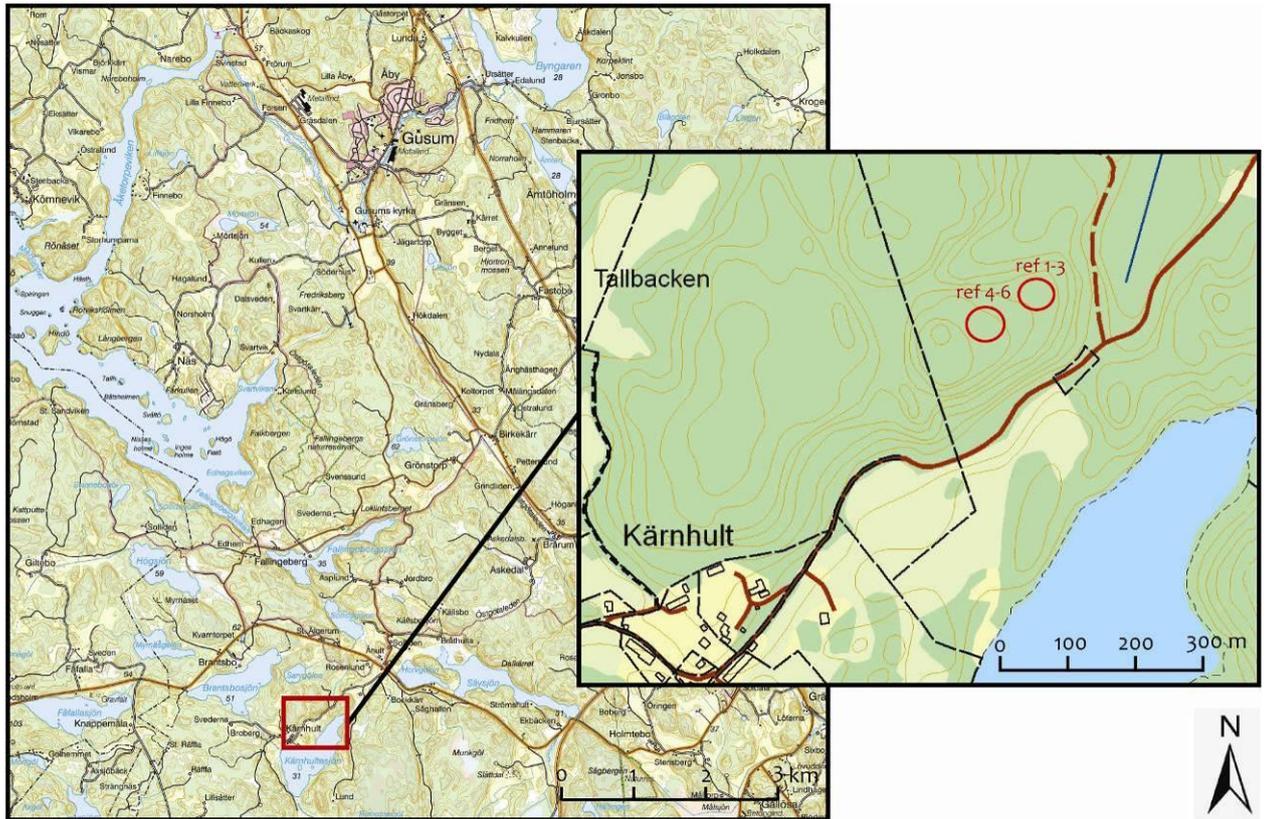
Figure 7. The reference area is located approximately 8 km south of Gusum. The figure also shows approximate locations of sample points. Figure: H. Almqvist, based on maps from Lantmäteriet (© Lantmäteriet Gävle 2010 Medgivande I 2010/0055).

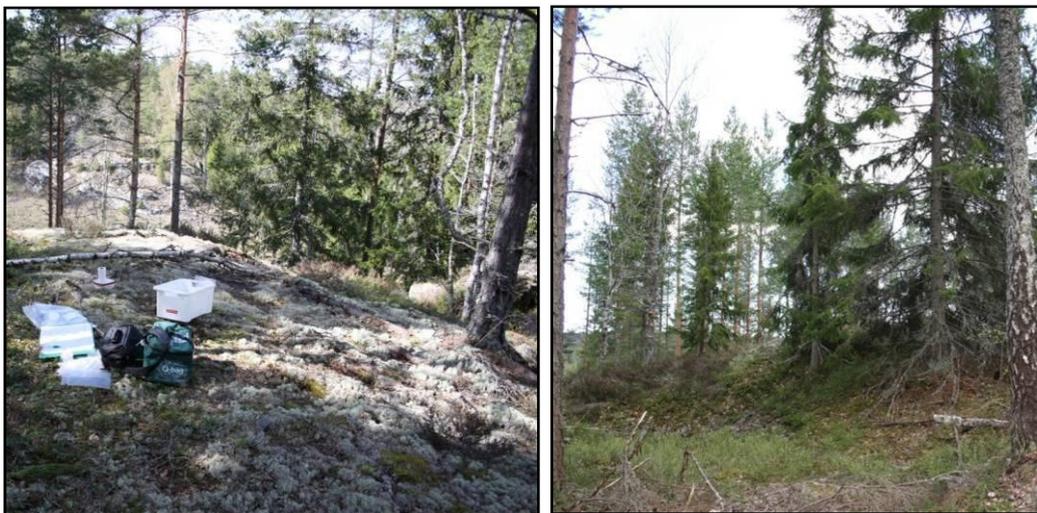
Figure 8. Sun exposed reference area (left), location for samples Ref 1, Ref 2 and Ref 3 and reference area close to spruce stand (right), location for samples Ref 4, Ref 5 and Ref 6. Photos: H. Almqvist 100505

Samples were taken from two parts of the reference area; three samples from a sun exposed part of the hill, close to the hillside, used as reference for the visibly disturbed part of Stångberget which was similarly exposed to the sun, and three samples from a more protected area in the forest, close to a spruce stand, used as a reference for the forested part of the transect on Stångberget (Figure 8).

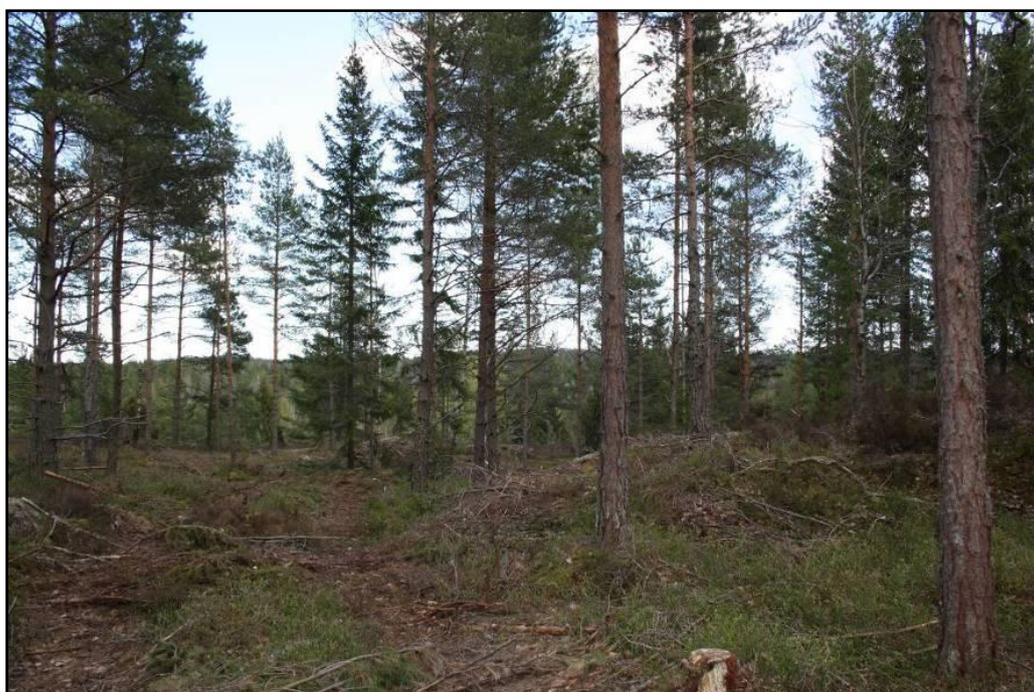
Figure 9. Typical forest in areas little affected by metal pollution around Gusum. Photo: H. Almqvist 100505.

Pine forests and mixed coniferous forests are the dominating forests in the area and low herbs and grasses are the dominating ground covers (Markinfo, 2007a). Figure 9 shows part of the forest near the reference area. The forest consists mainly of pine and some spruce, and the ground is covered by shrubs, such as bilberry, and mosses.

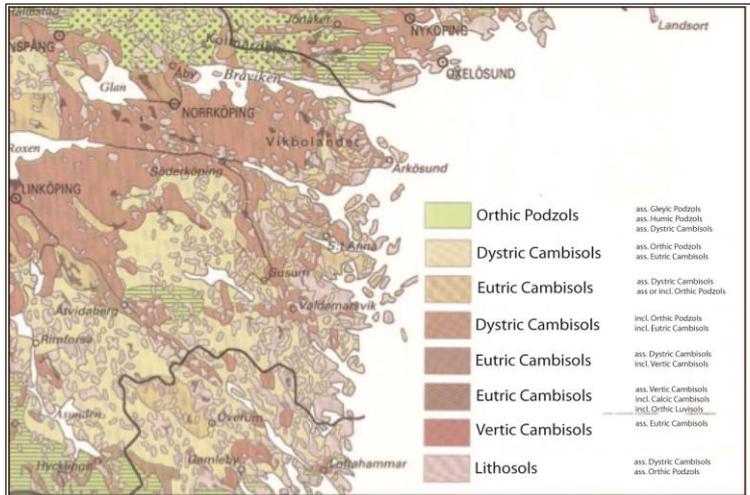
Figure 10. Dominating soil types in eastern Östergötland (from Troedsson & Wiberg, 1986).

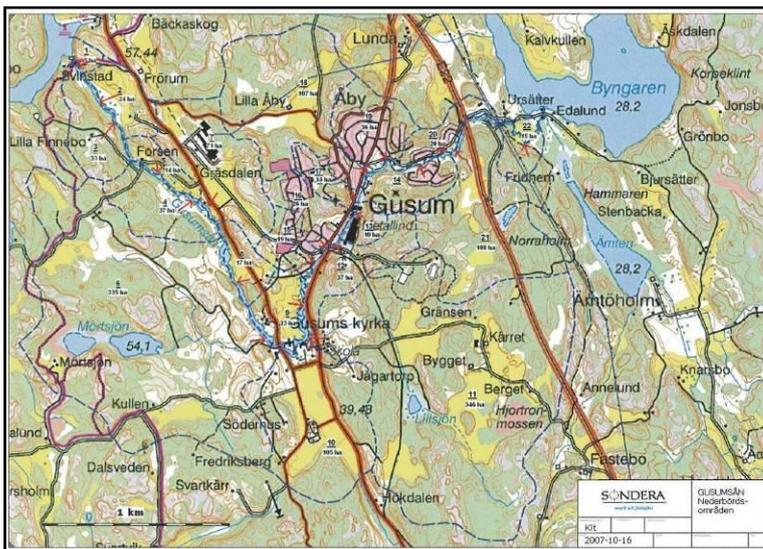
Figure 11. Sub catchments of the Gusum River. Stångberget is in catchments 16 and 17 (Figure: Envipro Miljöteknik, 2008).

The Gusum River has been divided in to 21 sub catchments (Envipro Miljöteknik, 2008). Stångberget is part of two of those catchments, with the dividing ridge line stretching in southeast-north-westerly direction. All sample points for lab analysis are situated in catchment 17. Figure 11 shows the sub catchments of Gusum River.

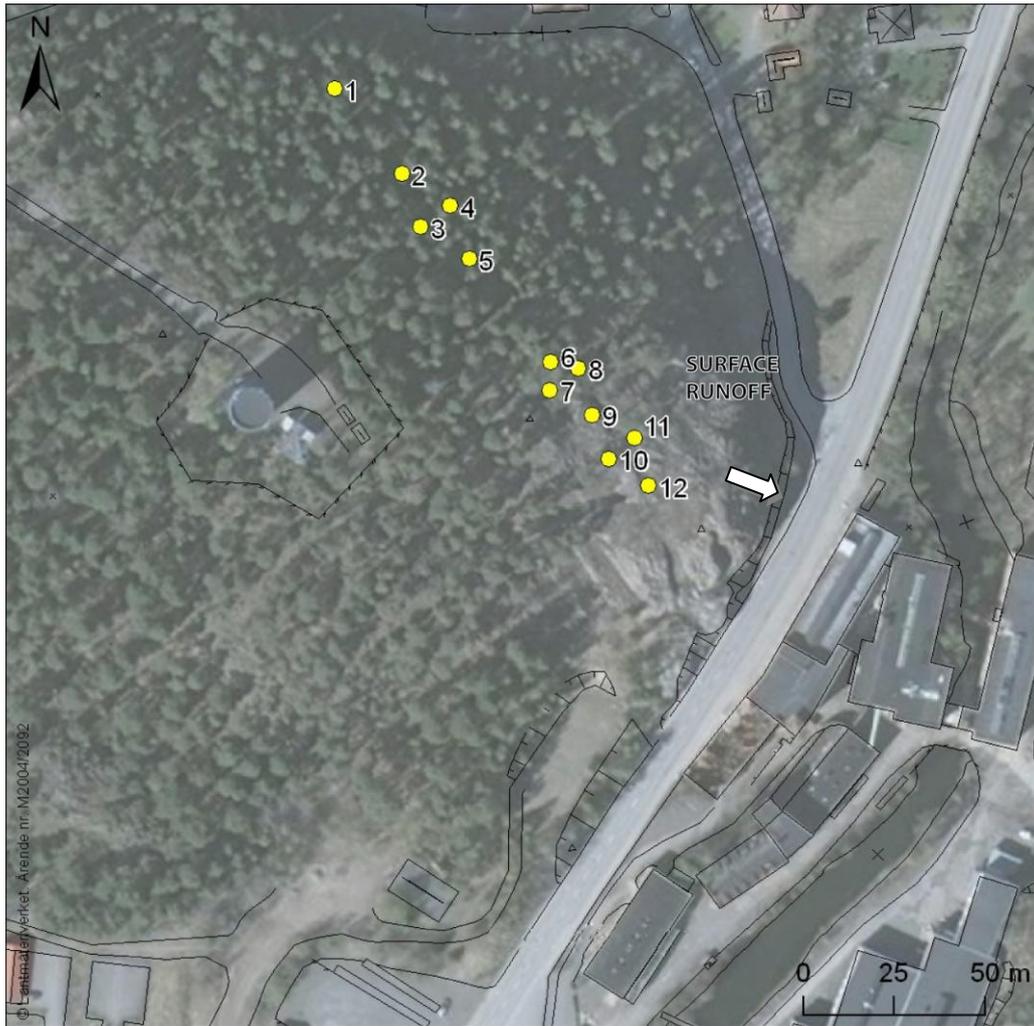
Figure 12. Sample points on Stångberget. Points 1-12 are soil samples and surface runoff a water sample. Figure: M. Sträng, Golder Associates, AB.

XRF measurements were performed in field on April 14 2010. On May 5 2010 samples for metal analysis, carbon/nitrogen, buffering capacity, soil pH, field leach test, sequential extraction, biological and texture analysis were collected from a transect of 150 meters running from the area that the XRF had shown to be highly contaminated and out into the less contaminated area further away from the old mill (Appendix A and Figure 12). At the same time soil depth was measured. Samples were collected from twelve points with a humus drill (Figure 13). From six of the points samples were collected from three layers (0-4 cm, 4-8 cm and 8-12 cm), from the rest only from the top layer (0-4 cm). Several sub samples were taken from each point and soil depth layer and pooled to general samples. The general samples were divided and put in plastic containers (Figure 13). Samples were air dried and sieved to 2 mm. Samples for microbial functional diversity were fresh sieved to 4 mm and preincubated for 20/29 days at 25°C. The top layer soil that were to be analysed for carbon and nitrogen content was fresh sieved to 4 mm, dried and then sieved to 2 mm. Samples for ANC were sieved to 1 mm. Samples for surface runoff were taken on July 27 2010. In Appendix A a table can be found stating which analyses were performed on which samples. Locations of the samples are shown in Figure 12 and in Appendix B photos of the sample points can be seen.

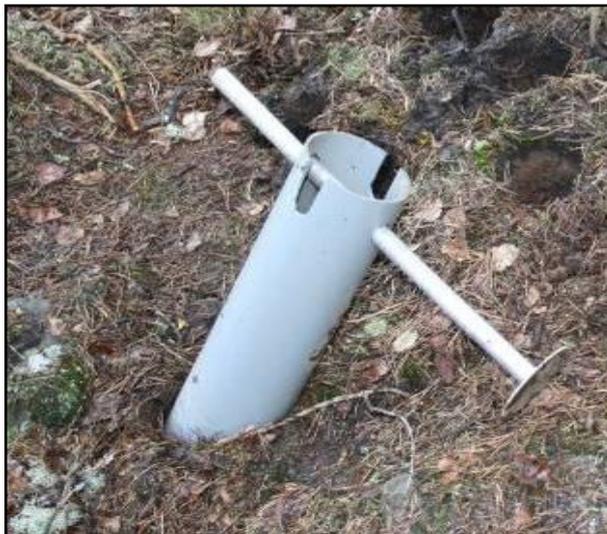
Figure 13. Humus drill for soil sampling. The drill consists of a steel serrated plastic tube, which is rotated down into the soil and pulled up with the soil core. Photo: H. Almqvist 100505.

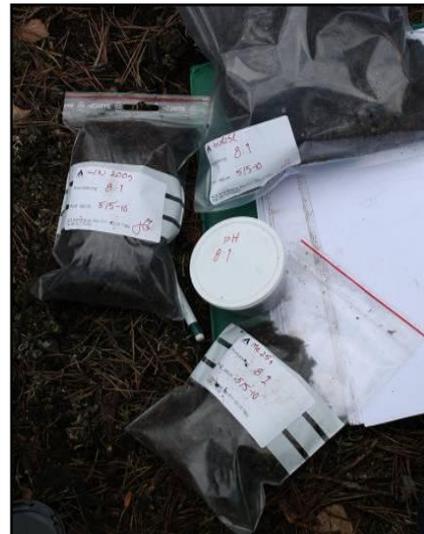
Figure 14. Collecting of soil samples. Photo: H. Almqvist 100505.

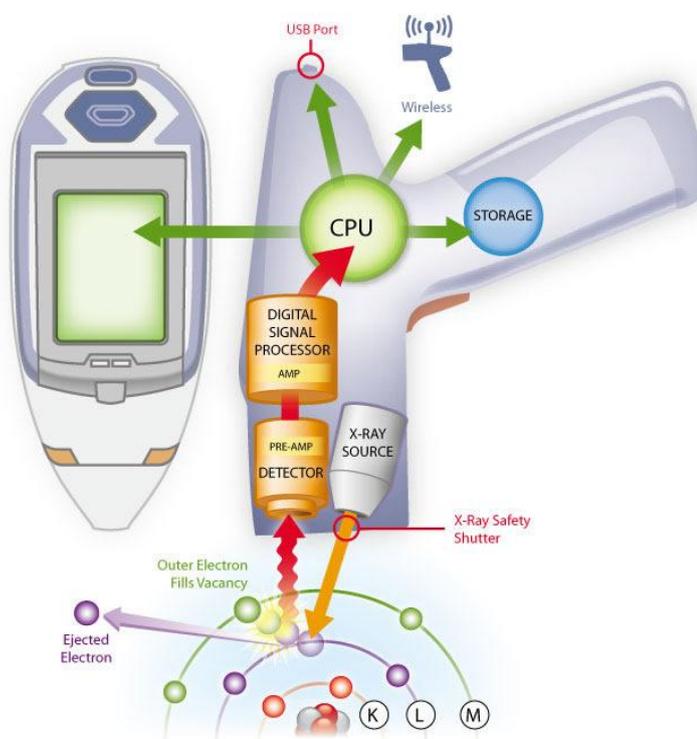
Figure 15. Action chart of Niton XRF instrument (Thermo Scientific, n.d.).

An X-ray Fluorescence Analyzer (NITON XL3t600 XRF) was used to analyze heavy metal concentrations directly in field. The XRF method is based on emissions of photons from excited atoms. X-rays are emitted from the instrument (Thermo Fisher Scientific, 2009) and when hitting an atom an electron can be ejected from an inner shell creating a vacancy. This is an unstable condition for the atom which is neutralized by the transfer of another electron from an outer shell to the free space. This leads to emission of a photon with an energy content characteristic for the specific element. (Kalnicky and Singhvi, 2001). The XRF instrument detects the emitted photons and transforms the information to a metal concentration in the substrate. Table 2 shows the theoretical detection limits for some elements and Figure 16 an action chart of the XRF.

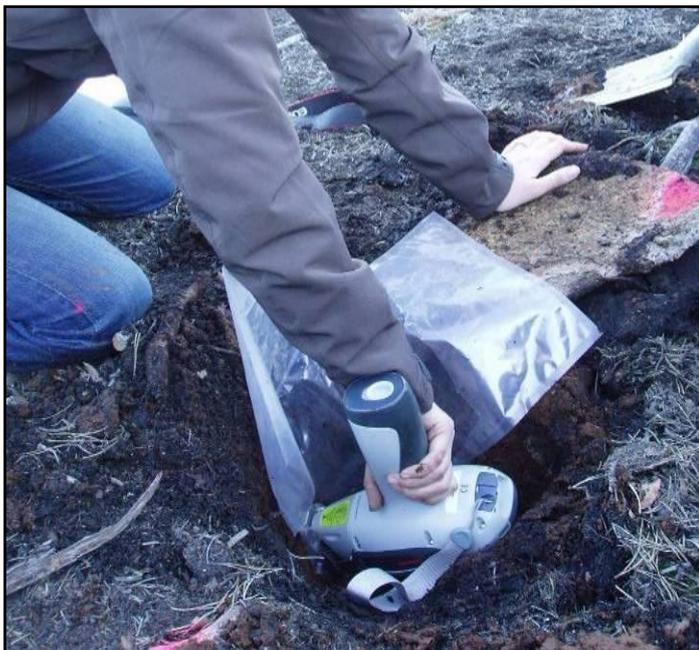
Figure 16. XRF measuring in small trial pit at Stångberget. Photo: S. Dahlin 140410.

with ground vegetation, and on the preliminary transect. Each measurement lasted 60 seconds. The locations of the points were established according to the RT90 system using a GPS instrument (Magellan MobileMapper GPS).

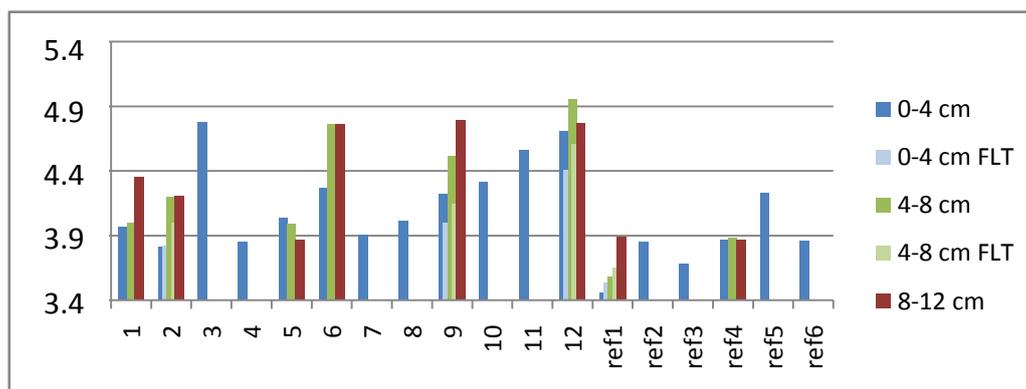
Figure 18. pH of soil solutions from Stångberget and reference area. FLT is pH measured in samples from the USGS Field Leach Test.

pH was higher on Stångberget than on the reference location (Figure 18). Average on Stångberget was 4.3 and on the reference location 3.8. pH was generally higher further down in the profile. pH was also measured in leachate from the USGS Field Leach Test (see chapter 4.6). The two methods gave comparable results. Average pH values were significantly different when comparing surface soils on Stångberget and the reference area ($p=0.027$), but not when comparing lower soil depths (4-8 cm $p=0.072$ and 8-12 cm $p=0.087$).

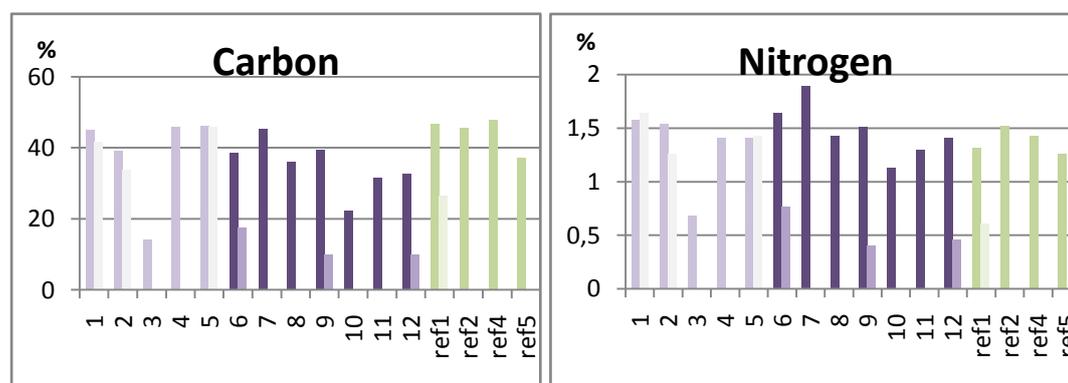
Figure 19. Carbon and nitrogen concentrations [% of dry weight] in the soils from Stångberget and the reference area. Pale purple is from the forested part of Stångberget, purple from the visibly contaminated part and green from the reference area. The left bars on each sample point are samples from 0-4 cm, the right bars samples from 4-8 cm.

Carbon content was between 30 and 50 % for most samples, but a few had a much lower content (Figure 19). Nitrogen content was between 1.0 and 2.0 % for most samples but a few had lower content (Figure 19). No pattern could be seen and there was no significant difference between the subareas (C $p=0.15$, N $p=0.86$). The C/N ratio varied between 20 and 44, significantly highest in the reference area and lowest in the visibly affected area ($p=0.006$). Forest soils often have a ratio of 25-50 in the O-horizon (Eriksson et al., 2005) which means that most samples had a normal C/N ratio.

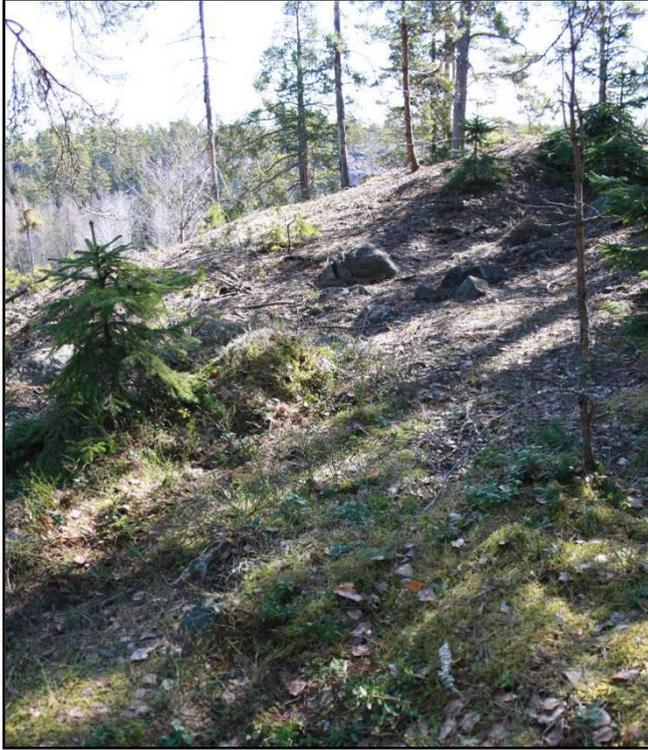
Figure 23. Transition zone on northern part of Stångberget. The transition was sharp where the hilltop shadowed the ground. Photo: H. Almqvist 100505

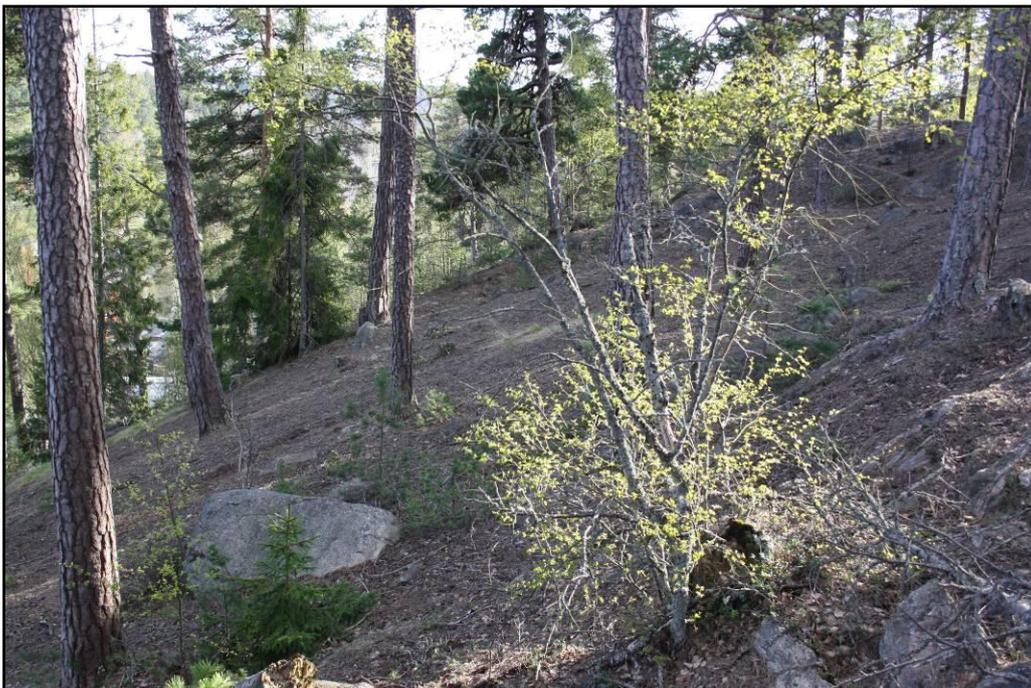
Figure 24. Southern part of Stångberget where the trees were alive but the soil was bare. Photo: H. Almqvist 100505

The southern part of the hill had bare soil but live trees. Soils showed high levels of metal pollution (Figure 24 and points 38-57 on Figure 20), but concentrations were about a tenth of those on the area to the northeast, where both the soil was bare and most trees were dead. The crest was not as steep in the southern part, and therefore the shadow effect from the flue gases not as obvious. Because of that the transit between the visibly affected area and the forested area was more gradual than in the northern part of Stångberget.

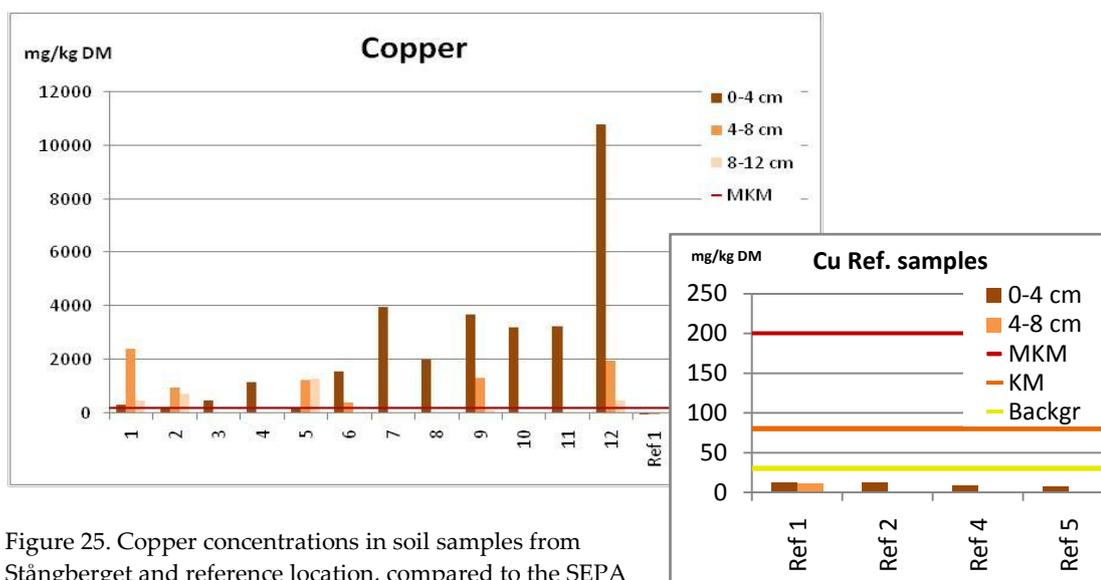
Figure 25. Copper concentrations in soil samples from Stångberget and reference location, compared to the SEPA guideline values for soil environment. (MKM = less sensitive land use, 200 mg/kg DM, KM = Sensitive land use, 80 mg/kg DM Backgr = background value, 30 mg/kg DM).

Copper was the metal showing the highest concentrations relative to the guideline values (Figure 25). On the worst affected point the concentrations were more than fifty times the MKM value (10800 mg/kg DM) and on several other points the levels were 16 to 20 times MKM. The whole hill showed concentrations above the MKM value and concentrations were higher on the visibly affected part than in the forest. On the reference area the concentrations were below the Swedish background value.

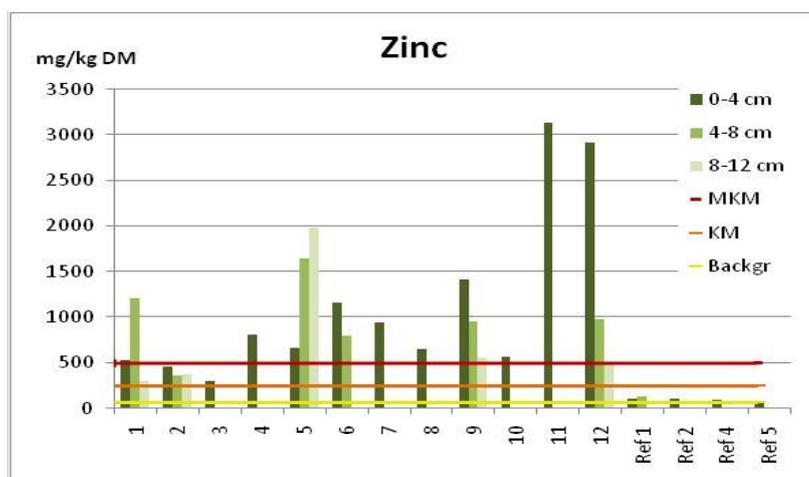
Figure 26. Zinc concentrations in soil samples from Stångberget and reference location, compared to SEPA guideline values for soil environment (MKM = less sensitive land use, 500 mg/kg DM, KM = Sensitive land use, 250 mg/kg DM Backgr = background value, 70 mg/kg DM).

Nine of the twelve sample points on Stångberget showed zinc concentrations above MKM in one or more soil depths (Figure 26). On the worst affected points concentrations were around 6 times MKM (the highest concentration was 3140 mg/kg DM). On the reference location values were above the Swedish background value.

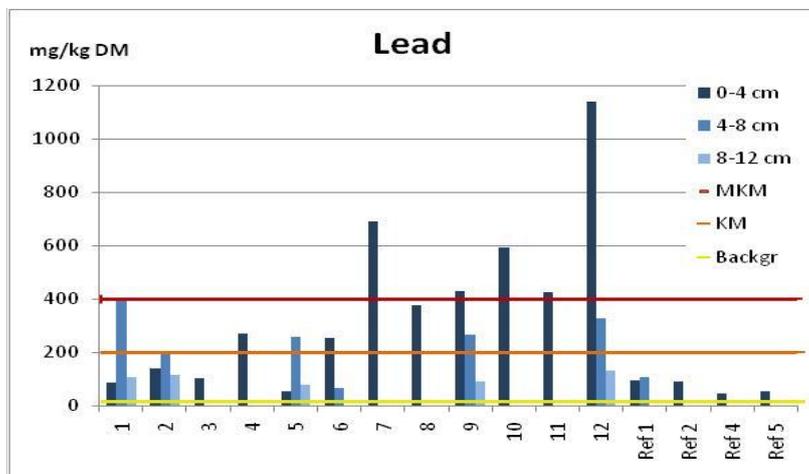
Figure 27. Lead concentrations in soil samples from Stångberget and reference location, compared to SEPA guideline values for soil environment (MKM = less sensitive land use, 400 mg/kg DM, KM = Sensitive land use, 200 mg/kg DM Backgr = background value, 15 mg/kg DM).

Lead showed values above MKM in five points, the highest one being three times MKM (1140 mg/kg DM) (Figure 27). All concentrations above MKM were from sample points on the visibly affected area. The reference values were quite far above the Swedish background value.

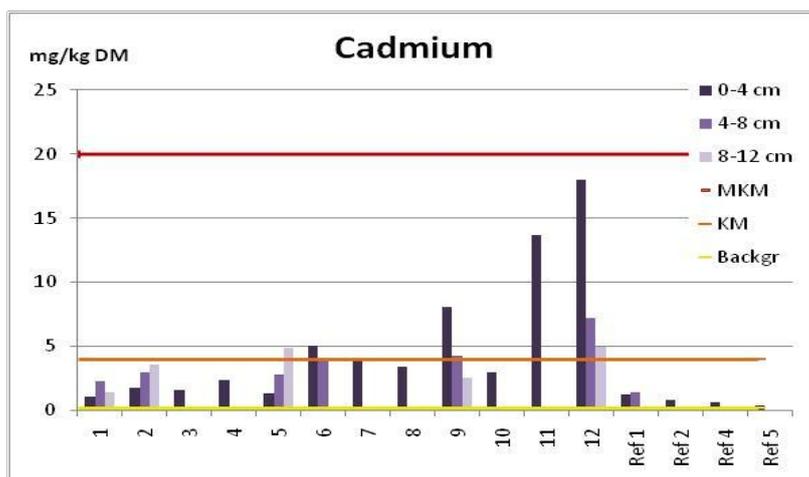
Figure 28. Cadmium concentrations in soil samples from Stångberget and reference location, compared to SEPA guideline values for soil environment (MKM = less sensitive land use, 20 mg/kg DM, KM = Sensitive land use, 4 mg/kg DM Backgr = background value, 0.2 mg/kg DM).

All over Stångberget and the reference location cadmium concentrations were below the guideline value for less sensitive land use, but samples from five locations were above the guideline value for sensitive land use (the highest concentration was 13.7 mg/kg DM) and all were above the Swedish background value (Figure 28). Also the reference values were above background.

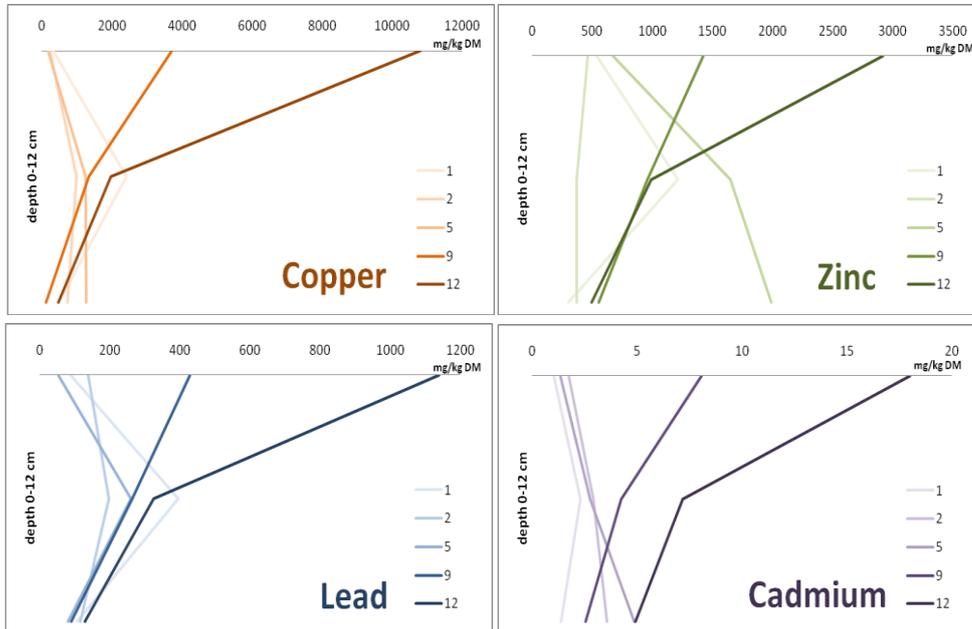
Figure 29. Variation in opper, zinc, lead and cadmium concentration with depth.

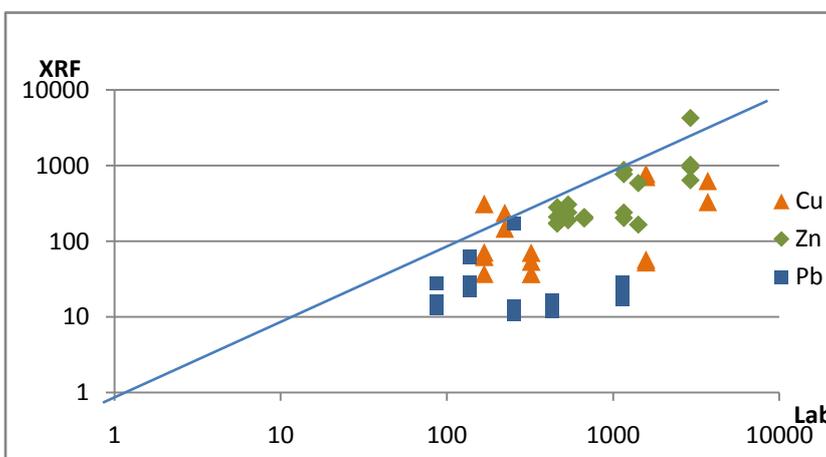
Figure 30. Correlation between results from XRF measurements and lab analysis for copper, zinc and lead concentrations. The blue line indicates perfect correlation [mg/kg DM]

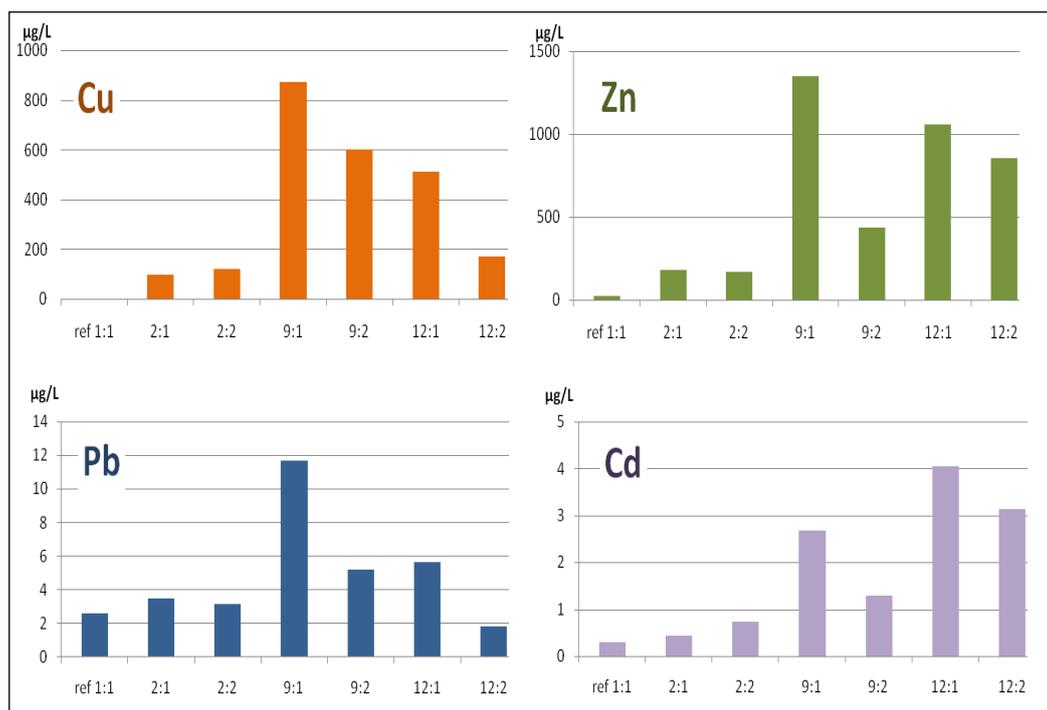
Figure 31. Concentrations of copper, zinc, lead and cadmium, as measured in leachates in the USGS Field Leach Test.

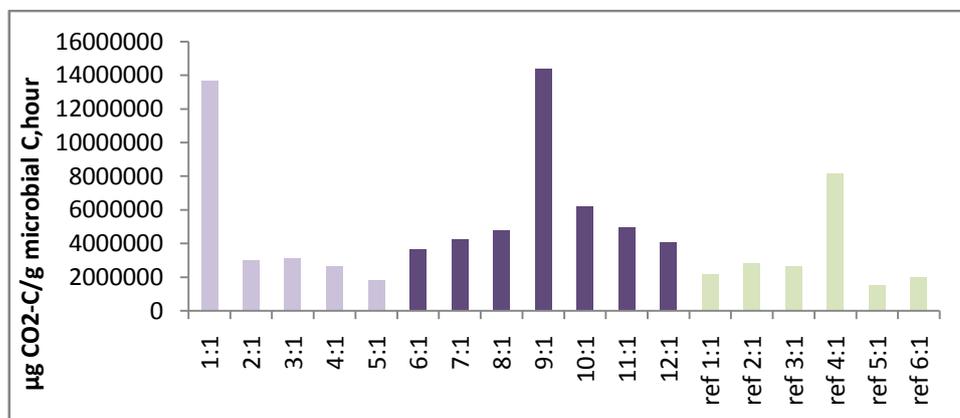
Figure 36. Specific respiration of soils from Stångberget and reference location.

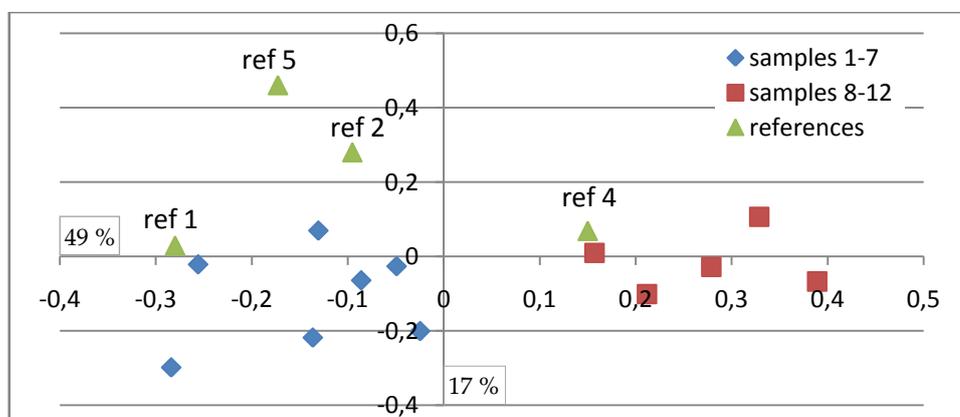
Figure 37. Ordination plot of the first canonical axis produced by CAP analysis of SIR/SOC*h for soils from Stångberget and the reference area. Percentages indicate percentage of variation explained by the axis.

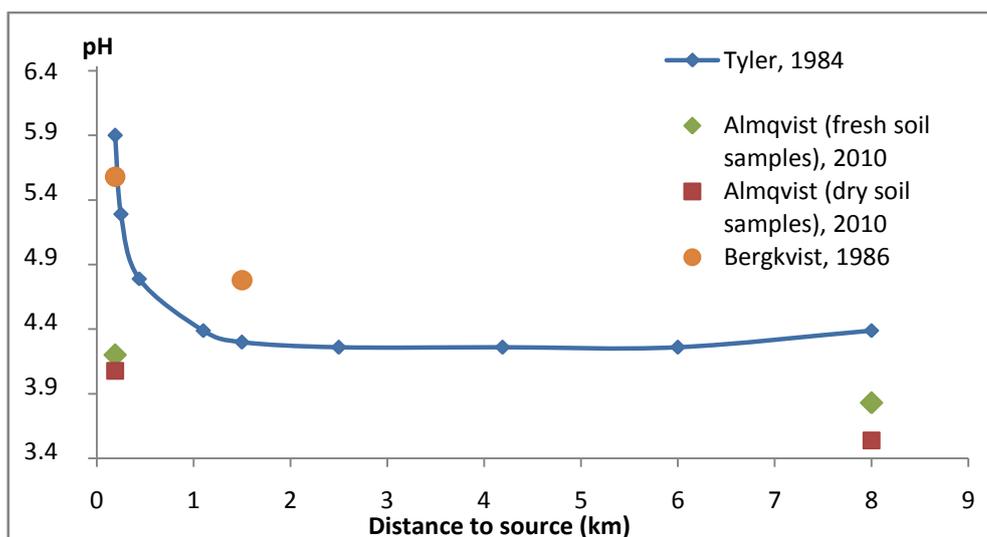
Figure 38. pH as a function of distance from the brass works in Gusum.

In the 1980s pH was measured in soils from locations up to 8 km from the mills in Gusum by Tyler (1984) and Bergkvist (1986) (Figure 38). Tyler found a drastic increase in pH towards the mills starting about 1 km away. Bergkvist's results, despite only showing two different distances, points in the same direction, but no such pattern was found in my study. Rühling (1983) and Tyler (1984b) explained the drastic increase by the pH raising effect of the metal oxides. Metals from the mill were emitted as large alkaline particles which caused a pH raise. It seems as though this impact on pH has decreased since the 1980s and that pH in soils on Stångberget has approached that of a typical Swedish forest soil. An increased pH leads to less leaching, so the lower pH in the soil today might be a factor leading to higher leaching of the metals. Tyler measured pH in a KCl solution whereas measurements in this study were made in H₂O. The potassium will compete with the protons for surface sites and thereby cause a lower pH in the soil solution than what would be the case if pH was measured in pure water.

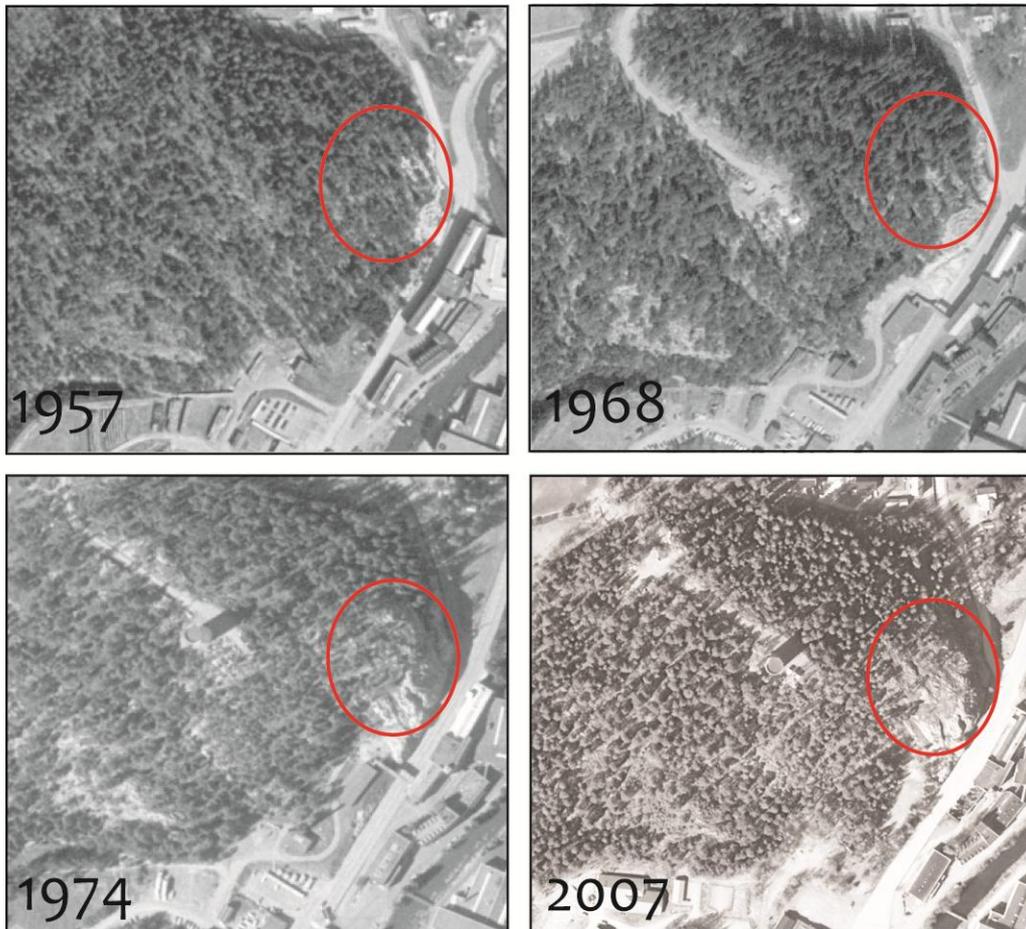
Figure 39. Ortho photos of Gusum from 1957, 1968, 1974 and 2007. Bare part of investigated area in red circle. (Photos from county administration board of Östergötland).

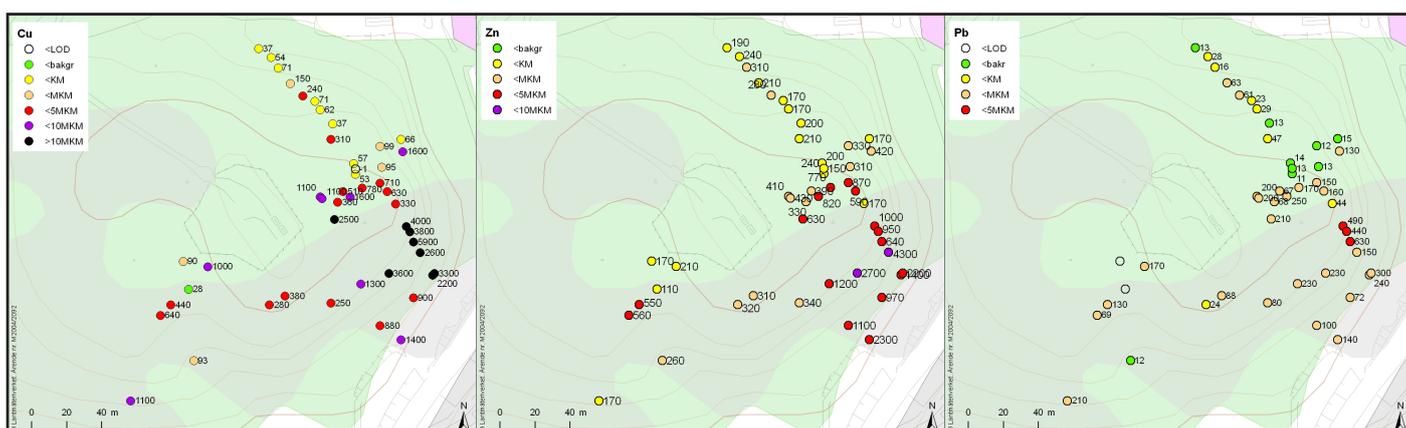
Resultat från XRF-undersökningarna visade att halterna av koppar, zink och bly var kraftigt förhöjda närmast bruket. På kartorna här ovanför är provpunkterna markerade med olika färg beroende på hur förhöjda metallhalterna är. XRF-mätning är snabbt och billigt och därför kunde mätningar utföras i betydligt fler punkter än övriga analyser.

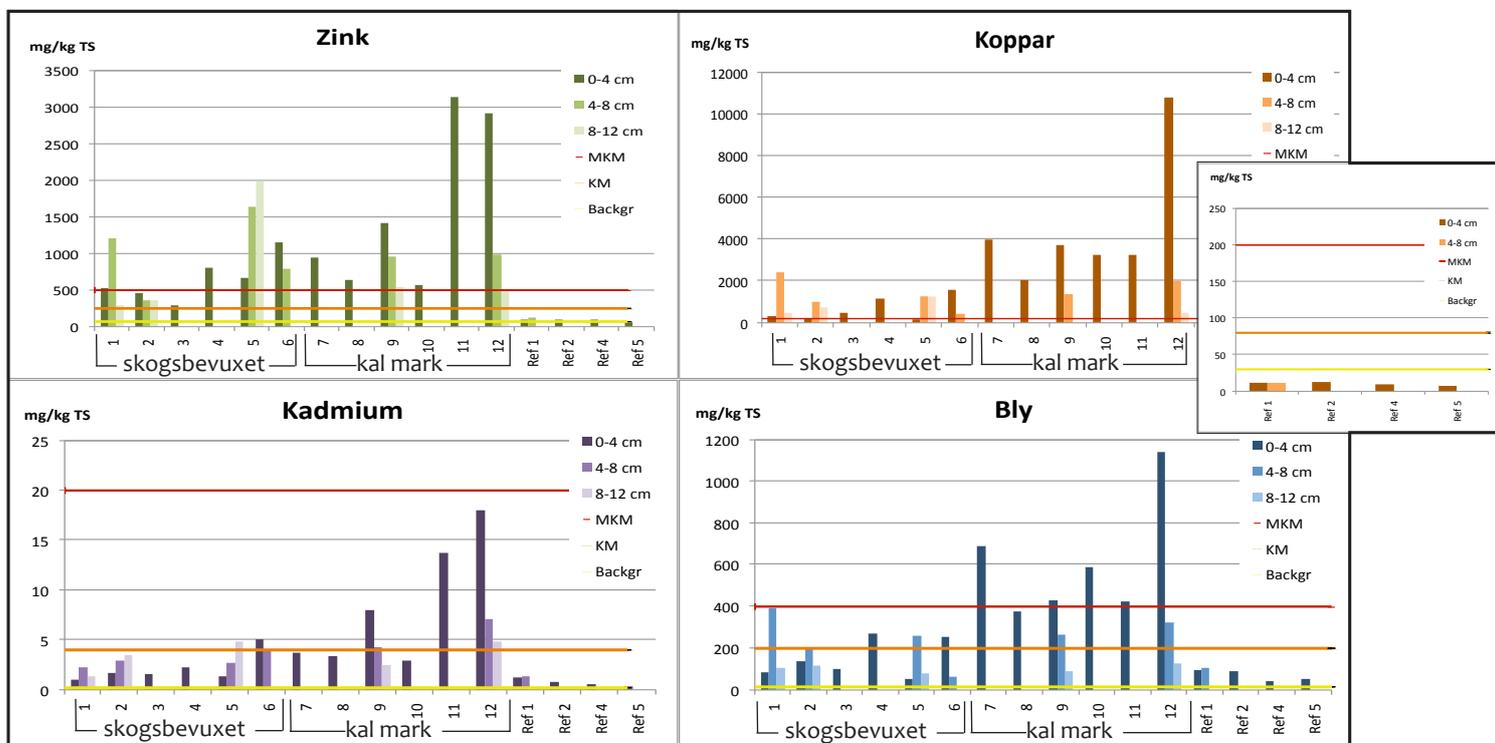
Analysen av metallhalterna visar att halterna koppar, zink, bly och kadmium är förhöjda. Allra högst är halterna av koppar, över 50 gånger riktvärdet i det mest förorenade provet! Proverna är tagna från tre olika markdjup (0-4 cm, 4-8 cm och 8-12 cm). MKM är riktvärdet för mindre känslig markanvändning, områden där man kan bygga kontor och industrier, och KM är riktvärdet för känslig markanvändning, där man kan bygga bostäder. Backgr är den svenska bakgrundhalten.

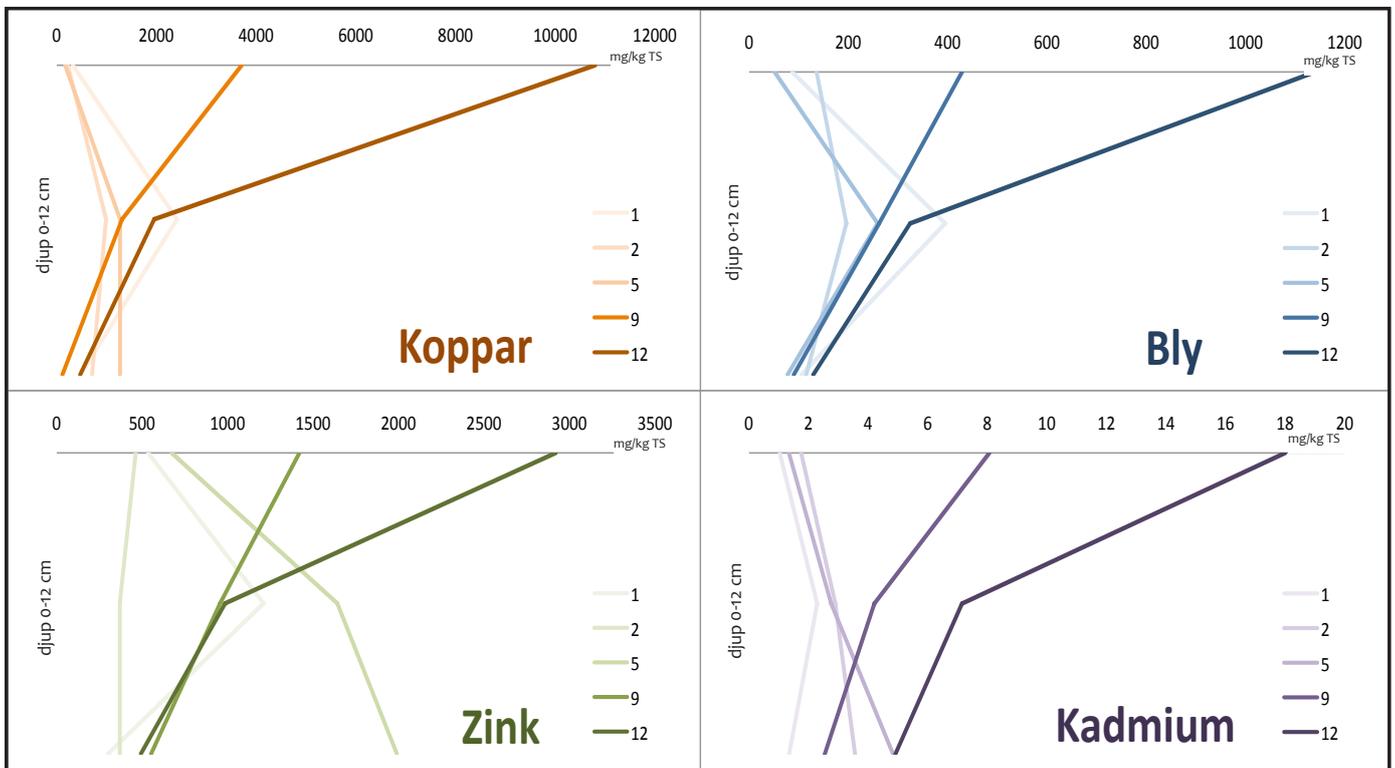
Metallhalterna varierar med djupet. Där marken är täckt av skog är halterna högst en bit ner i marken, men på det kala området är halterna högst i ytan. 1, 2, och 5 är provpunkter från den skogsbevuxna delen av Stångberget och 9 och 12 är provpunkter från den kala delen av berget.
