The legacy of the mill – a metal polluted forest soil in Gusum

Master's Thesis in Soil Science
Environmental Pollution and Risk Assessment – Master's programme

SLU, Swedish University of Agricultural Sciences
Faculty of Natural Resources and Agricultural Sciences
Department of Soil and Environment

Keywords: Gusum, copper, zinc, MicroResp, brass, contaminated soil

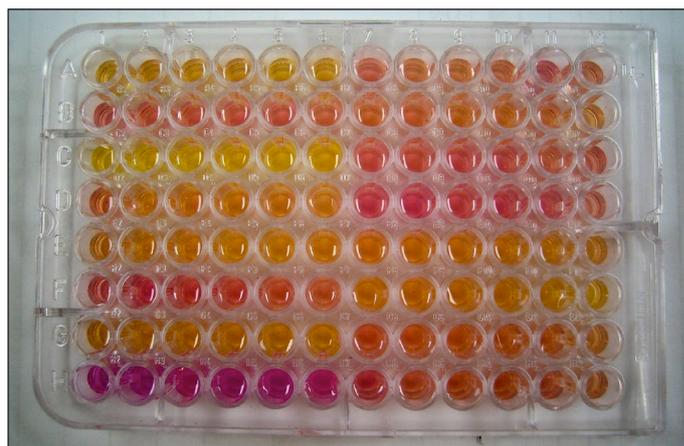
Indikatorgelén ändrar färg när den kommer i kontakt med koldioxid. På så sätt går det att se hur mycket mikroorganismerna andas. MicroResp™ kallas metoden.

Mikroorganismerna på den kala delen av Stångberget, där metallföroreningen är som värst, måste lägga mycket energi på att överleva i jorden och kan därför inte växa lika mycket som mikroorganismer i en oförorenad jord. Därför andas, respirerar, mikroorganismerna där mycket mer i förhållande till sin vikt än kontrollprovets mikroorganismer. Det gick att se när mängden koldioxid som kom från jorden mättes. Jord lades i små mikrobrunnar och ovanpå lades en gelé som ändrade färg när den kom i kontakt med koldioxid.
