# **Evaluating the Rehabilitative Properties of the Outdoor Environments of Uppsala University Hospital:**

Application of Evidence-Based Design tools to an existing hospital.

Degree project/Independent project • 30 credits  
Swedish University of Agricultural Sciences, SLU  
Faculty of Natural Resources and Agricultural Sciences  
Landscape Architecture Programme - Uppsala  
Uppsala 2025

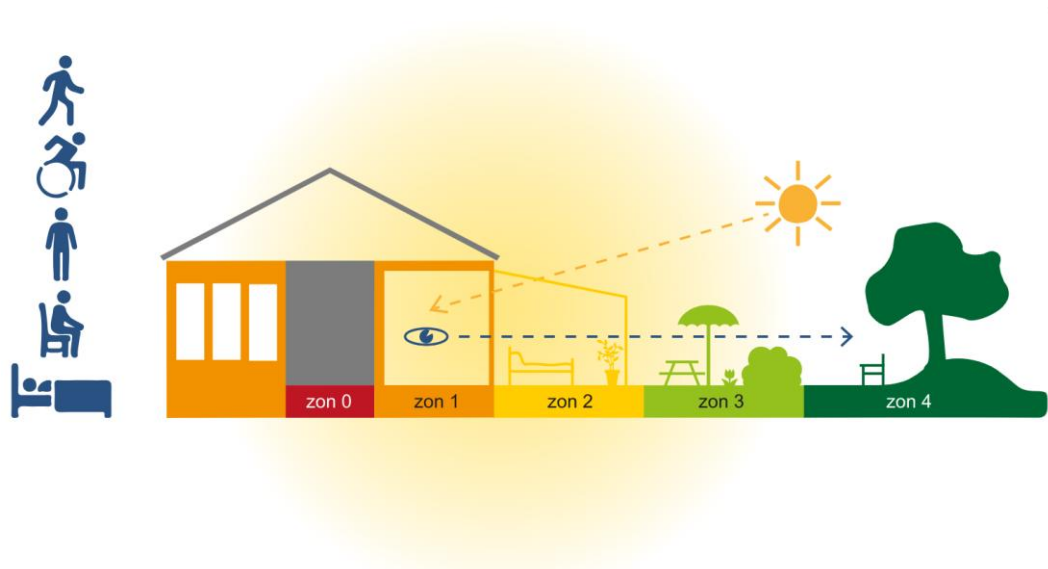
*Figure 1. An illustration of the concept of the four zones of contact with the outdoor environment. Illustrated by Jenny Lilja from Boverket 2022b, based on a model by Anna Bengtsson from SLU.*

The Outdoor Environment Zones are an Evidence-Based Design theory used in hospital settings which details degrees of contact between individuals and the outdoor environment (Bengtsson et al. 2018). The degrees of contact are split into zones (see figure 1 above) and are briefly described as follows:

To add further context to the above quote and figure 1, a detailed description of the zones and what they mean has been outlined below:

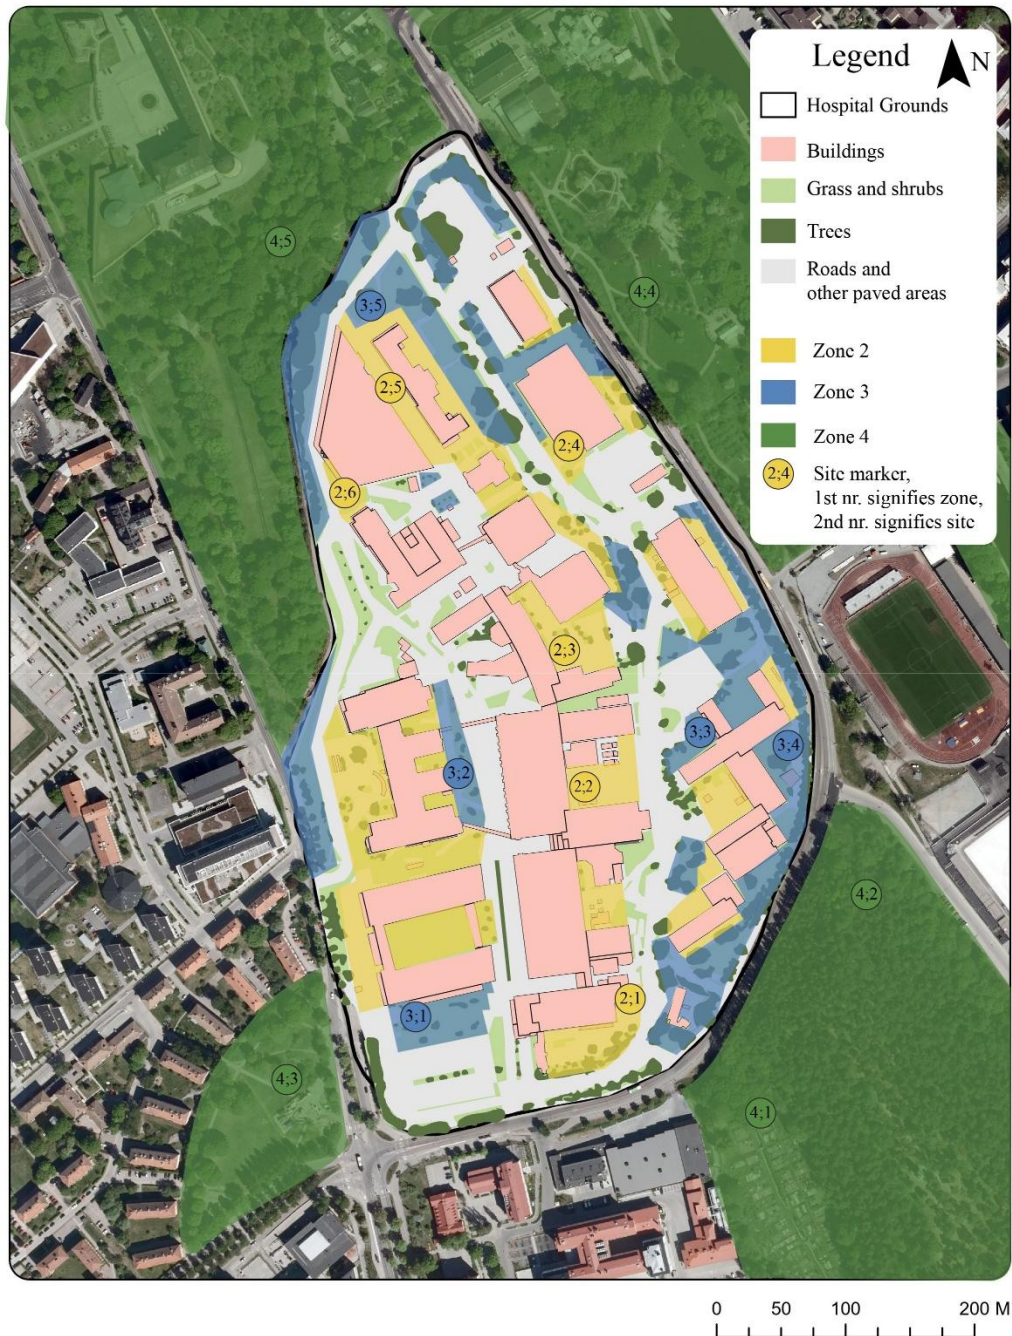
Figure 6. Orthophoto from Lantmäteriet with zones and sites marked out, as well as the outdoor structure makeup of Uppsala University Hospital. Yellow signifies zone 2, blue signifies zone 3 and green signifies zone 4. Thus, a site marked in yellow with 2;1 signifies the location of zone 2 site 1. Base map from Lantmäteriet 2017.

Since the inside of the buildings have not been included in the scope of this thesis, for the reasons previously detailed, a re-definition of zone 2 has made for the purpose of this thesis. Zone 2 has been reinterpreted to include entrance areas and courtyards as they accurately fit the description of a transition zone between inside and outside. Furthermore, this decision was motivated as entrances receive the highest amount of traffic and thus affect the most people, and are the most visibly and physically accessible of a hospital's outdoor environments. The map of Uppsala University Hospitals environment zones and sites chosen per this new definition can be seen in figure 6 below.

From zone 2 six sites were chosen, and for the remaining zones five sites were chosen. The sixth site is the only site chosen from zone 2 that is not by an

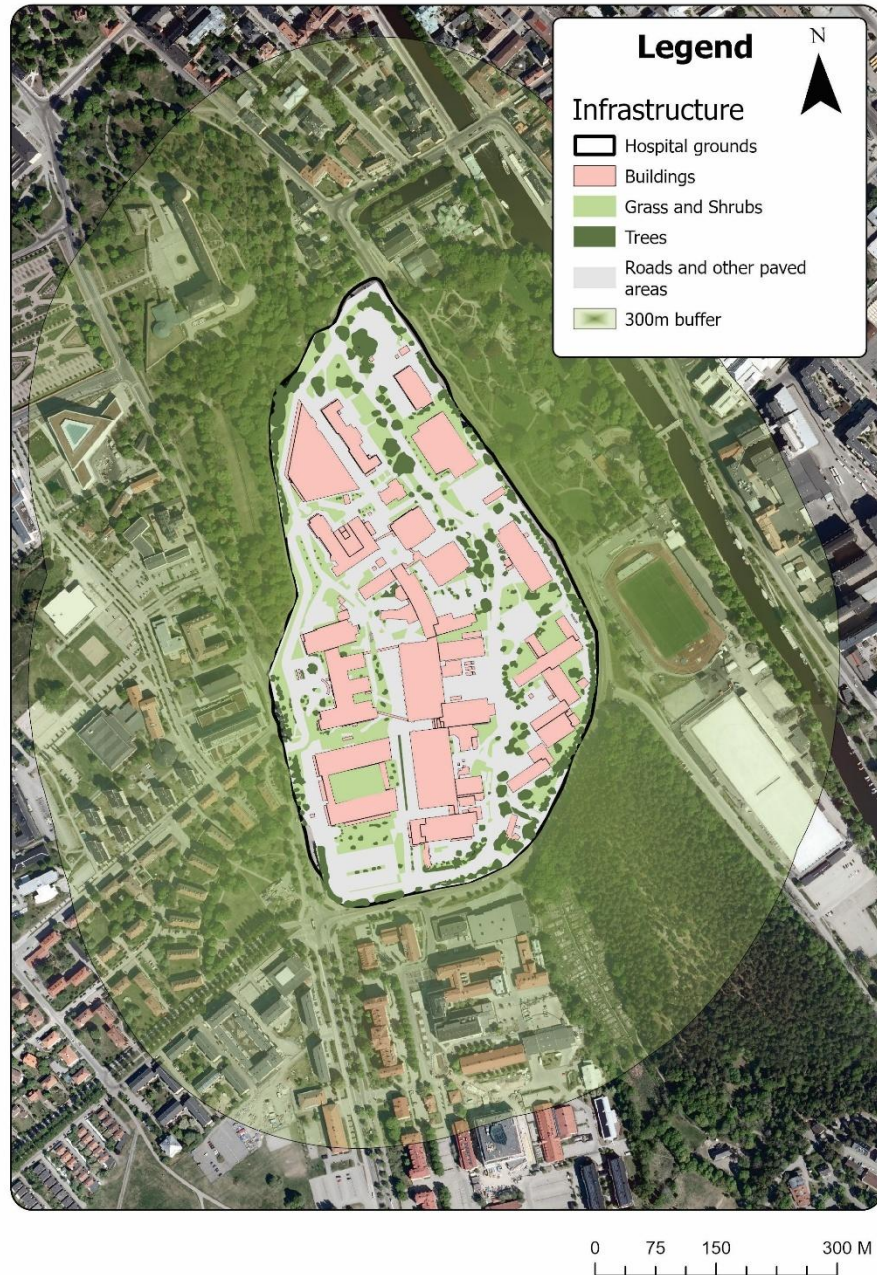
*Figure 7. Map of Uppsala University Hospital, illustrating the various forms of infrastructure within the hospital area. A buffer zone has been created from the perimeter of the hospital grounds 300m outwards [map]. Base map from Lantmäteriet 2017.*

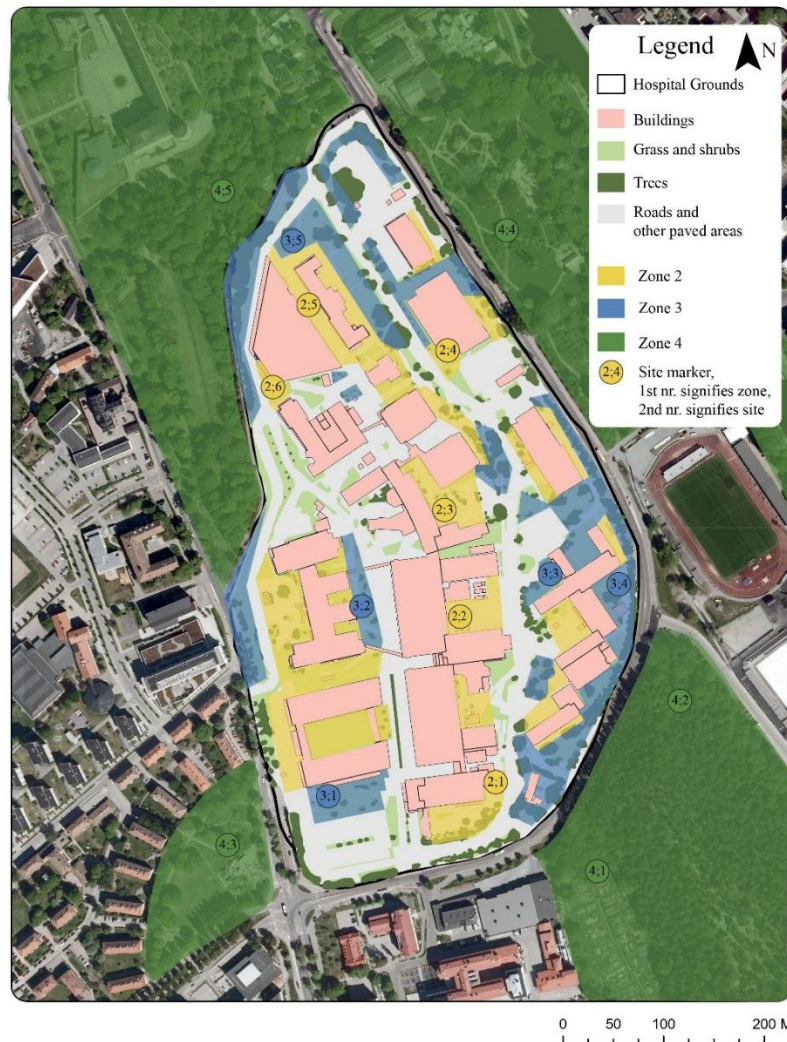
Figure 9. Orthophoto from Lantmäteriet with zones and sites marked out, same as figure 5. Repeated to show where the QET site analysis was performed. Yellow signifies zone 2, blue signifies zone 3 and green signifies zone 4. Thus, a site marked in yellow with 2;1 signifies the location of zone 2 site 1. Base map from Lantmäteriet 2017.

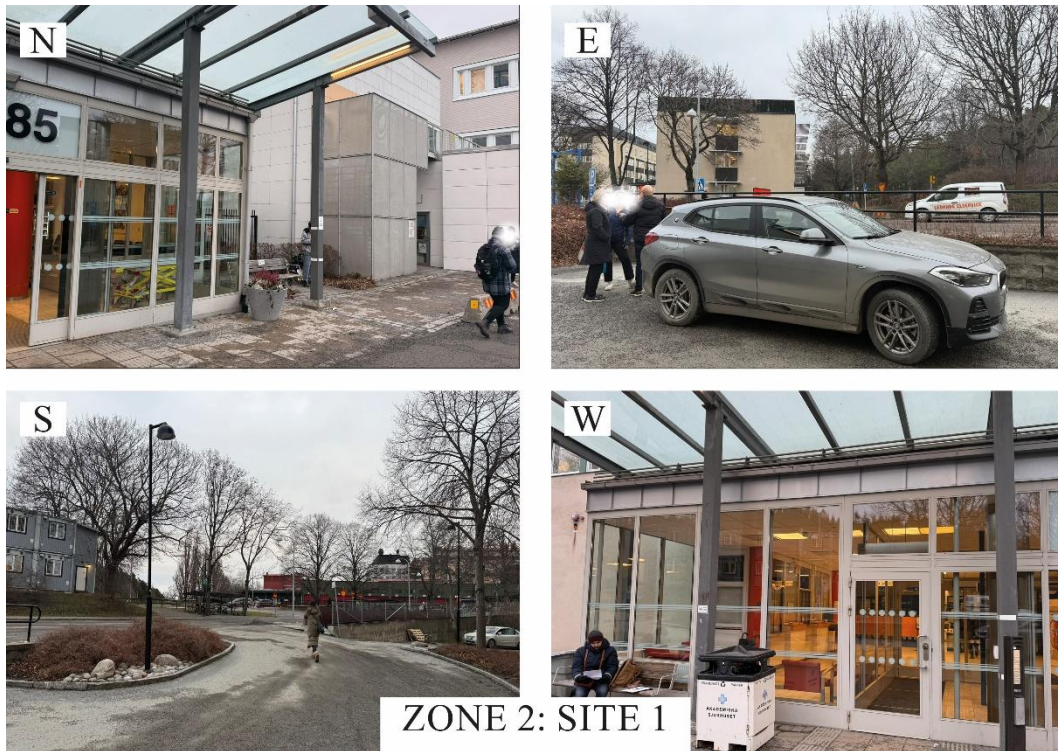
*Figure 10. Photos from zone 2: site 1 facing north, east, south and west. Taken by author on 26-02-2025 [photography].*

Zone 2: site 1 is located by entrance 85 (Google 2025). The site consists of an entrance area with a marked pick up/ drop off area, walls with fencing plants to the east to address the height differences of the site. To the southwest there is a rest-area with smoking disposal bins, large trees, hedges and a grass field, as well as a loading dock for hospital operations. There is a significant height difference there which is addressed through a large concrete wall and chain link fencing, seen in the south facing image above (see figure 10).

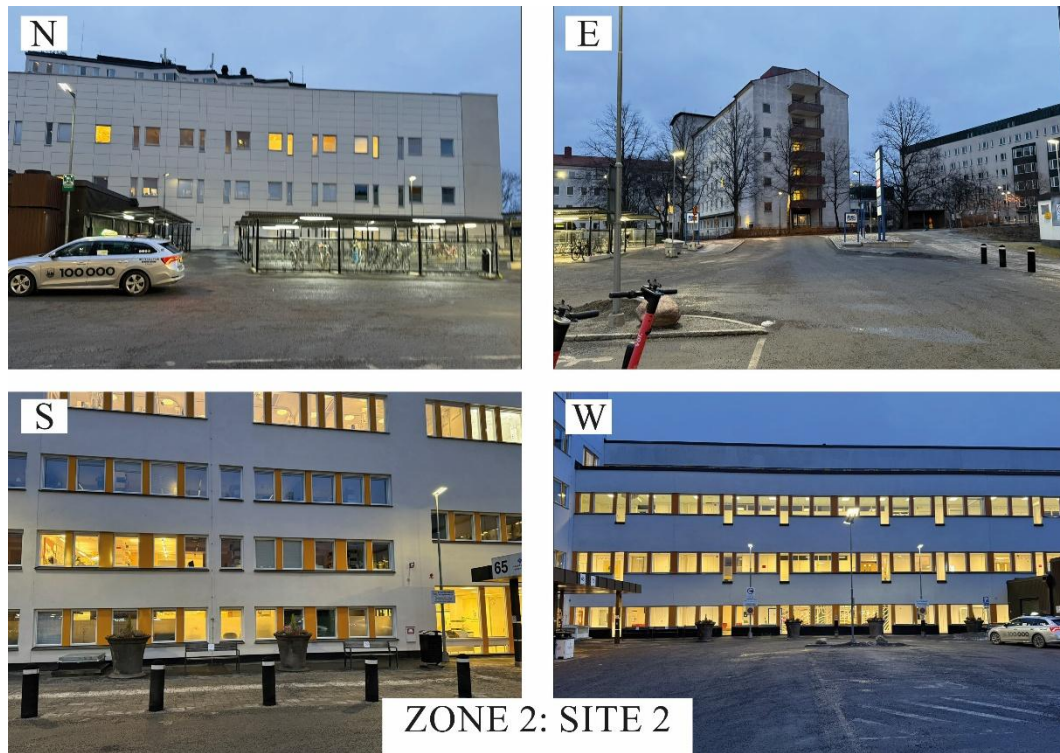
*Figure 14. Photos from zone 2: site 2 facing north, east, south and west. Taken by author on 26-02-2025 [photography].*

Zone 2: site 2 is located by entrance 65/70 (Google 2025). The site is mainly a parking lot for cars and bicycles. The main form of greenery is large pots with plants by the entrance (see figure 14).

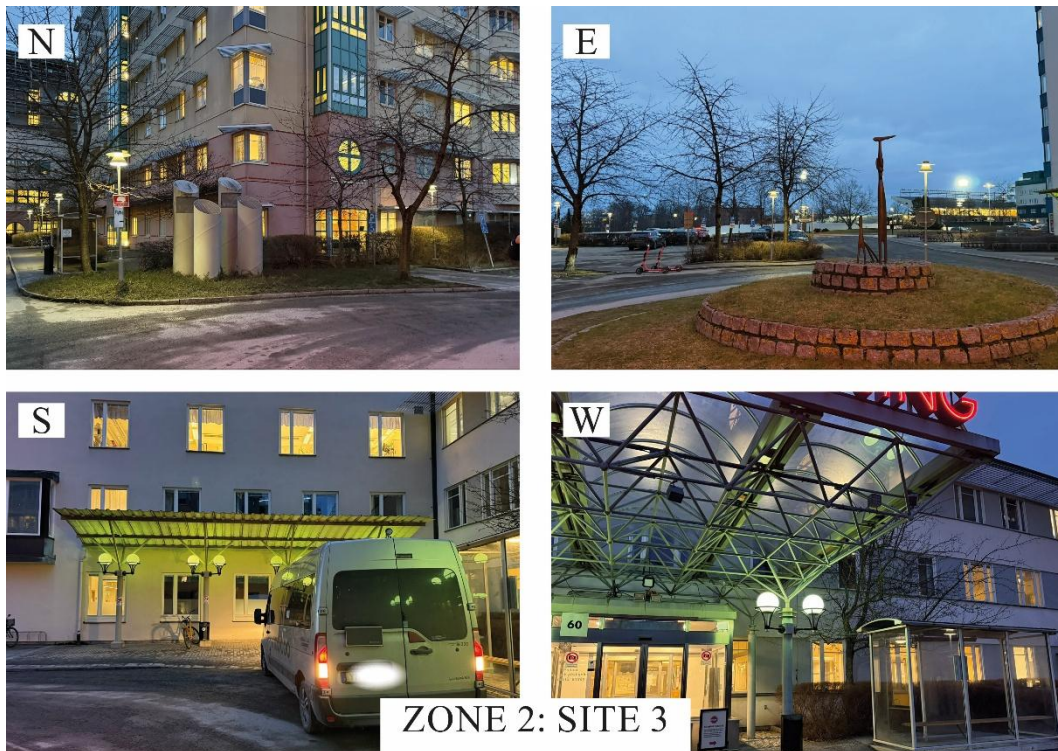
*Figure 18. Photos from zone 2: site 3 facing north, east, south and west. Taken by author on 26-02-2025 [photography].*

Zone 2: site 3 is located by the entrance to the emergency ward (Google 2025). Right by the entrance there are smokers' cubes with seating. There is a cultural roundabout with an artwork in it, as well as an area to the northwest with additional seating, smoking cube, bicycle parking, trees and bushes (see figure 18).

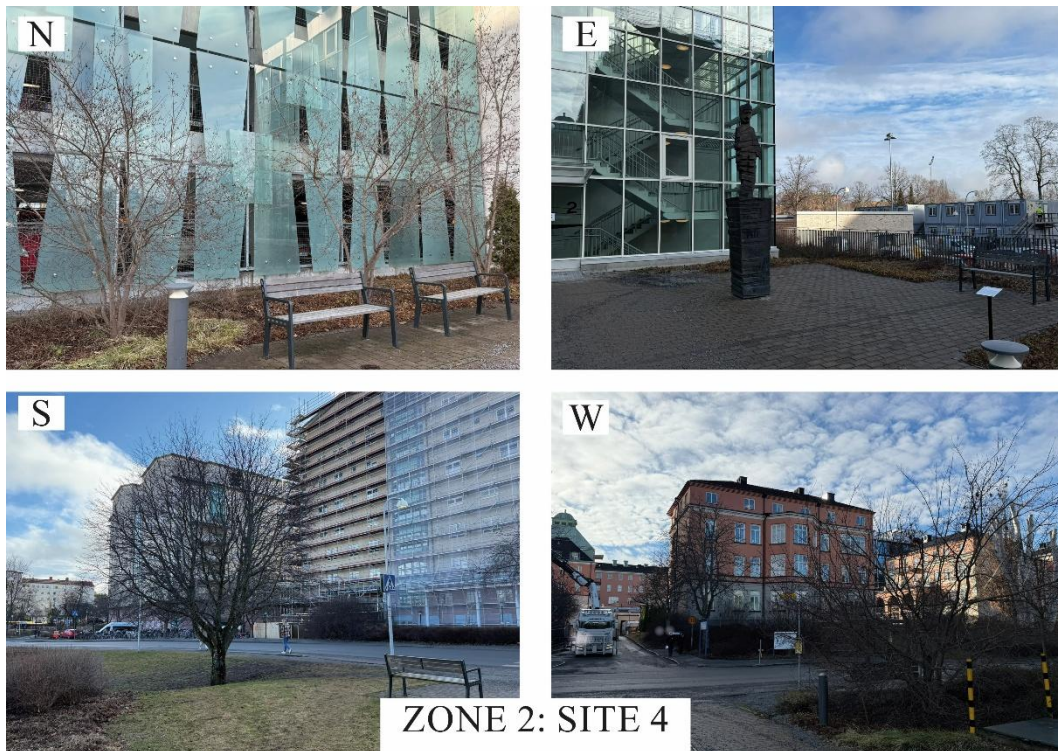
*Figure 22. Photos from zone 2: site 3 facing north, east, south and west. Taken by author on 27-02-2025 [photography].*

Zone 2: site 5 is located by the entrance to the major parking garage of the hospital grounds (Google 2025). East and north of the site, the parking garage is adjacent. To the west of the site major construction is ongoing. A big tree can be seen to the south, and right by the entrance there is a statue/artwork (see figure 22).

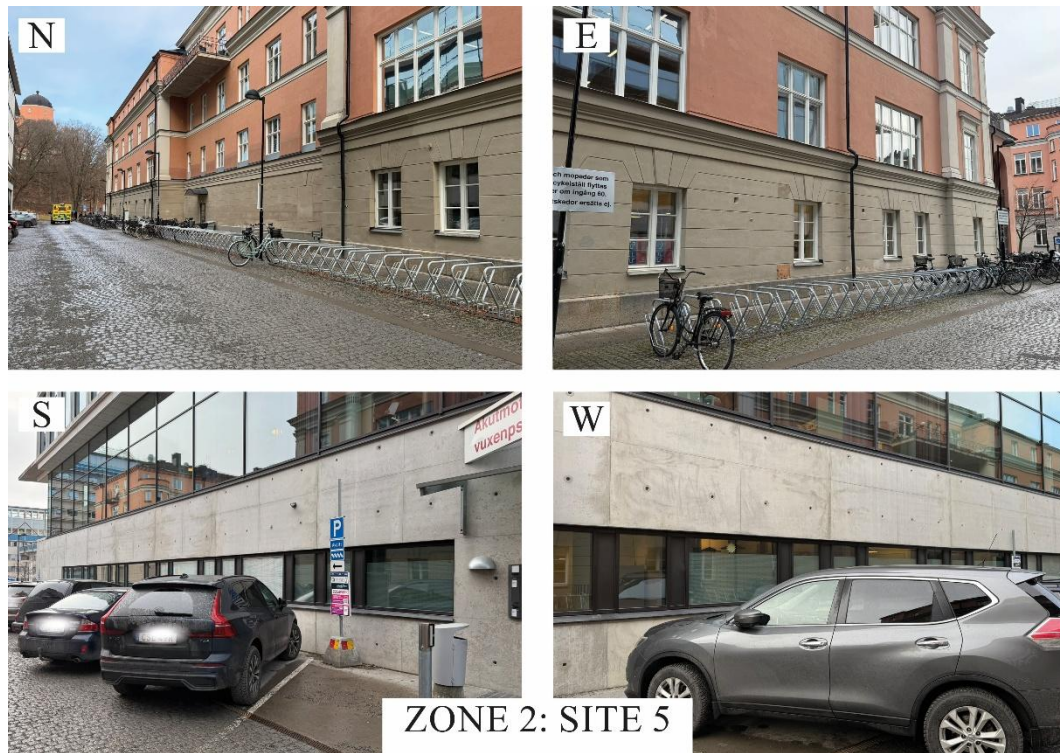
*Figure 26. Photos from zone 2: site 5 facing north, east, south and west. Taken by author on 27-02-2025 [photography].*

Zone 2: site 5 is located by the entrance to the emergency ward for adult psychiatry (Google 2025). The area acts as a narrow passage between two buildings with mixed traffic utilising the cobbled area (see figure 26). Car parking on either side of the entrance to the south and west, and bicycle parking across on the other side. To the far northwest Uppsala Castle can be seen with large trees beneath it. To the southwest a single tree can be seen, as well as ongoing construction.

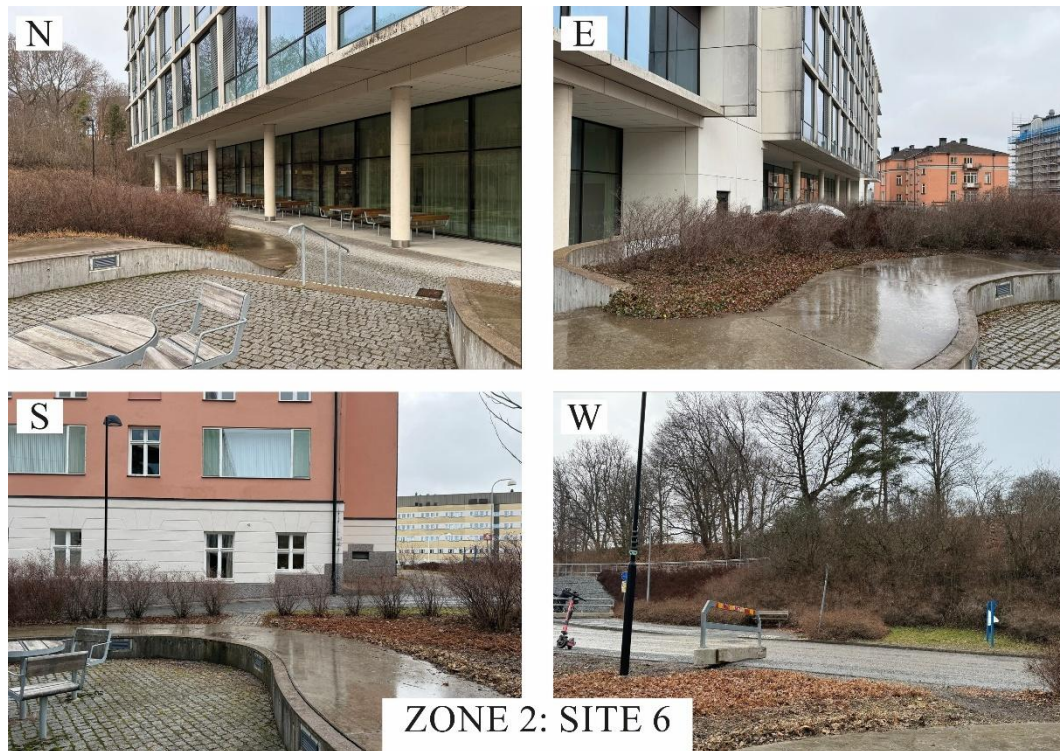
*Figure 30. Photos from zone 2: site 6 facing north, east, south and west. Taken by author on 27-02-2025 [photography].*

Zone 2: site 6 is located on the back side of the psychiatry building (Google 2025) and is the only site in zone 2 not near an entrance. It was selected to balance the report, as it seems to compensate for limited green space elsewhere, particularly at zone 2 site 5. It consists of a semi-enclosed seating area with cobble stones and cast-in-place concrete that is about 30cm below road level with trimmed hedges surrounding the concrete. To the north, a covered cafeteria area is accessible via stairs. The site includes notable height differences, with a green, sloped area to the east and north showing wilder nature (see figure 30).

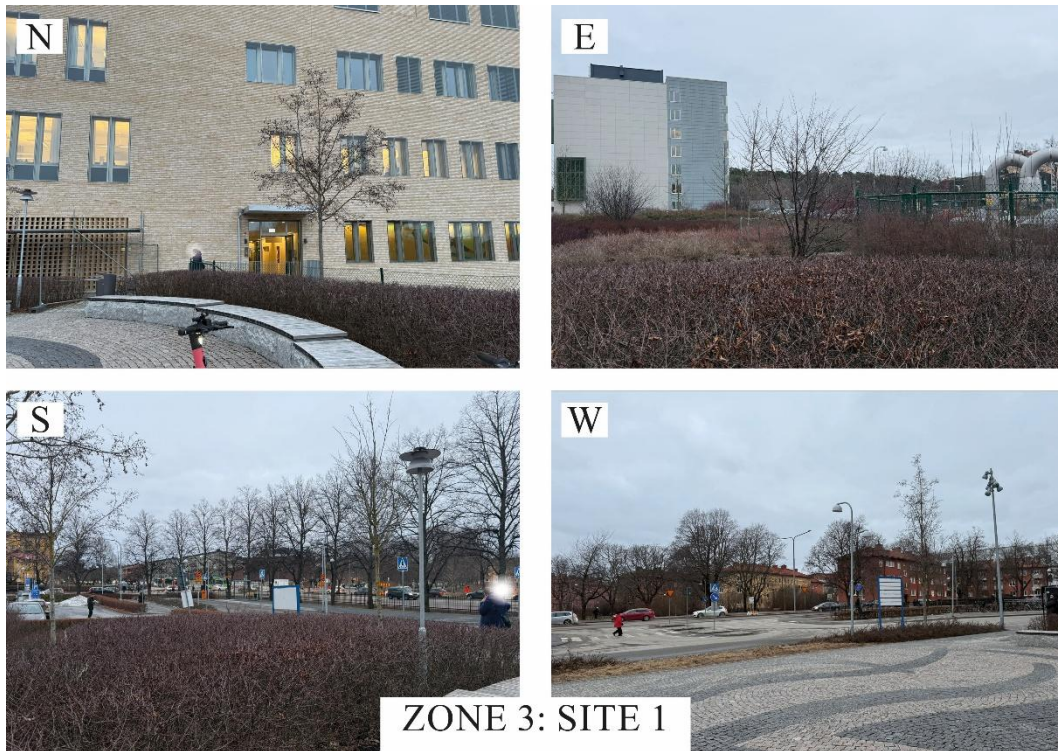
*Figure 34. Photos from zone 3 site 1 facing north, east, south and west. Taken by author on 26-02-2025 [photography].*

The green area where the exact site is marked is inaccessible trimmed hedges, and thus the closest reasonable area was chosen, a paved plaza area right next to it. The area is signified by a patterned cobble stones in light and dark stones, as well as stone seating made custom for the site with roughhewn sides and a wooden seating area (see figure 34).

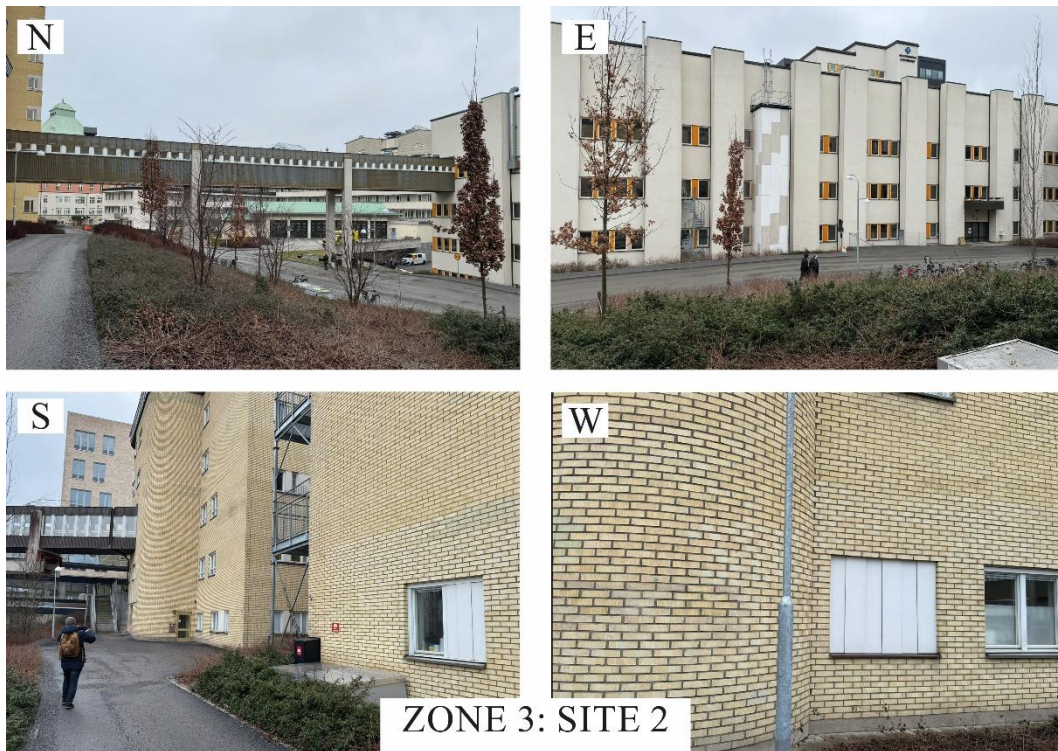
*Figure 38. Photos from zone 3 site 2 facing north, east, south and west. Taken by author on 26-02-2025 [photography].*

The actual site chosen was in the slope, in the bushes. As that location is inaccessible, the closest accessible site was chosen, just to the west of the originally marked site on a paved road. The site consists of a slope covered in low bushes, and a road above it connecting two different courtyards. The slope covers a large height difference and is largely inaccessible. It acts as a pathway between different departments, and as a way to take up the large height difference (see figure 38). The analysis is of the site in zone 3, not of the connecting courtyards defined as zone 2. Thus, the attributes of these courtyards will be excluded in the analysis.

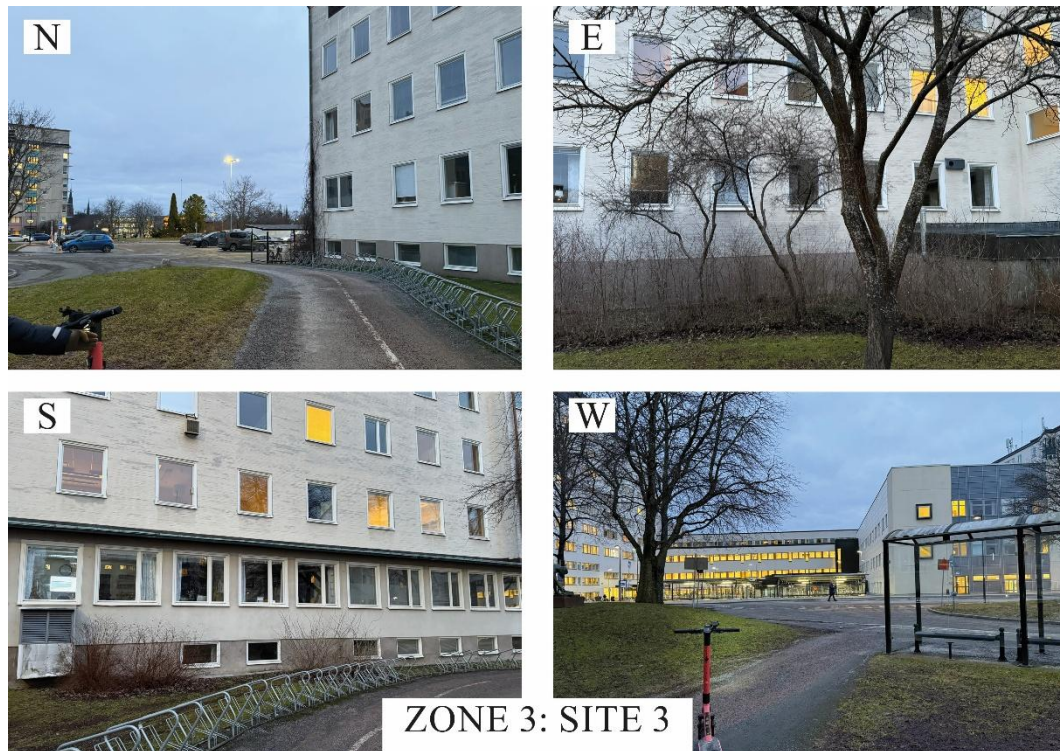
*Figure 42. Photos from zone 3 site 3 facing north, east, south and west. Taken by author on 26-02-2025 [photography].*

The site consists of a bike and walking lane lined with bike racks all along the east side of the road. There are some large trees, some bushes and hedges, but the main vegetation type is grass. There is a statue of a man sitting to the southwest, and a bus stop with roofing and benches (see figure 42). The site is located at the backside of the building and faces Zone 2: site 2 to the west, which is located by entrance 65/70 (Google 2025).

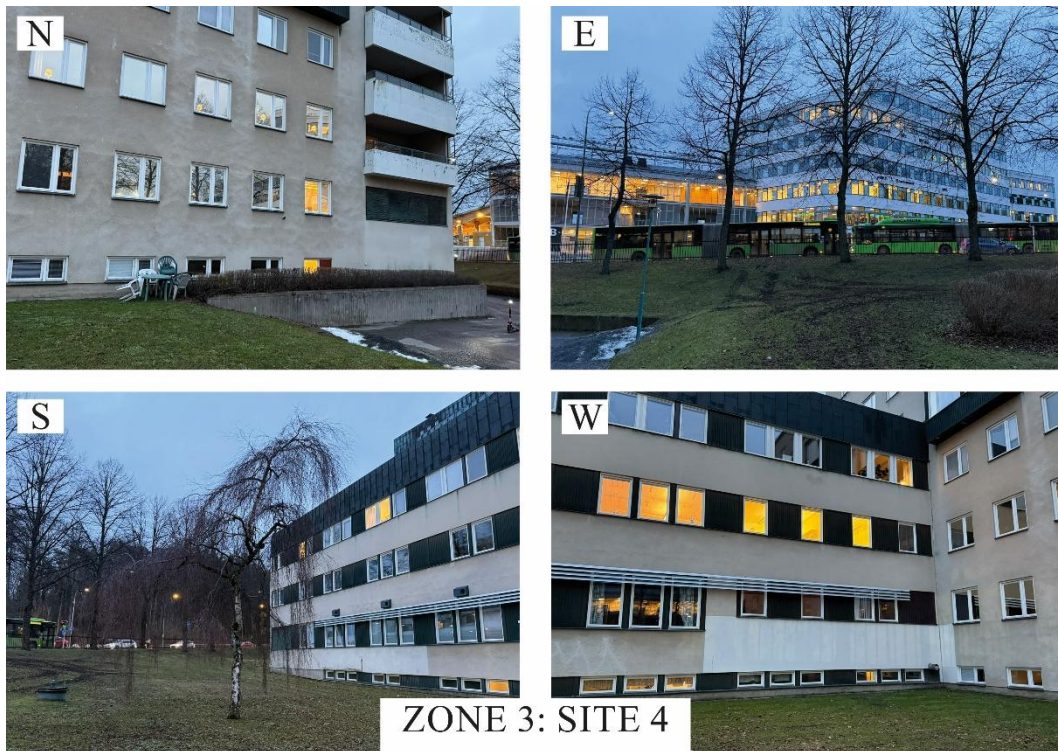
*Figure 46. Photos from zone 3 site 4 facing north, east, south and west. Taken by author on 26-02-2025 [photography].*

The site is located at the backside of the building for nephrology department, between entrance 77 and entrance 79 (Google 2025). The site has significant height differences and consists mainly of a trimmed grass field enclosed by large trees and a black fence from east to south. To the north there is a paved road leading to the site which ends in a cul-de-sac. Trimmed hedges and a concrete wall solve the height difference of the building to street level there. To the south a culturally significant weeping birch stands alone (*Betula Pendula* “Youngii”). Informal seating exists in the form of plastic lawn chairs and table (see figure 46).

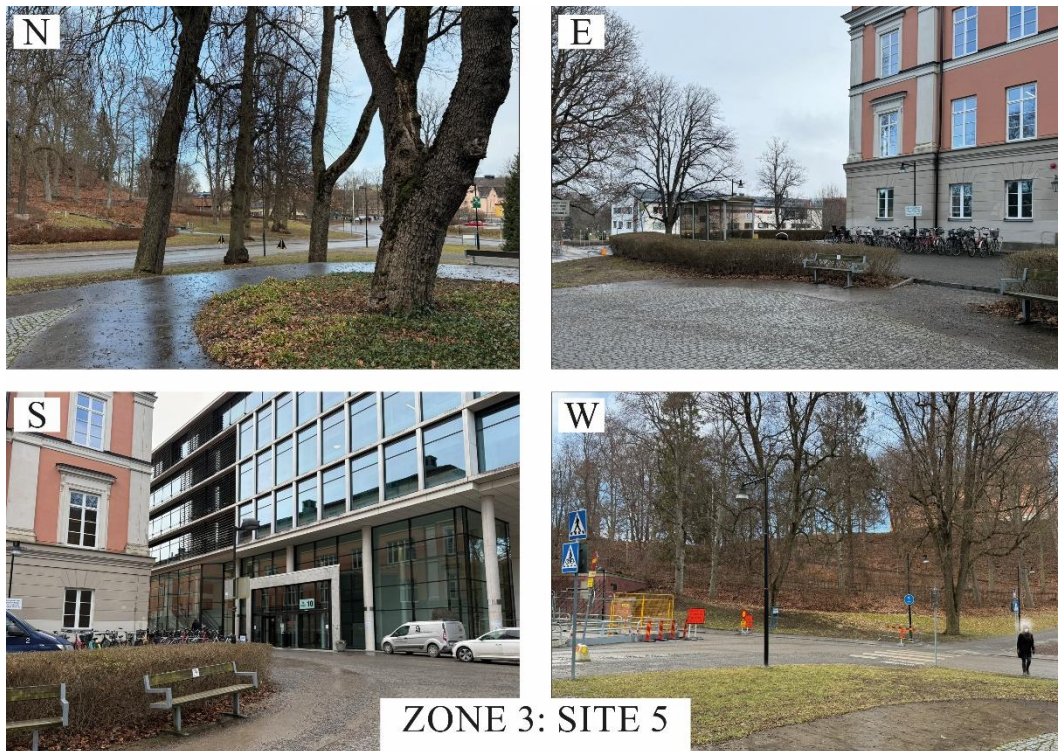
*Figure 50. Photos from zone 3 site 5 facing north, east, south and west. Taken by author on 27-02-2025 [photography].*

The site is located at the main entrance of the psychiatry building, which is entrance 10 and can be seen to the south of the site (Google 2025). On the southeast there are benches backed by trimmed hedges, and beyond that is bicycle parking. To the west is a construction zone, and beyond it and to the north is a forest with large coniferous trees and significant height differences. Up on the hill to the west is Uppsala Castle. To the far north there is a fountain and designed area which is difficult to see. Beyond it, to the northeast, is the start of the city centre of Uppsala (see figure 50).

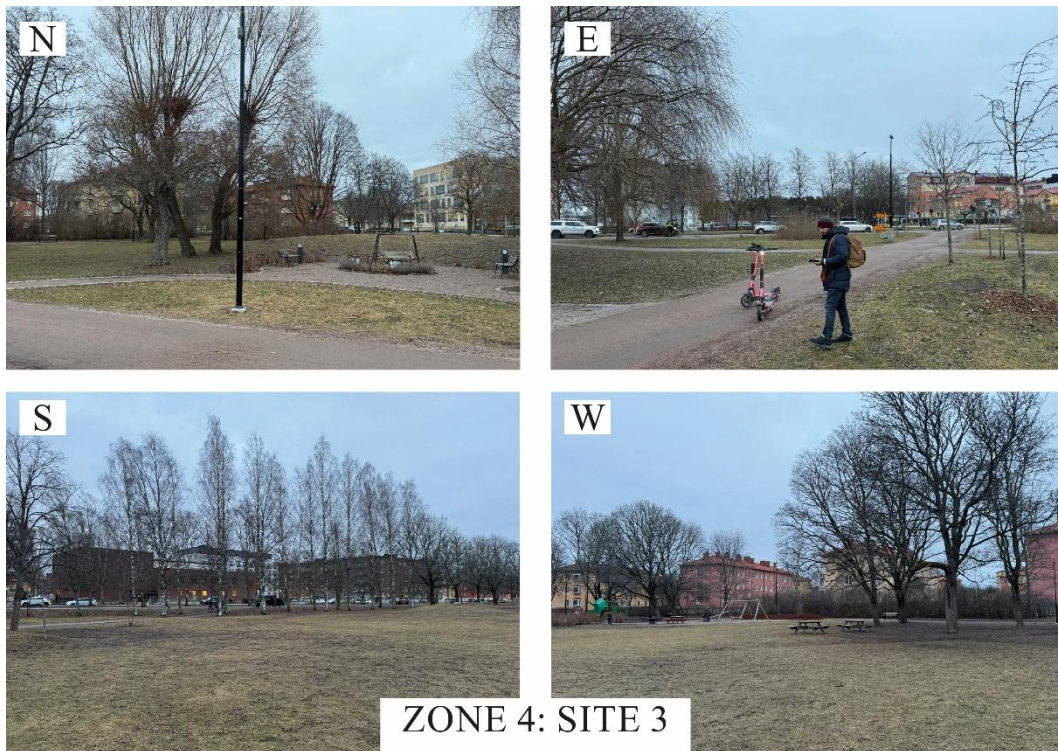
*Figure 62. Photos from zone 4 site 3 facing north, east, south and west. Taken by author on 26-02-2025 [photography].*

The site is located about 160m away from the entrance 100/101 of Uppsala University Hospital measured by pedestrian movement through the Lantmäteriet measurement tool (Lantmäteriet 2025). Entrance 100/101 is next to zone 3 site 1 (Google 2025). The site consists of a park called Batteriparken which consist of an open field of cut grass framed by large trees in all directions (Google 2025). There are playgrounds and different seating opportunities. The hospital grounds are to the east of the site, and to the south and west are residential buildings (see figure 62).

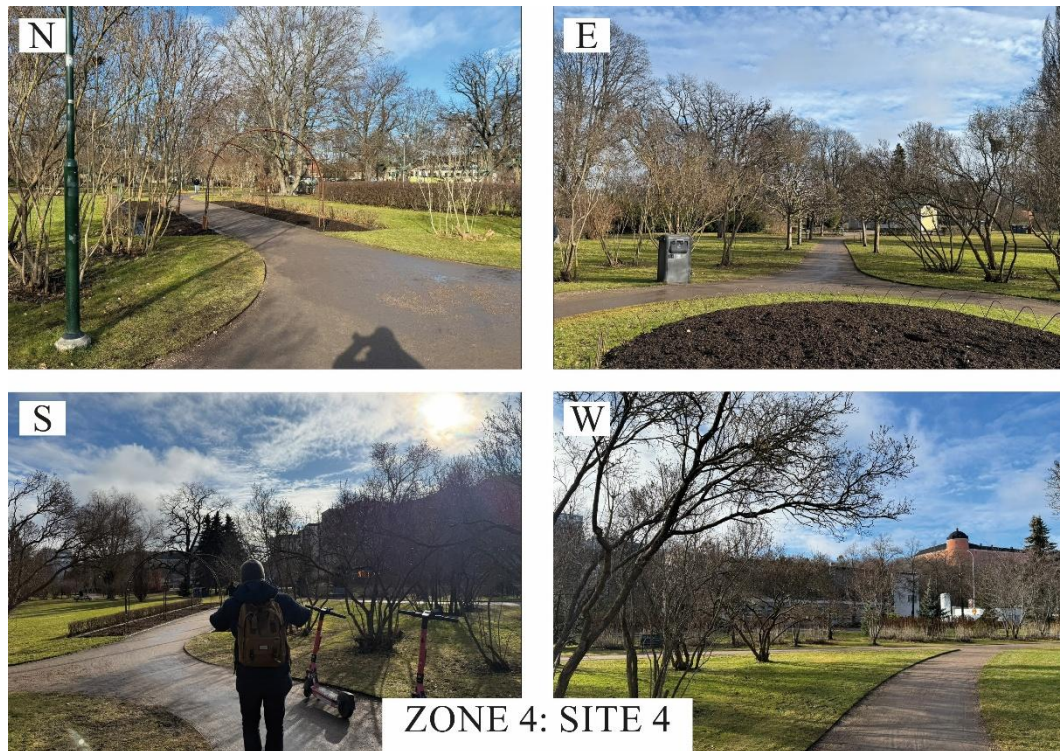
*Figure 66. Photos from zone 4 site 4 facing north, east, south and west. Taken by author on 26-02-2025 [photography].*

The site is located about 160m away from the entrance to the staff gym facility of Uppsala University Hospital measured by pedestrian movement through the Lantmäteriet measurement tool (Lantmäteriet 2025). The entrance to the gym facility is next to the parking garage of the hospital grounds (Google 2025). The site consists of a park called Uppsala City Park (Google 2025). This is a park with high visitor traction in the centre of Uppsala and is highly funded. Among others, there are opportunities to watch children play on the playground, enjoy seasonal plantings in the form of summer flower beds, a large variety of cultural plants, and seating opportunities (see figure 66).

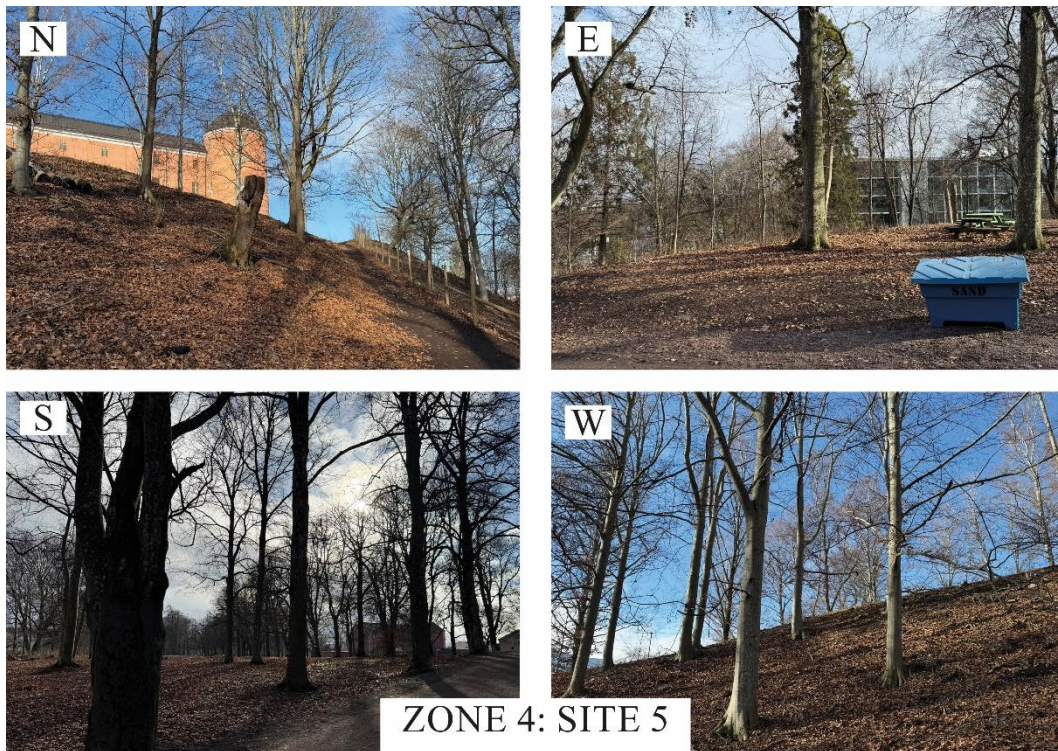
*Figure 70. Photos from zone 4 site 5 facing north, east, south and west. Taken by author on 27-02-2025 [photography].*

The site is located about 120m away from the main entrance of the psychiatry building (entrance 10) of Uppsala University Hospital measured by pedestrian movement through the Lantmäteriet measurement tool (Lantmäteriet 2025). Entrance 10 is next to zone 3 site 5 (Google 2025). The study area comprises a forested, sloping hill dominated by large coniferous trees, upon which Uppsala Castle is situated (see figure 70). Seating exists to the east.

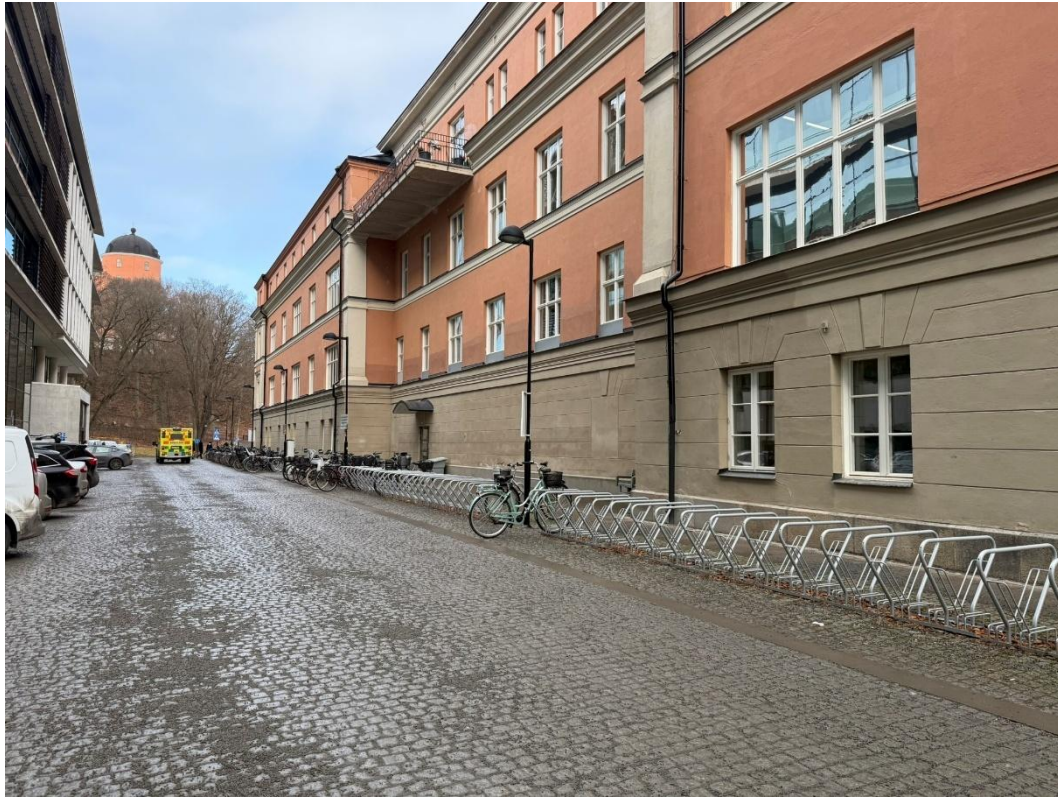
*Figure 74. Photo from zone 2: site 5 facing north. This illustrates a prime example of a site scoring low in multiple qualities. Taken by author on 27-02-2025 [photography].*

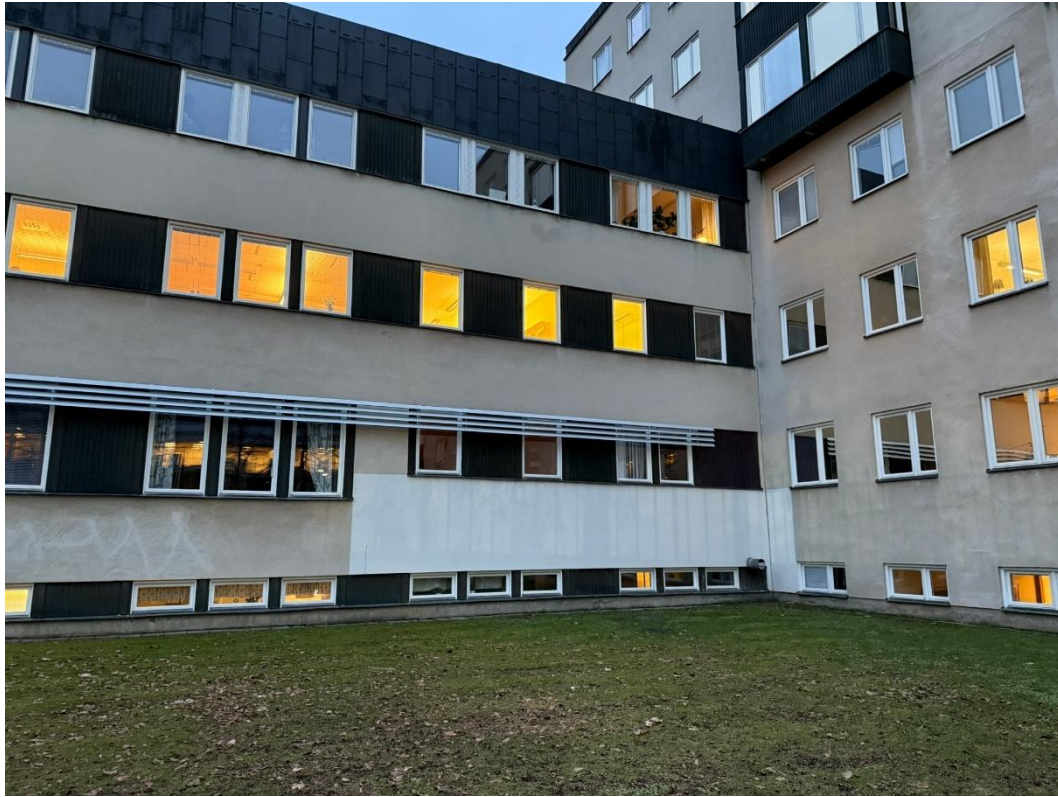
*Figure 76. Photo from zone 3 site 4 west. This illustrates a lack in familiarity and welcoming feeling. Taken by author on 26-02-2025 [photography].*

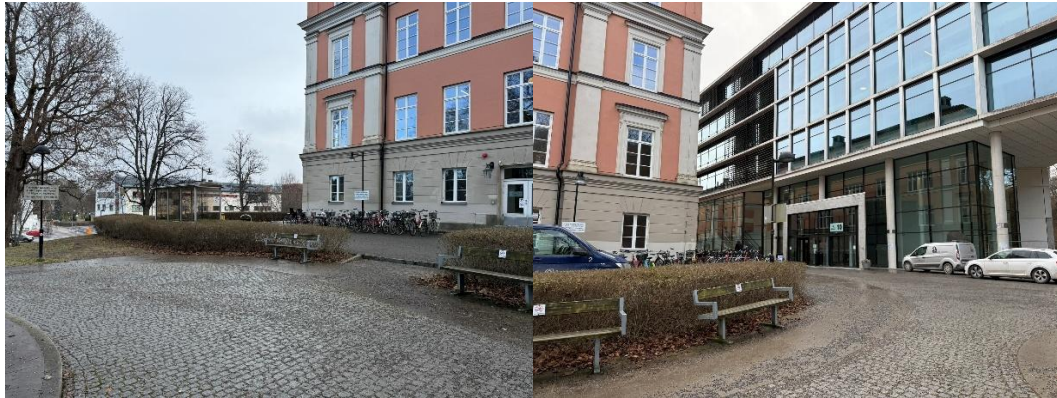
*Figure 77. Photos from zone 3 site 5 facing east and south. They illustrate a seamless connection and sense of familiarity. Taken by author on 27-02-2025 [photography].*

The site connects seamlessly to the main entrance of the psychiatry building which is to the south of the zone (see figure 77 above). It also does the same to pink building to the southeast and meets the surrounding environments on the outside of the hospital grounds as a clear beginning and entrance of the entire hospital grounds.

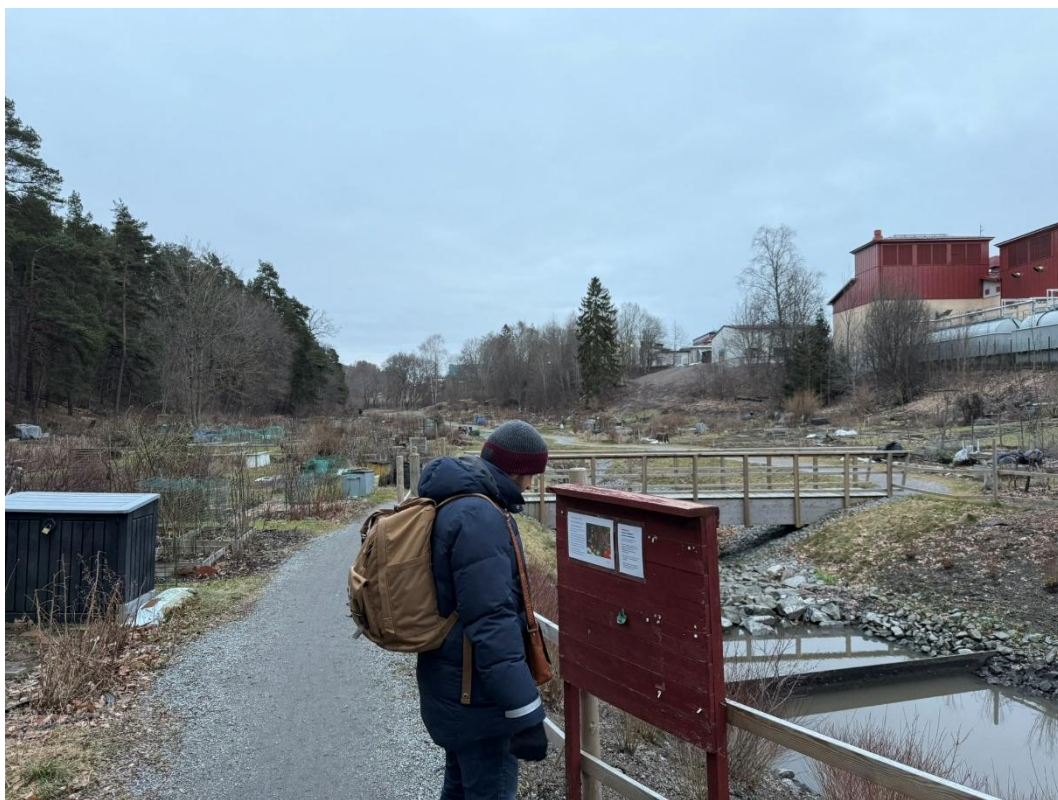
A key environmental quality for people experiencing high levels of stress, as well as just generally for rehabilitating environments to be achieved is B3: Joyful and meaningful activities. In Uppsala University Hospital, this environmental quality received an average rating of 2,4 and thus needs a significant improvement. Many sites within the hospital grounds were found lacking in this quality, however, one of the zone 4 sites stood out in its excellence, see figure 78 below:

*Figure 78. Photos from zone 4 site 1 facing south, showing an expansive nature area with gardening beds. Taken by author on 26-02-2025 [photography].*

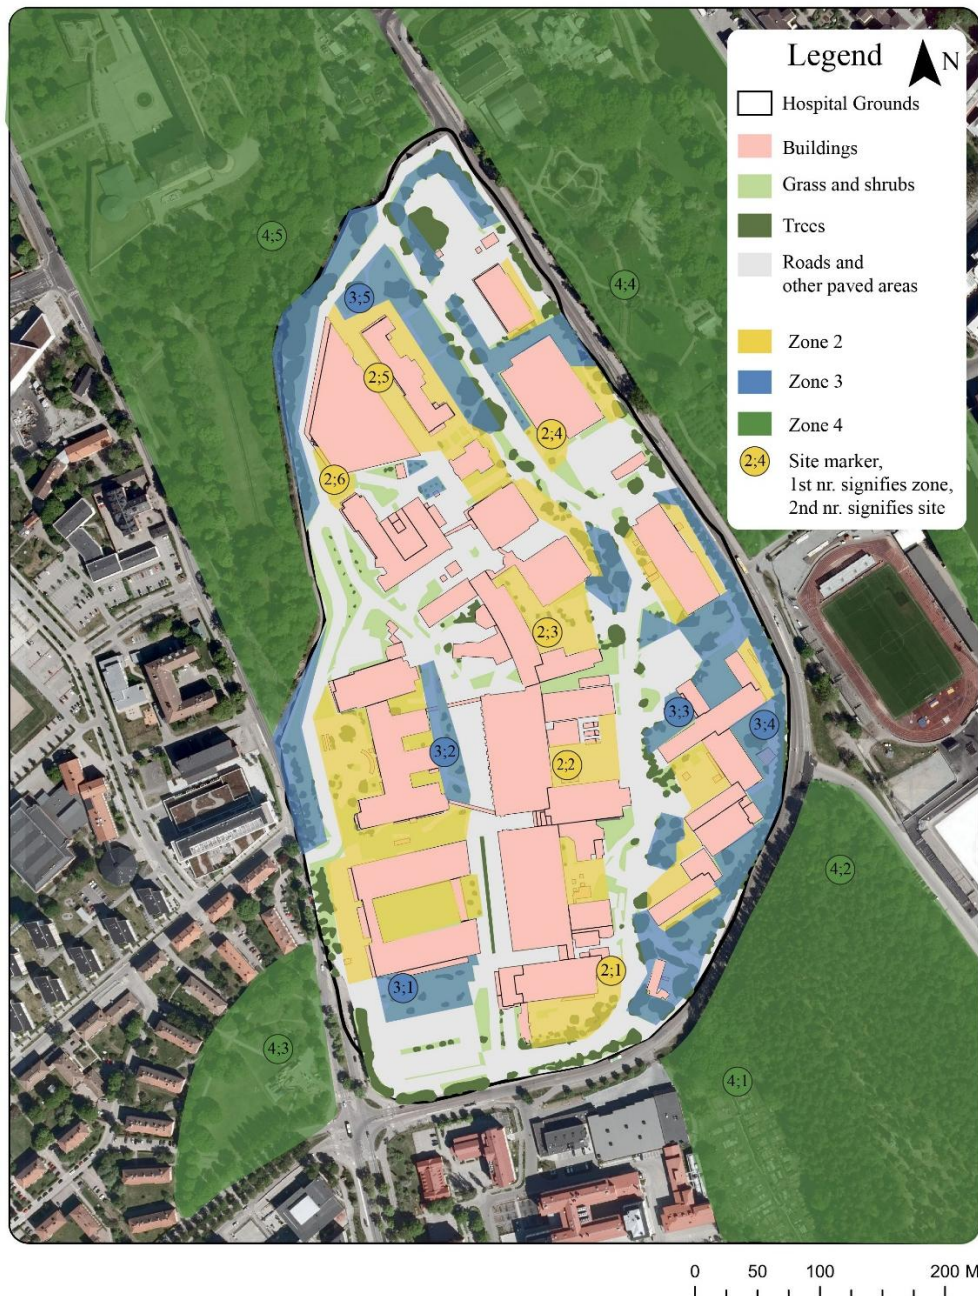
Figure 1. The map shows zones and sites using colour codes: yellow for Zone 2, blue for Zone 3, and green for Zone 4. E.g. a yellow marker labelled 2:1 indicates Zone 2, Site 1. Base map Lantmäteriet 2017.
