# **Evaluating the Rehabilitative Properties of the Outdoor Environments of Uppsala University Hospital:**

Application of Evidence-Based Design tools to an existing hospital.

Degree project/Independent project • 30 credits  
Swedish University of Agricultural Sciences, SLU  
Faculty of Natural Resources and Agricultural Sciences  
Landscape Architecture Programme - Uppsala  
Uppsala 2025

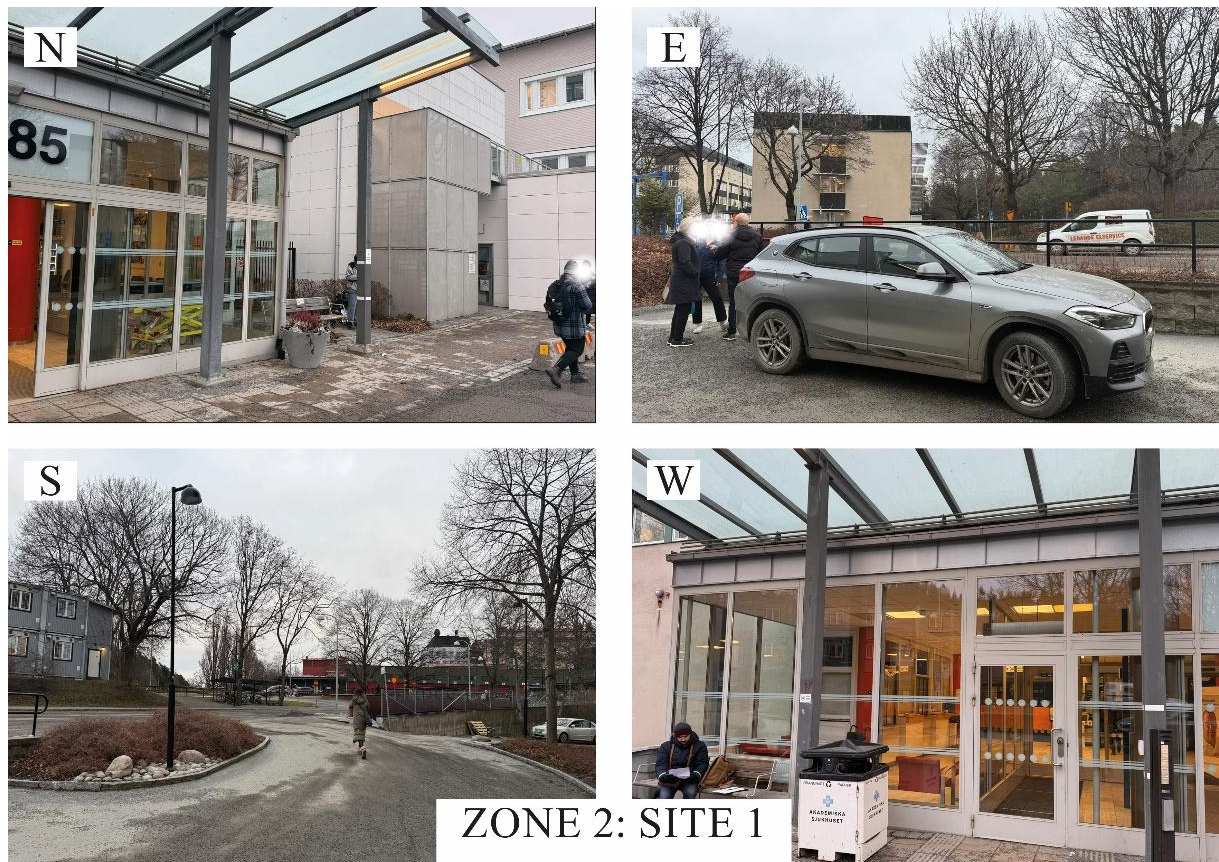
Figure 2. Photos from zone 2: site 1 facing north, east, south and west. Taken by author on 26-02-2025 [photography].

Zone 2: site 1 is located by entrance 85 (Google 2025). The site consists of an entrance area with a marked pick up/ drop off area, walls with fencing plants to the east to address the height differences of the site. To the southwest there is a rest-area with smoking disposal bins, large trees, hedges and a grass field, as well as a loading dock for hospital operations. There is a significant height difference there which is addressed through a large concrete wall and chain link fencing, seen in the south facing image above.

Section A: Comfortable	1 – 2 – 3 – 4 – 5 1 = not at all 2 = inadequate 3 = partially 4 = mostly 5 = fully	Observations/ Comments:
A1: Closeness and easy access	5	I am analyzing the entrance, so it is close.
A2: Enclosure and entrance	4	Surrounded nicely but the fencing/walls are visible.

A3: Safety and security	2	Physical comforts are good. Psychological not as much; viewed from inside, sitting next to a garbage can, wall+fence to the south is jarring. Cars keep coming.
A4: Familiarity	5	Simple and easy.
A5: Orientation and way finding	5	Simple and clear.
A6: Different options in different kinds of weather	5	Clear roof allows for sitting, standing, protection if needed.
<b>Section B: Access to nature</b>	<b>1 – 2 – 3 – 4 – 5</b> <b>1 = not at all</b> <b>2 = inadequate</b> <b>3 = partially</b> <b>4 = Mostly</b> <b>5 = fully</b>	<b>Observations/ Comments:</b>
B1: Contact with surrounding life	4	Plenty of people and cars coming and going. Major road visible. No animals.
B2: Social opportunities	2	There is one bench on either side of the entrance. There are also social places more in nature further away, to the southwest as well as across the road to the east, but this is not included in the site.

Zone 2: site 1 received an average grade of 4,3 for Section A comfortable qualities, and an average grade of 2 for Section B qualities for access to nature.

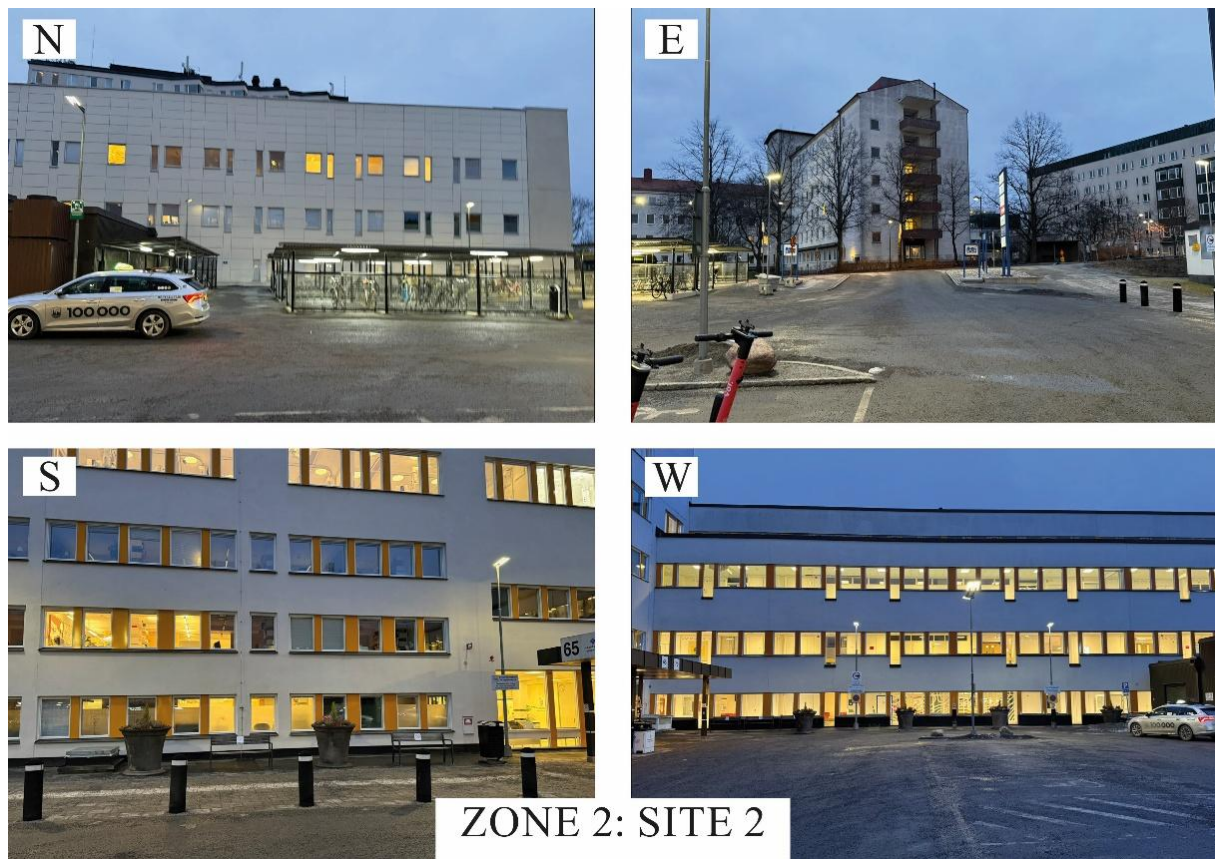
Figure 3. Photos from zone 2: site 2 facing north, east, south and west. Taken by author on 26-02-2025 [photography].

Zone 2: site 2 is located by entrance 65/70 (Google 2025). The site is mainly a parking lot for cars and bicycles. The main form of greenery is large pots with plants by the entrance.

Section A: Comfortable	1 – 2 – 3 – 4 – 5 1 = not at all 2 = inadequate 3 = partially 4 = mostly 5 = fully	Observations/ Comments:
A1: Closeness and easy access	5	It is accessible easily as it is the main entrance of this building.
A2: Enclosure and entrance	1	No enclosure. Entirely glass entrance leads to observed feeling from inside.
A3: Safety and security	2	A hard-paved area equals good physical safety, no sloping etc. Phytologically the area feels oppressive due to the lack of green.
A4: Familiarity	2	Easy to get to but the character of the site is distinctly that of a parking lot, so while easily

recognizable the association is not necessarily positive.
A5: Orientation and way finding	5	Largely uncomplicated and open area.
A6: Different options in different kinds of weather	3	There are benches placed both under roofing and outside of it, allowing for sun or protection from rain depending on weather. Opportunities for other activities are lacking.
<b>Section B: Access to nature</b>	<b>1 – 2 – 3 – 4 – 5</b> <b>1 = not at all</b> <b>2 = inadequate</b> <b>3 = partially</b> <b>4 = mostly</b> <b>5 = fully</b>	<b>Observations/ Comments:</b>
B1: Contact with surrounding life	5	High traffic pick up/drop off area.
B2: Social opportunities	2	Seating is accessible as well as potted plants to observe or discuss, otherwise lacking in social opportunities.
B3: Joyful and meaningful activities	1	Seated activities available, any other activities not available.
B4: Culture and connection to past times	1	None.

Zone 2: site 2 received an average grade of 3 for Section A comfortable qualities, and an average grade of 1,5 for Section B qualities for access to nature.

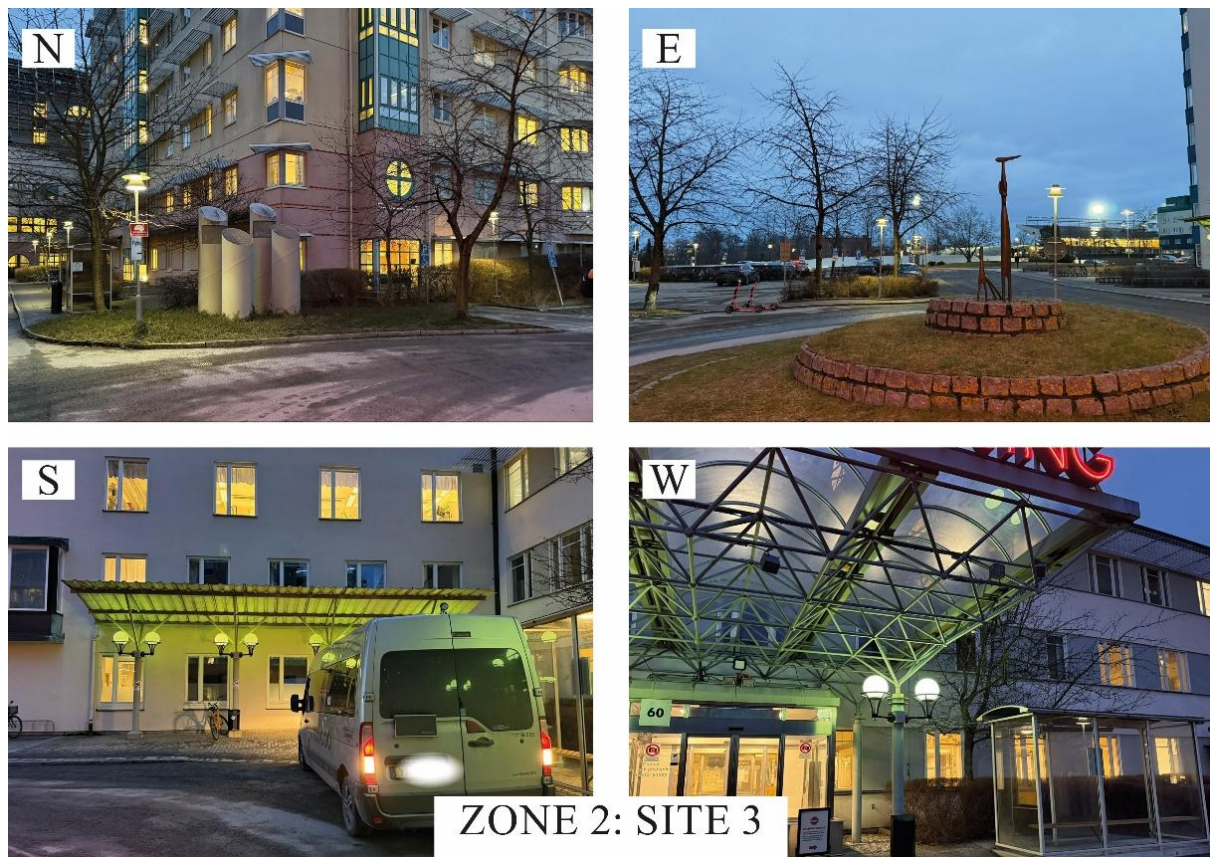
Figure 4. Photos from zone 2: site 3 facing north, east, south and west. Taken by author on 26-02-2025 [photography].

Zone 2: site 3 is located by the entrance to the emergency ward (Google 2025). Right by the entrance there are smokers' cubes with seating. There is a cultural roundabout with an artwork in it, as well as an area to the northwest with additional seating, smoking cube, bicycle parking, trees and bushes.

Section A: Comfortable	1 – 2 – 3 – 4 – 5 1 = not at all 2 = inadequate 3 = partially 4 = mostly 5 = fully	Observations/ Comments:
A1: Closeness and easy access	5	It is accessible easily as it is the main entrance of this building.
A2: Enclosure and entrance	4	Main entrance is open but more enclosed area to the northwest is available.
A3: Safety and security	4	Protected both psychologically and physically. The parking areas are not as oppressive or intruding as they could be. High traffic area but the opportunity to go further away to a more protected area does much. The signage is

neon red and could be psychologically disturbing.
A4: Familiarity	5	Easily accessed and familiar.
A5: Orientation and way finding	5	Distinct roundabout with artwork does much as a landmark for the site. Older trees add additional character.
A6: Different options in different kinds of weather	3	Three smoking cubes allow for resting and smoking outside, but there is a lack of roofed seating for non-smokers.
<b>Section B: Access to nature</b>	<b>1 – 2 – 3 – 4 – 5</b> <b>1 = not at all</b> <b>2 = inadequate</b> <b>3 = partially</b> <b>4 = mostly</b> <b>5 = fully</b>	<b>Observations/ Comments:</b>
B1: Contact with surrounding life	5	High traffic pick up/drop off area.
B2: Social opportunities	4	Seating farther away allows for more restful conversation as well as potential other activities. Large trees to discuss.
B3: Joyful and meaningful activities	2	Allows for seating, smoking, bike-parking, pick up, drop off. However, the site is still too exposed and high trafficked to allow for therapeutic or physical activities.

Zone 2: site 3 received an average grade of 4,3 for Section A comfortable qualities, and an average grade of 2,6 for Section B qualities for access to nature.

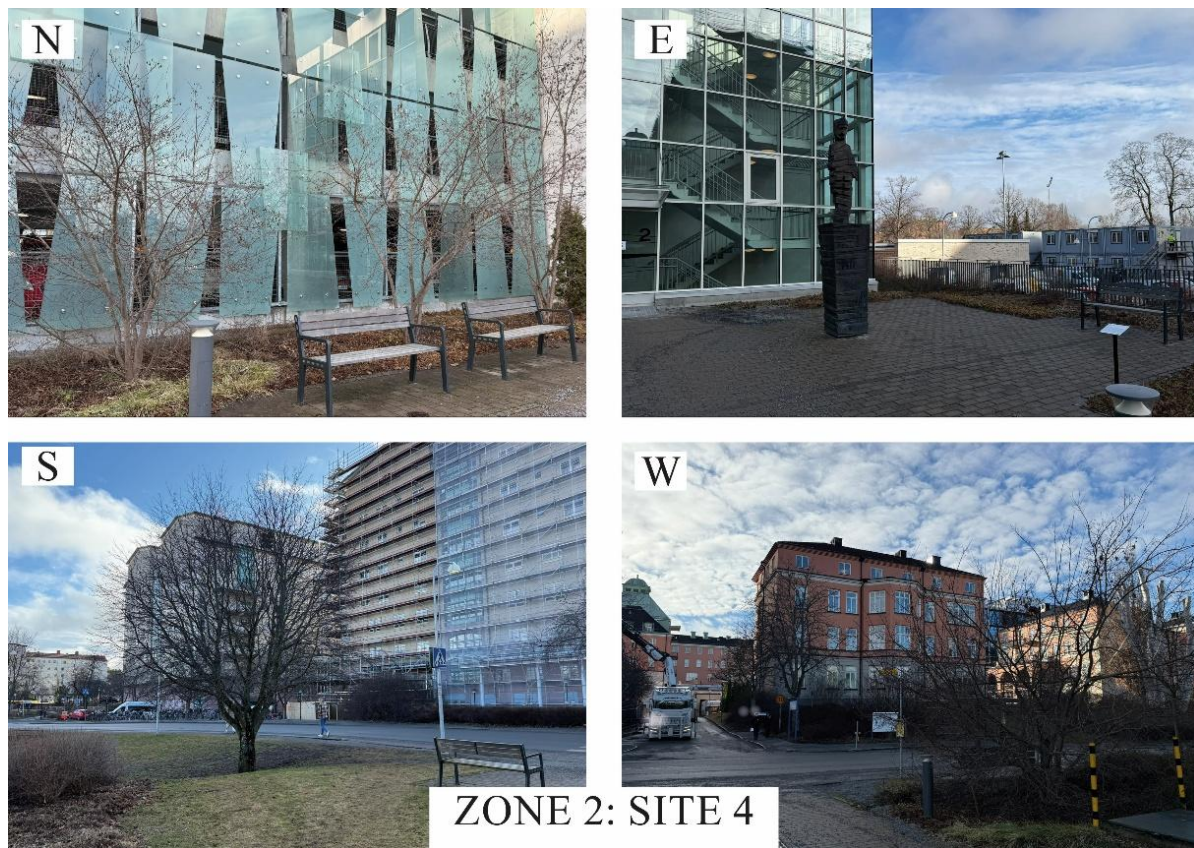
Figure 5. Photos from zone 2: site 3 facing north, east, south and west. Taken by author on 27-02-2025 [photography].

Zone 2: site 5 is located by the entrance to the major parking garage of the hospital grounds (Google 2025). East and north of the site, the parking garage is adjacent. To the west of the site major construction is ongoing. A big tree can be seen to the south, and right by the entrance there is a statue/artwork.

Section A: Comfortable	1 – 2 – 3 – 4 – 5 1 = not at all 2 = inadequate 3 = partially 4 = mostly 5 = fully	Observations/ Comments:
A1: Closeness and easy access	5	I am analyzing the entrance, so it is close.
A2: Enclosure and entrance	2	Trees at the back behind the benches add some sense of protection, but site is largely open. Fencing is visible.
A3: Safety and security	4	Open and easily overlookable area with plants at the back feels safe psychologically, with exception for visible fence (southeast) with height difference behind it. The ground is flat and paved with ground pavers.

Zone 2: site 4 received an average grade of 3,7 for Section A comfortable qualities, and an average grade of 2,6 for Section B qualities for access to nature.

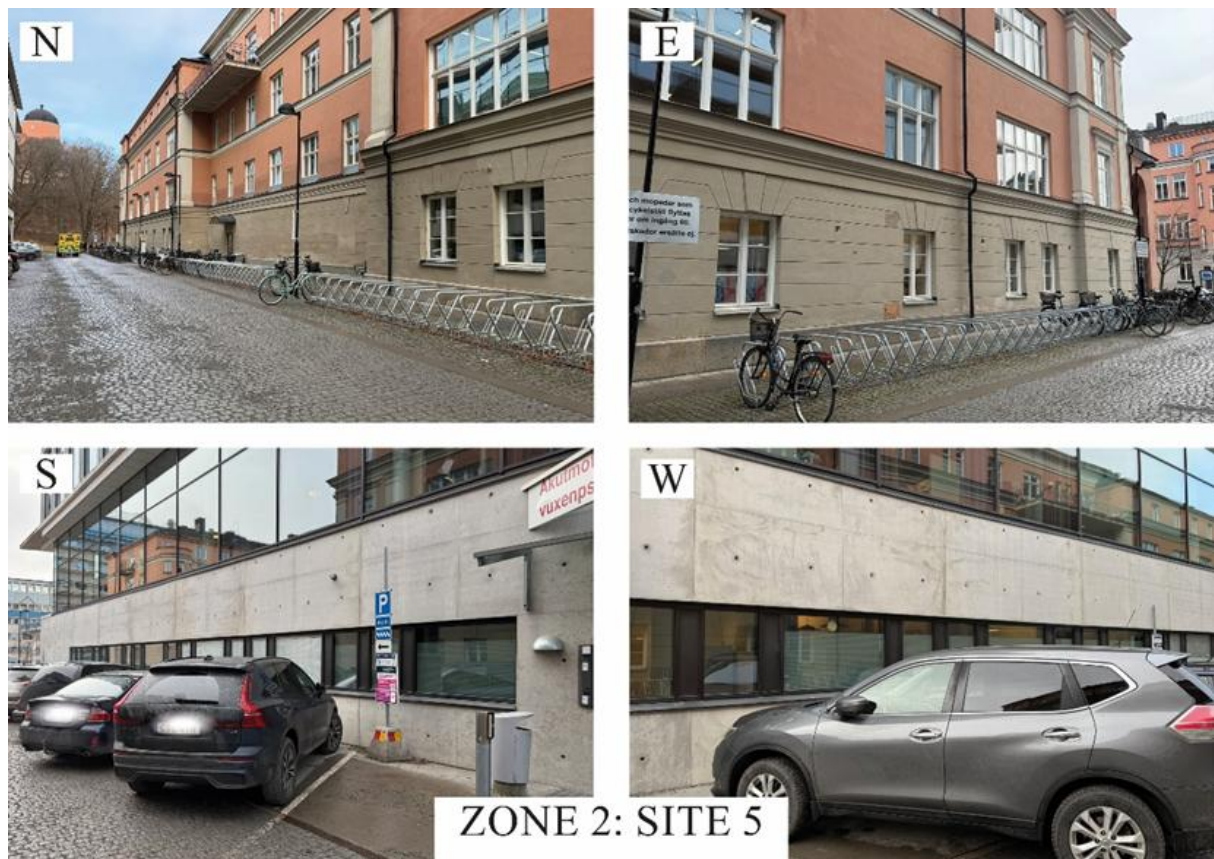
Figure 6. Photos from zone 2: site 5 facing north, east, south and west. Taken by author on 27-02-2025 [photography].

Zone 2: site 5 is located by the entrance to the emergency ward for adult psychiatry (Google 2025). The area acts as a narrow passage between two buildings with mixed traffic utilising the cobble area. Car parking on either side of the entrance to the south and west, and bicycle parking across on the other side. To the far northwest Uppsala Castle can be seen with large trees beneath it. To the southwest a single tree can be seen, as well as ongoing construction.

Zone 2: site 4 received an average grade of 1,7 for Section A comfortable qualities, and an average grade of 1,4 for Section B qualities for access to nature. This is the site most needing improvement of all the sites in zone 2.

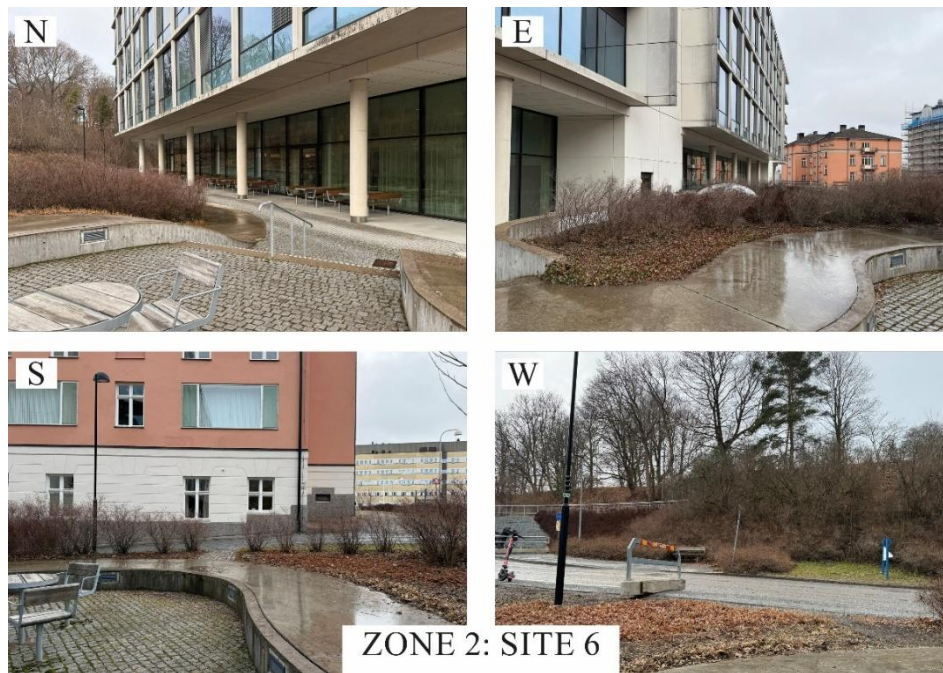
Figure 7. Photos from zone 2: site 6 facing north, east, south and west. Taken by author on 27-02-2025 [photography].

Zone 2: site 6 is located on the back side of the psychiatry building (Google 2025) and is the only site in zone 2 not near an entrance. It was selected to balance the report, as it seems to compensate for limited green space elsewhere, particularly at zone 2 site 5. It consists of a semi-enclosed seating area with cobble stones and cast-in-place concrete that is about 30cm below road level with trimmed hedges surrounding the concrete. To the north, a covered cafeteria area is accessible via stairs. The site includes notable height differences, with a green, sloped area to the east and north showing wilder nature.

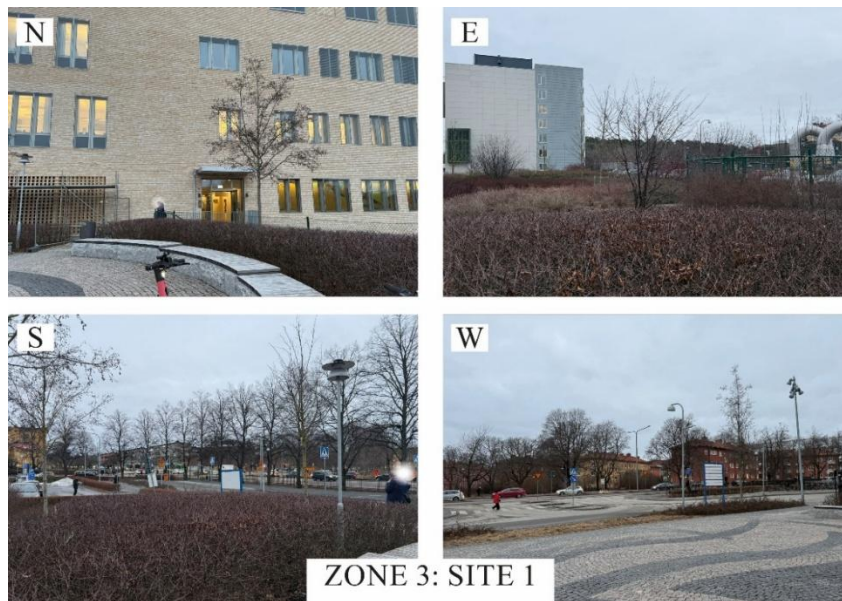
Figure 8. Photos from zone 3 site 1 facing north, east, south and west. Taken by author on 26-02-2025 [photography].

The green area where the exact site is marked is inaccessible trimmed hedges, and thus the closest reasonable area was chosen, a paved plaza area right next to it. The area is signified by a patterned cobble stones in light and dark stones, as well as stone seating made custom for the site with roughhewn sides and a wooden seating area.

Zone 3: site 1 received an average grade of 4 for Section A comfortable qualities, and an average grade of 3,6 for Section B qualities for access to nature.

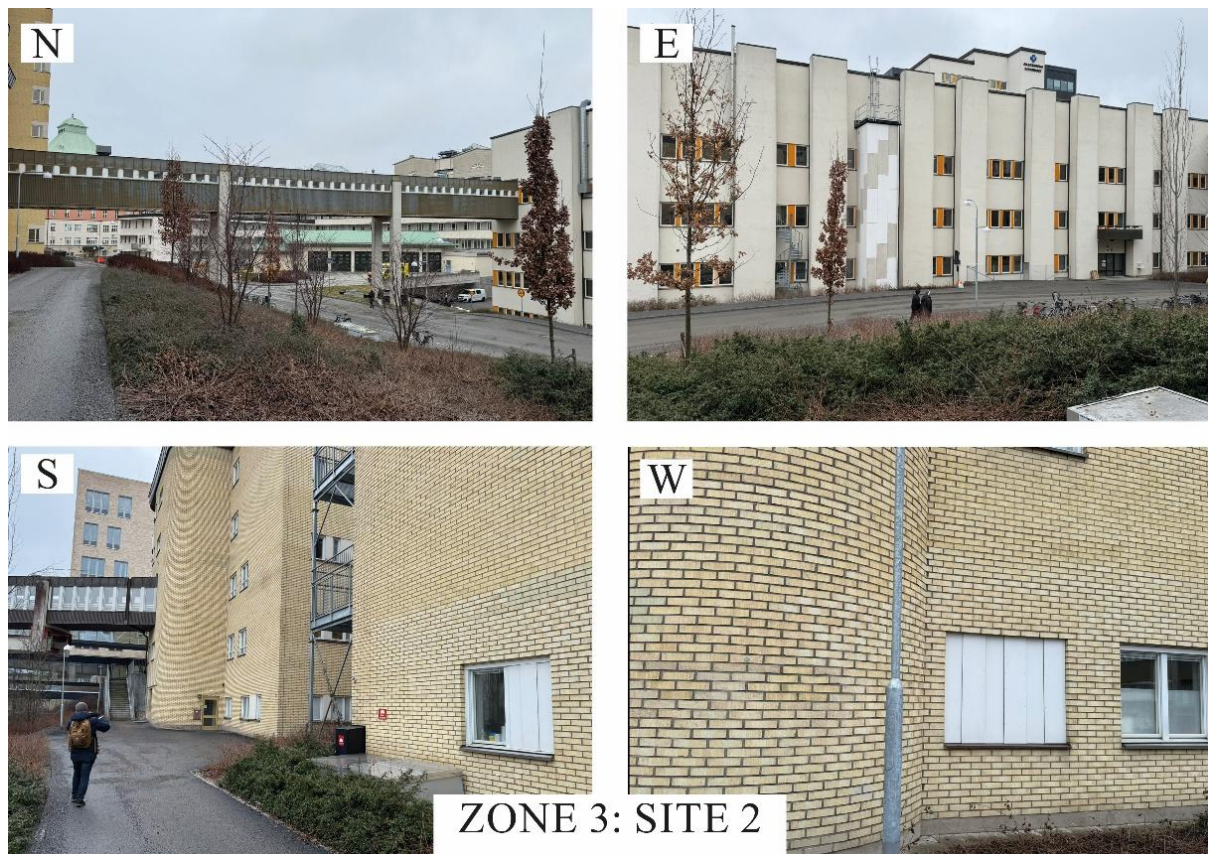
Figure 9. Photos from zone 3 site 2 facing north, east, south and west. Taken by author on 26-02-2025. [photography].

The actual site chosen was in the slope, in the bushes. As that location is inaccessible, the closest accessible site was chosen, just to the west of the originally marked site on a paved road. The site consists of a slope covered in low bushes, and a road above it connecting two different courtyards. The slope covers a large height difference and is largely inaccessible. Acts as a pathway between different departments, and as a way to take up the large height difference. The analysis is of the site in zone 3, not of the connecting courtyards defined as zone 2. Thus the attributes of these courtyards will be excluded in the analysis.

Zone 3: site 2 received an average grade of 1,4 for Section A comfortable qualities, and an average grade of 1,8 for Section B qualities for access to nature.

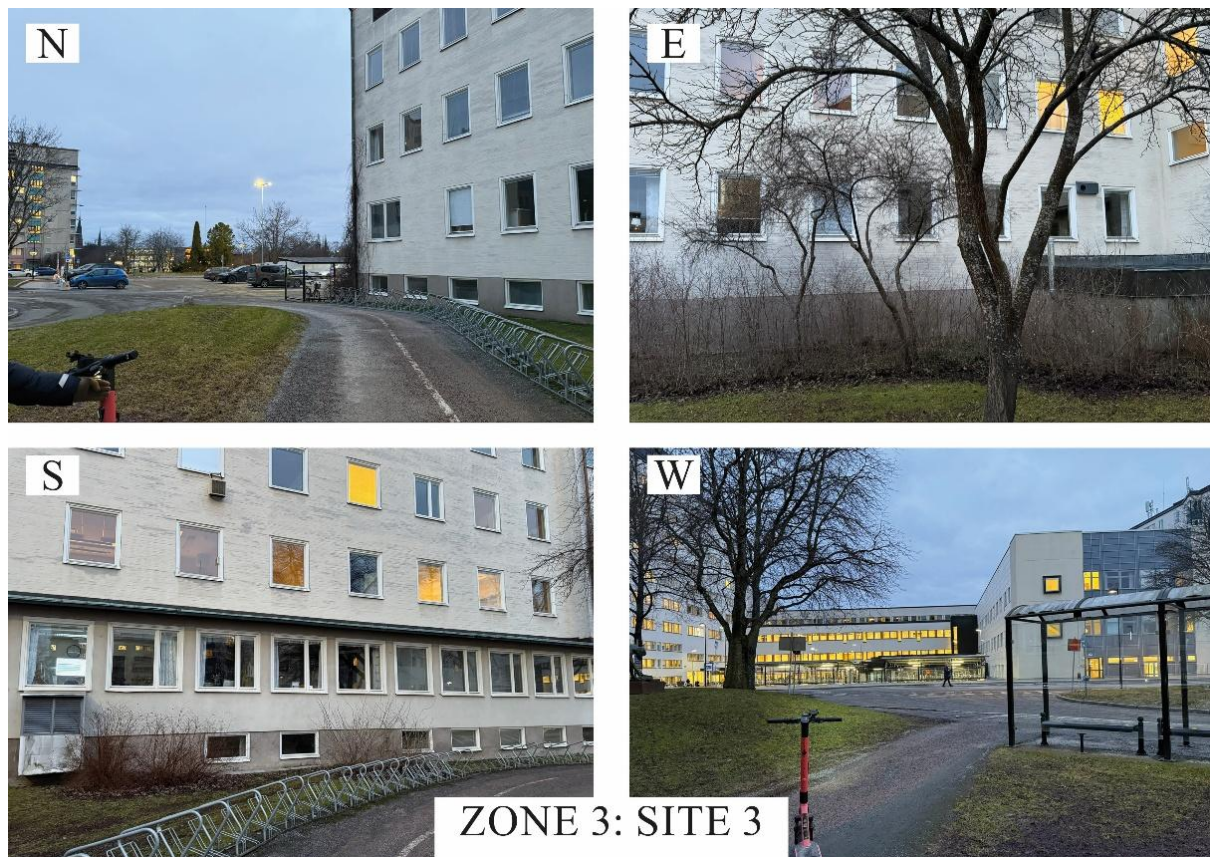
Figure 10. Photos from zone 3 site 3 facing north, east, south and west. Taken by author on 26-02-2025 [photography].

The site consists of a bike and walking lane lined with bike racks all along the east side of the road. There are some large trees, some bushes and hedges, but the main vegetation type is grass. There is a statue of a man sitting to the southwest, and a bus stop with roofing and benches. The site is located at the backside of the building and faces Zone 2: site 2 to the west, which is located by entrance 65/70 (Google 2025).

Zone 3: site 3 received an average grade of 2,6 for Section A comfortable qualities, and an average grade of 2,2 for Section B qualities for access to nature.

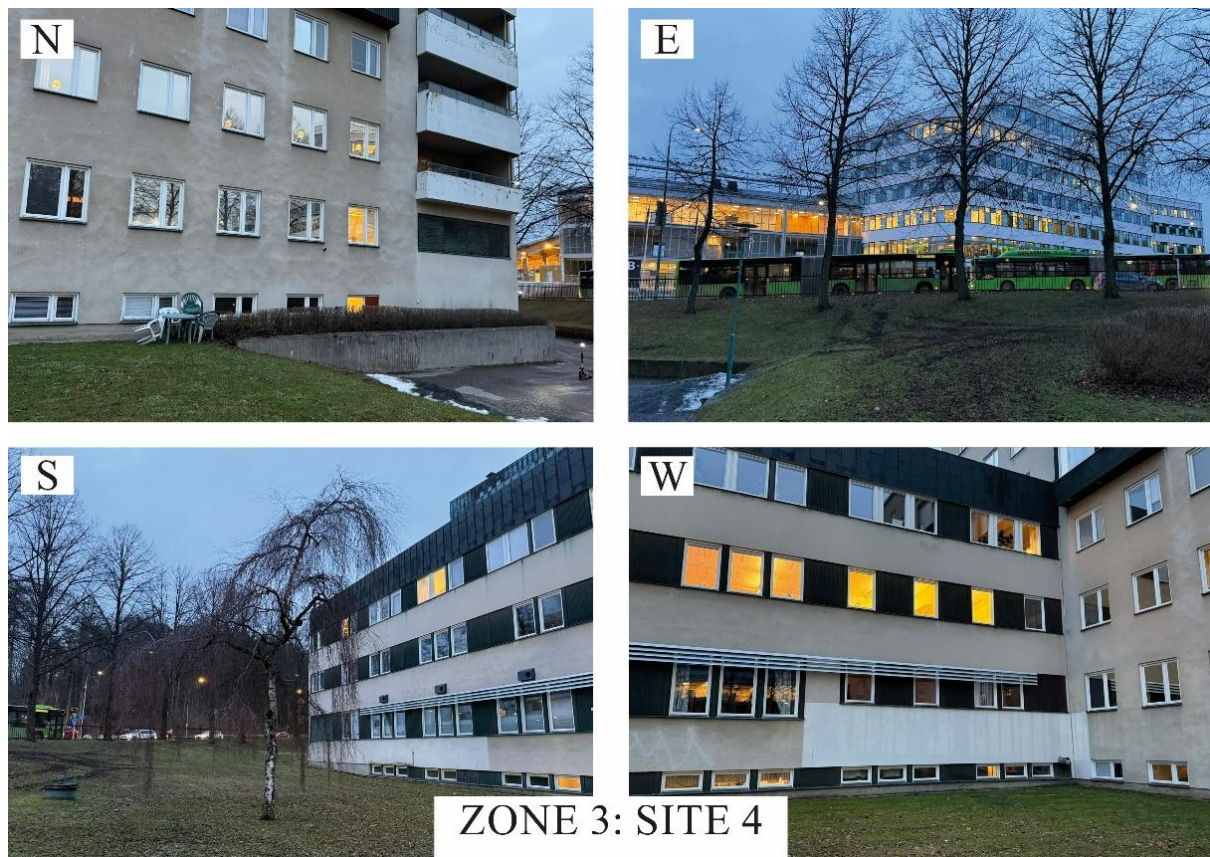
Figure 11. Photos from zone 3 site 4 facing north, east, south and west. Taken by author on 26-02-2025 [photography].

The site is located at the backside of the building for Nephrology Department, between entrance 77 and entrance 79 (Google 2025). The site has significant height differences and consists mainly of a trimmed grass field enclosed by large trees and a black fence from east to south. To the north there is a paved road leading to the site which ends in a cul-de-sac. Trimmed hedges and a concrete wall solve the height difference of the building to street level there. To the south a culturally significant weeping birch stands alone (*Betula Pendula* “Youngii”). Informal seating exists in the form of plastic lawn chairs and table.

Zone 3: site 4 received an average grade of 1,8 for Section A comfortable qualities, and an average grade of 2 for Section B qualities for access to nature.

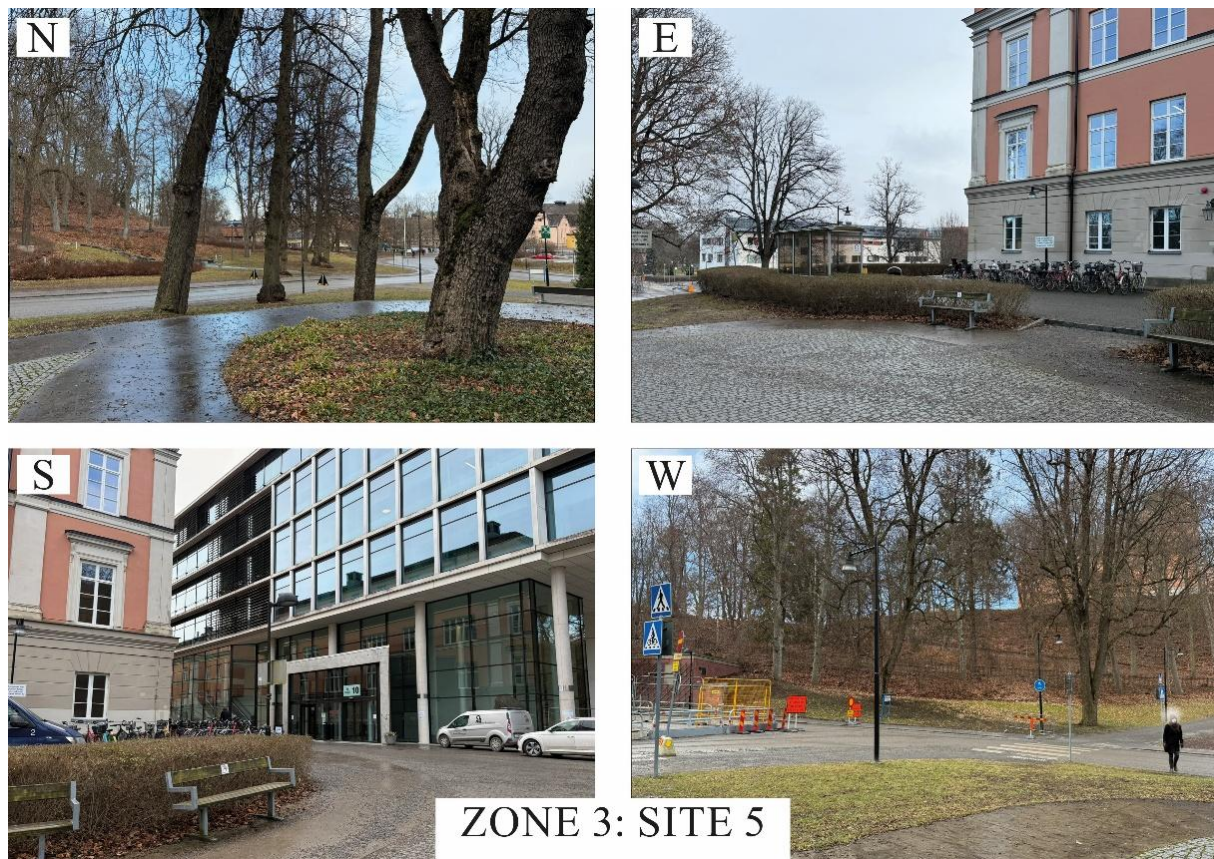
Figure 12. Photos from zone 3 site 5 facing north, east, south and west. Taken by author on 27-02-2025 [photography].

The site is located at the main entrance of the psychiatry building, which is entrance 10 and can be seen to the south of the site (Google 2025). On the south east there are benches backed by trimmed hedges, and beyond that is bicycle parking. To the west is a construction zone, and beyond it and to the north is a forest with large coniferous trees and significant height differences. Up on the hill to the west is Uppsala Castle. To the far north there is a fountain and designed area which is hard to see. Beyond it, to the northeast, is the start of the city centre of Uppsala.

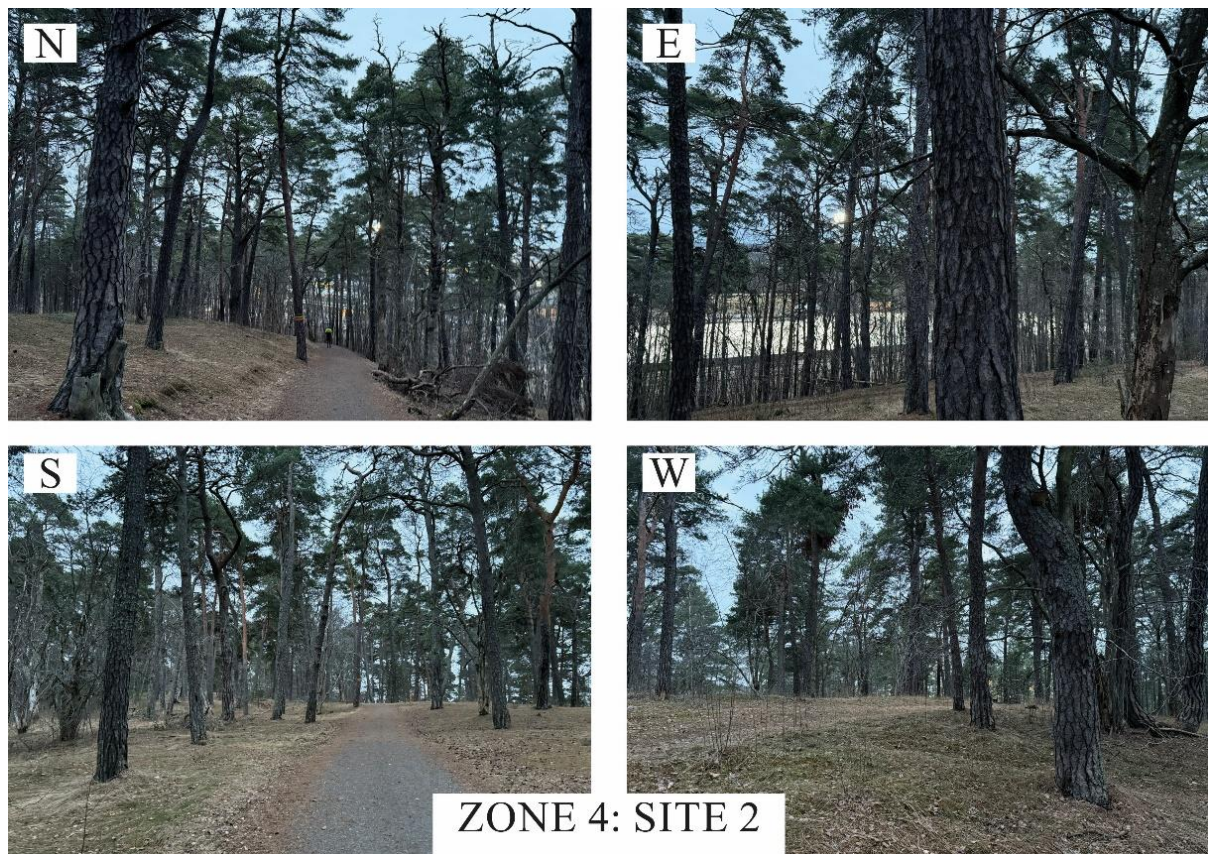
Figure 14. Photos from zone 4 site 2 facing north, east, south and west. Taken by author on 26-02-2025 [photography].

The site is located about 350m away from the entrance 79/77 of Uppsala University Hospital measured by pedestrian movement through the Lantmäteriet measurement tool (Lantmäteriet 2025). Entrance 77 is next to zone 3 site 3 (Google 2025). Because there is fencing along the road, the real life distance is further than what it appears on the map initially. I chose to place Zone 4 site 2 far into the forest, 120m past the forest entry to allow for full immersion of the forest as the road separating the hospital ground and the forest is highly trafficked and to crest the hill.

Zone 4: site 2 received an average grade of 3 for Section A comfortable qualities, and an average grade of 3,8 for Section B qualities for access to nature.

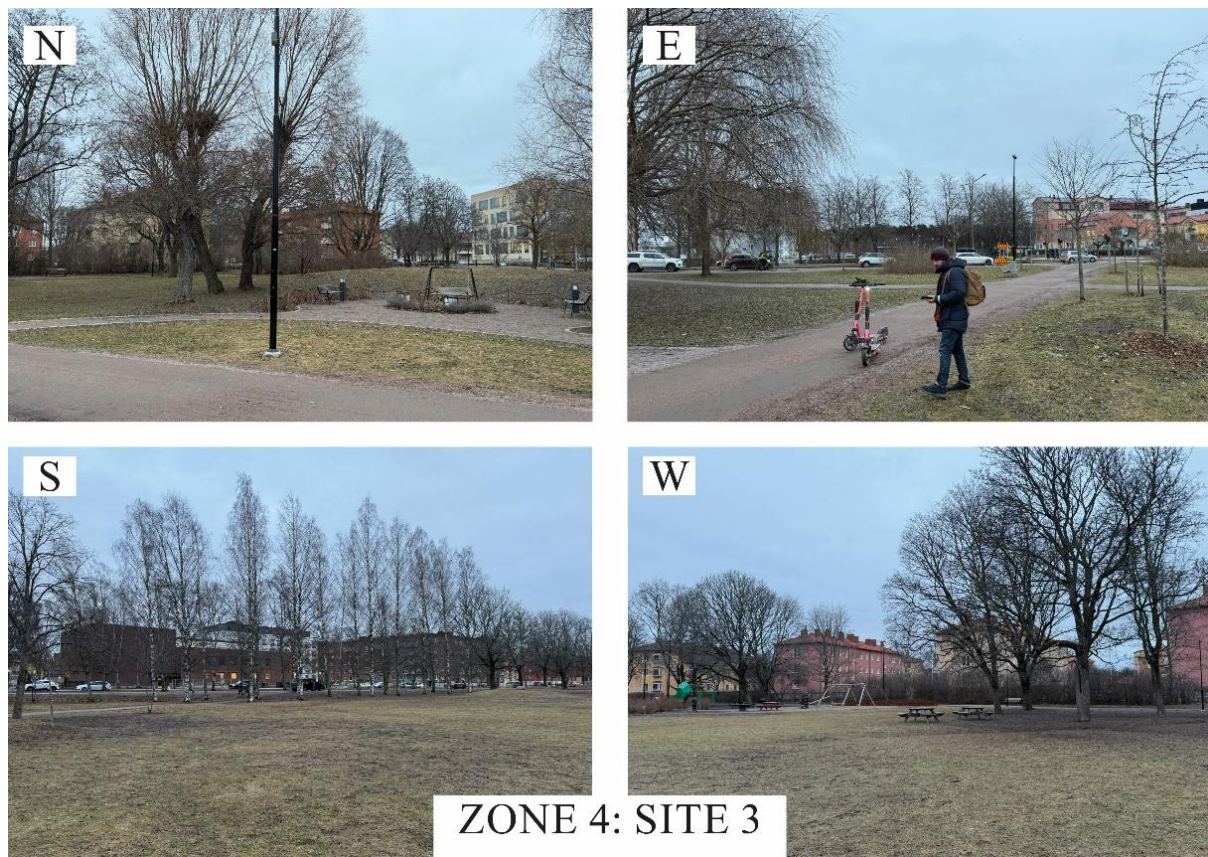
Figure 15. Photos from zone 4 site 3 facing north, east, south and west. Taken by author on 26-02-2025 [photography].

The site is located about 160m away from the entrance 100/101 of Uppsala University Hospital measured by pedestrian movement through the Lantmäteriet measurement tool (Lantmäteriet 2025). Entrance 100/101 is next to zone 3 site 1.

Zone 4: site 2 received an average grade of 3,7 for Section A comfortable qualities, and an average grade of 4,3 for Section B qualities for access to nature.

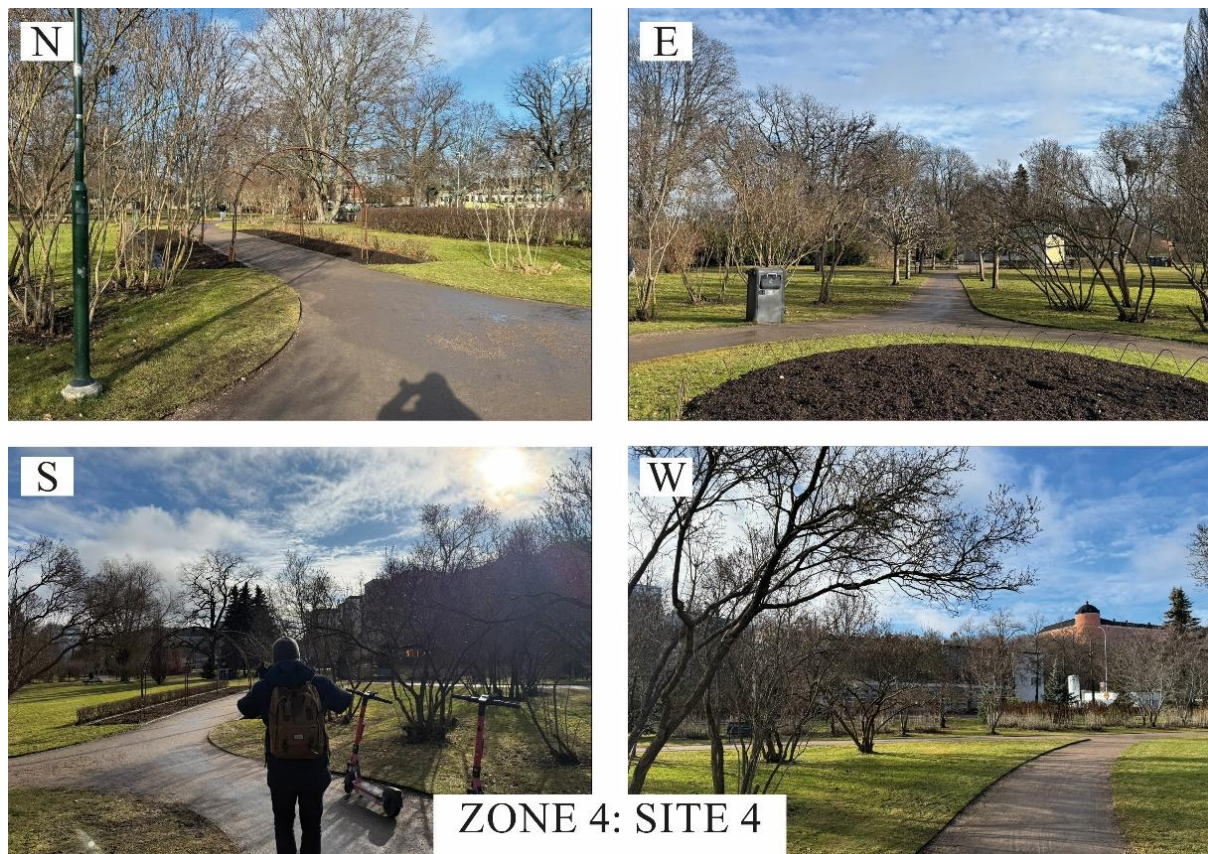
Figure 16. Photos from zone 4 site 4 facing north, east, south and west. Taken by author on 26-02-2025 [photography].

The site is located about 160m away from the entrance to the staff gym facility of Uppsala University Hospital measured by pedestrian movement through the Lantmäteriet measurement tool (Lantmäteriet 2025). The entrance of the gym facility is next to the parking garage of the hospital grounds.

Zone 4: site 4 received an average grade of 4,7 for Section A comfortable qualities, and an average grade of 4,2 for Section B qualities for access to nature.

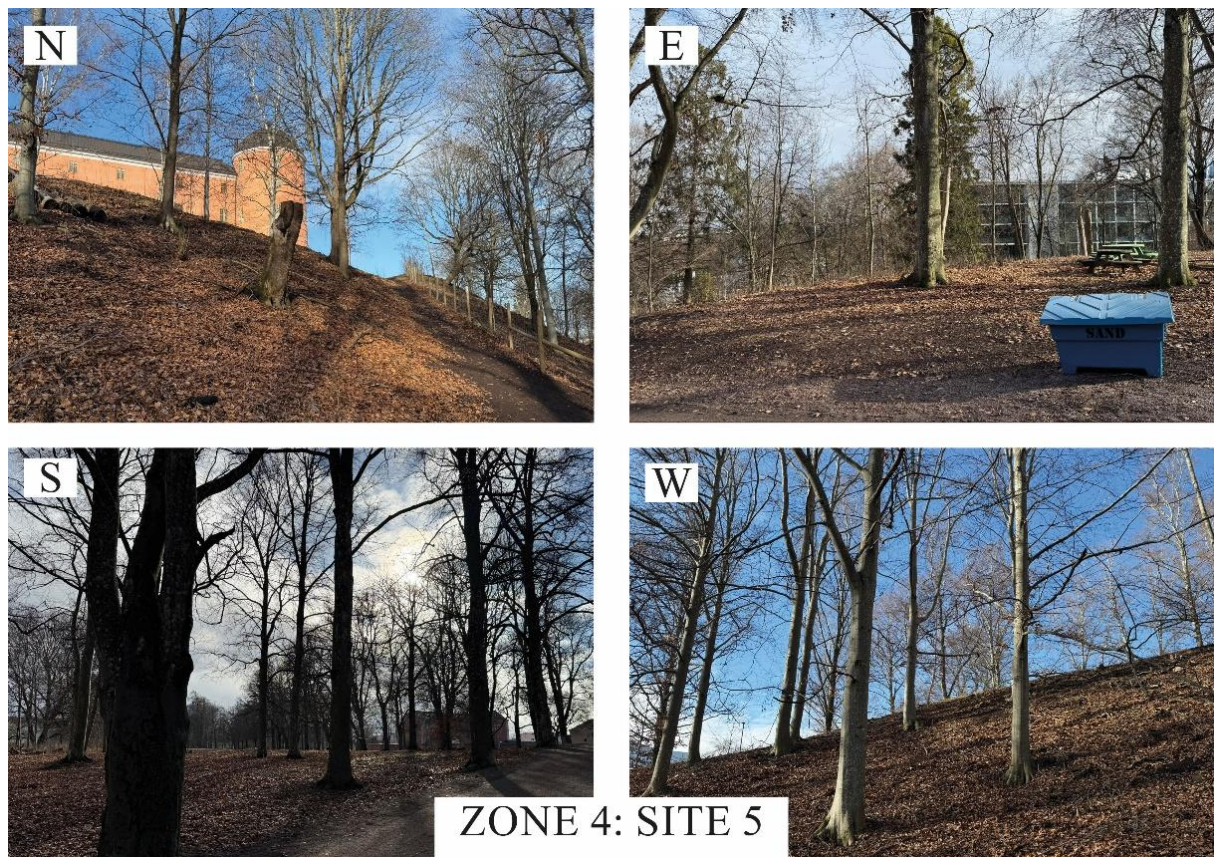
Figure 17. Photos from zone 4 site 5 facing north, east, south and west. Taken by author on 27-02-2025 [photography].

The site is located about 120m away from the main entrance of the psychiatry building (entrance 10) of Uppsala University Hospital measured by pedestrian movement through the Lantmäteriet measurement tool (Lantmäteriet 2025). Entrance 10 is next to zone 3 site 5 (Google 2025). The study area comprises a forested, sloping hill dominated by large coniferous trees, upon which Uppsala Castle is situated. Seating exists to the east.
